**Review of liquefaction hazard
information in eastern
Canterbury, including
Christchurch City and parts of
Selwyn, Waimakariri and
Hurunui Districts**

Report No. R12/83

**Institute of Geological and Nuclear
Sciences Limited (GNS Science)**

GNS Science Consultancy Report 2012/218

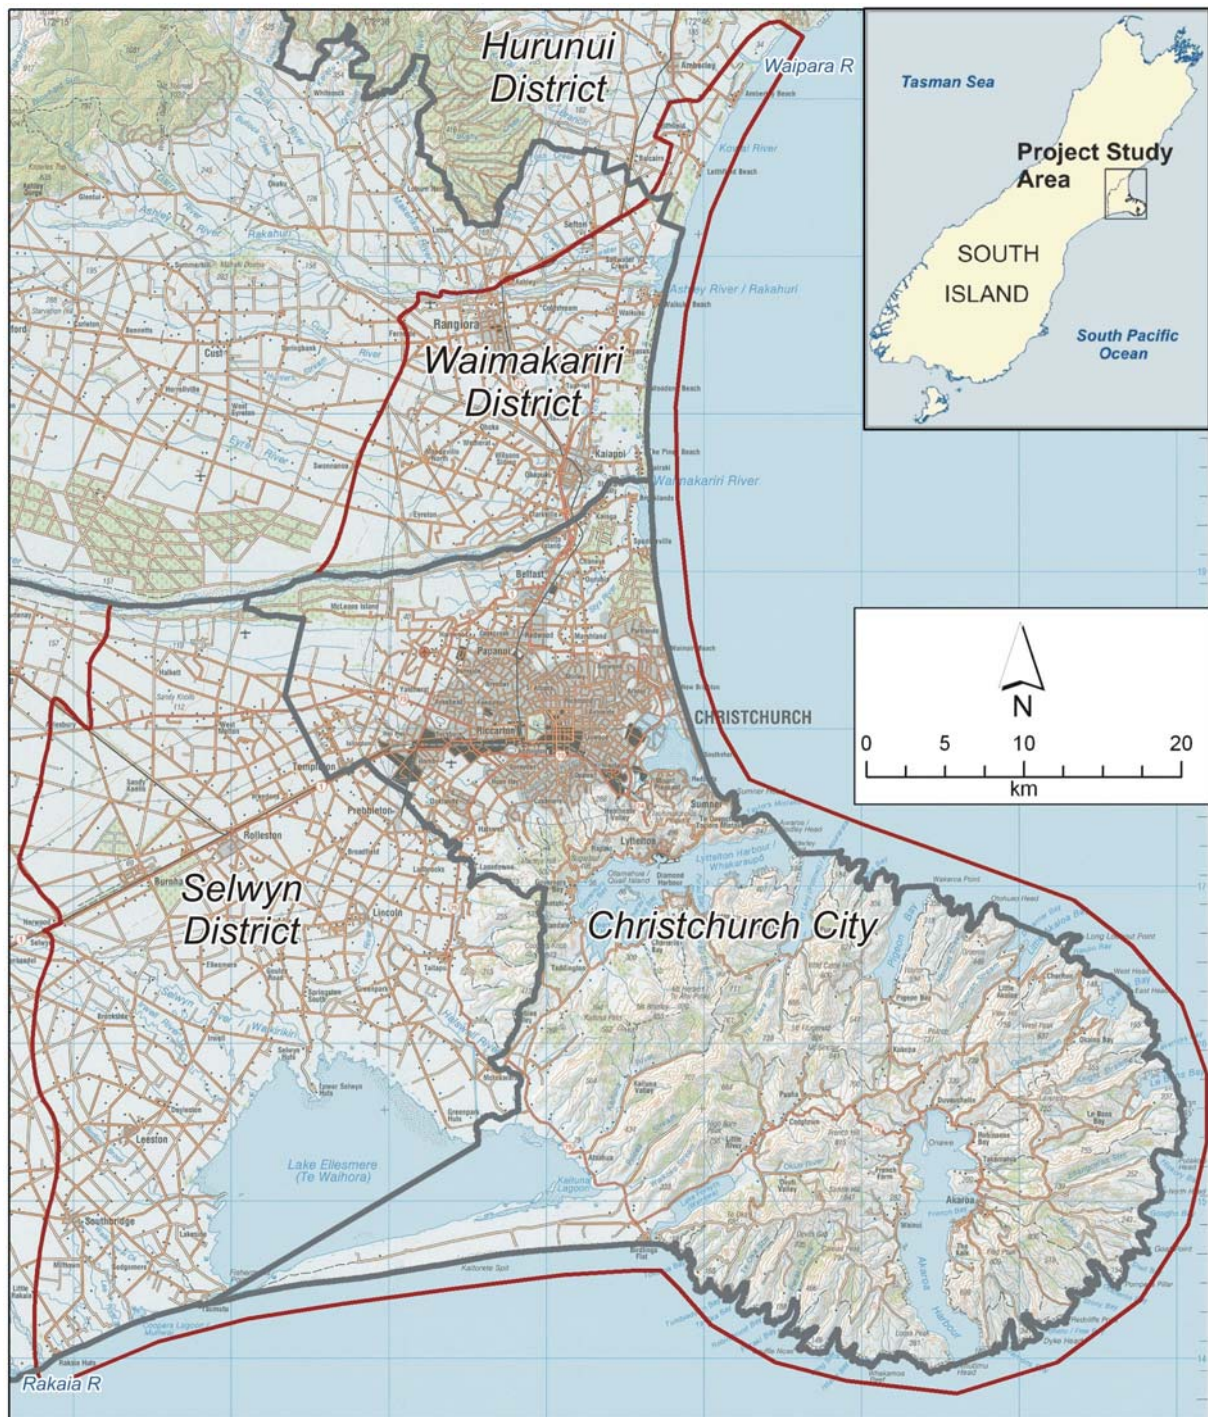
Figure 1.1 Map of the project area (outlined in red).

The project area is shown in Figure 1.1. It covers an area of eastern Canterbury bordering the coastline between the Rakaia and Waipara Rivers and includes Christchurch city (including Banks Peninsula) and parts of Selwyn, Waimakariri and Hurunui districts. It excludes those parts of the Christchurch urban area that have been assigned a Foundation Technical Category (TC) by the Department of Building and Housing (DBH) because those areas already have specific conditions and guidance regarding planning and building requirements^{1, 2}.

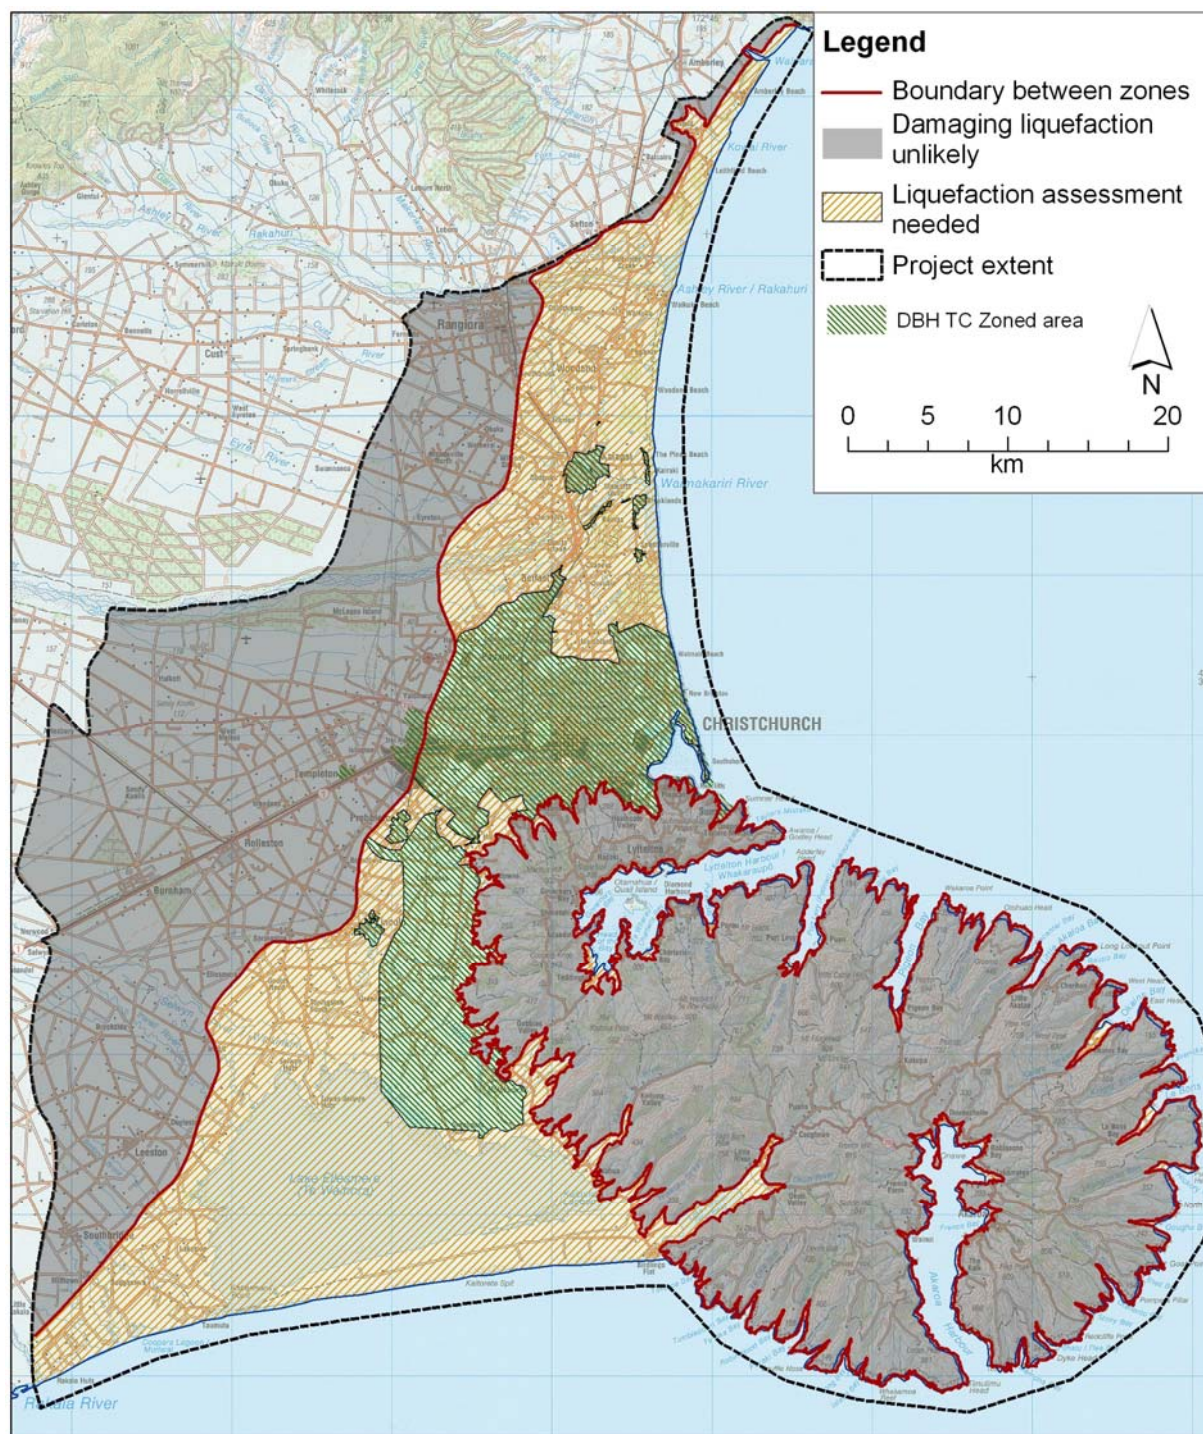
Figure 2.1 Liquefaction assessment area map for the eastern Canterbury project area. Liquefaction susceptibility is categorised in two areas, “damaging liquefaction unlikely” and “liquefaction assessment needed”. The area covered by DBH Technical Categories at the time of this report is excluded.

1. Liquefaction susceptibility - identifying areas susceptible to liquefaction (Figure 2.1);
2. Probabilistic liquefaction hazard - mapping variations in the extent of liquefaction for different earthquake shaking scenarios (Appendix 6).

These data provide the ability to spatially differentiate liquefaction susceptibility. This information was calibrated against observations of liquefaction that occurred during the 2010 Darfield and 2011 Christchurch earthquakes (Appendix 3) to produce the liquefaction susceptibility zones (Figure 2.1).

GIS shapefiles of the liquefaction assessment areas are provided in the enclosed CD, and should be used when more detail is required than that presented in Figure 2.1.

The liquefaction susceptibility zonation map (Figure 2.1) is intended primarily for use by territorial authority staff to help them:

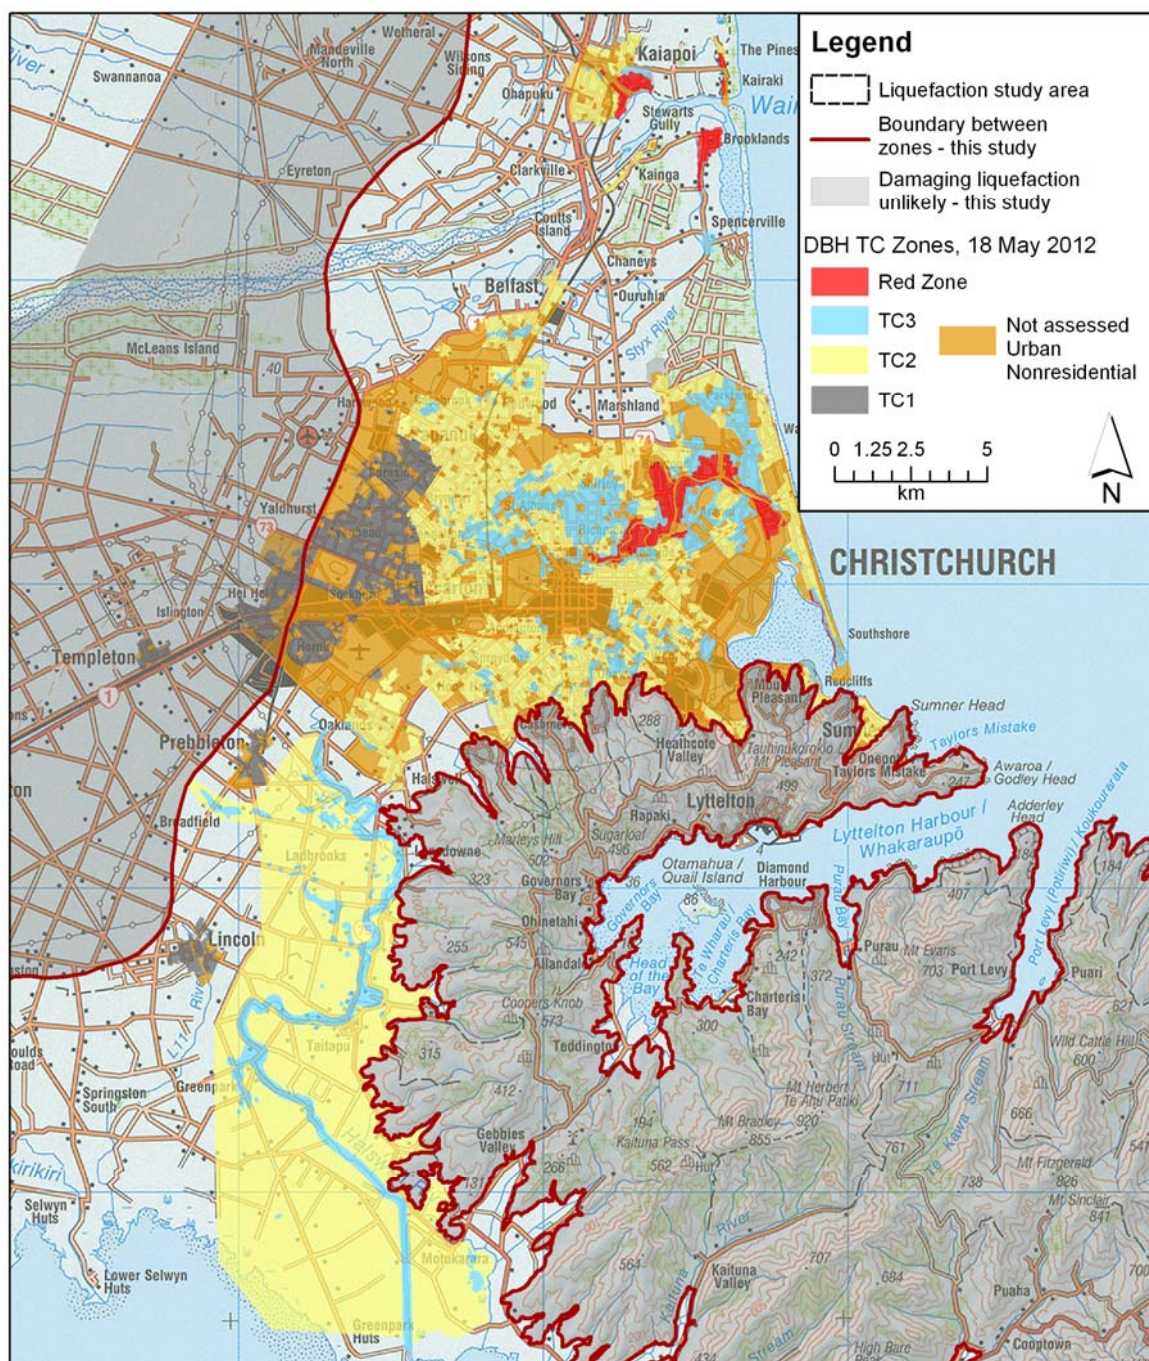
Figure A1.1 DBH Foundation Technical Category zones.

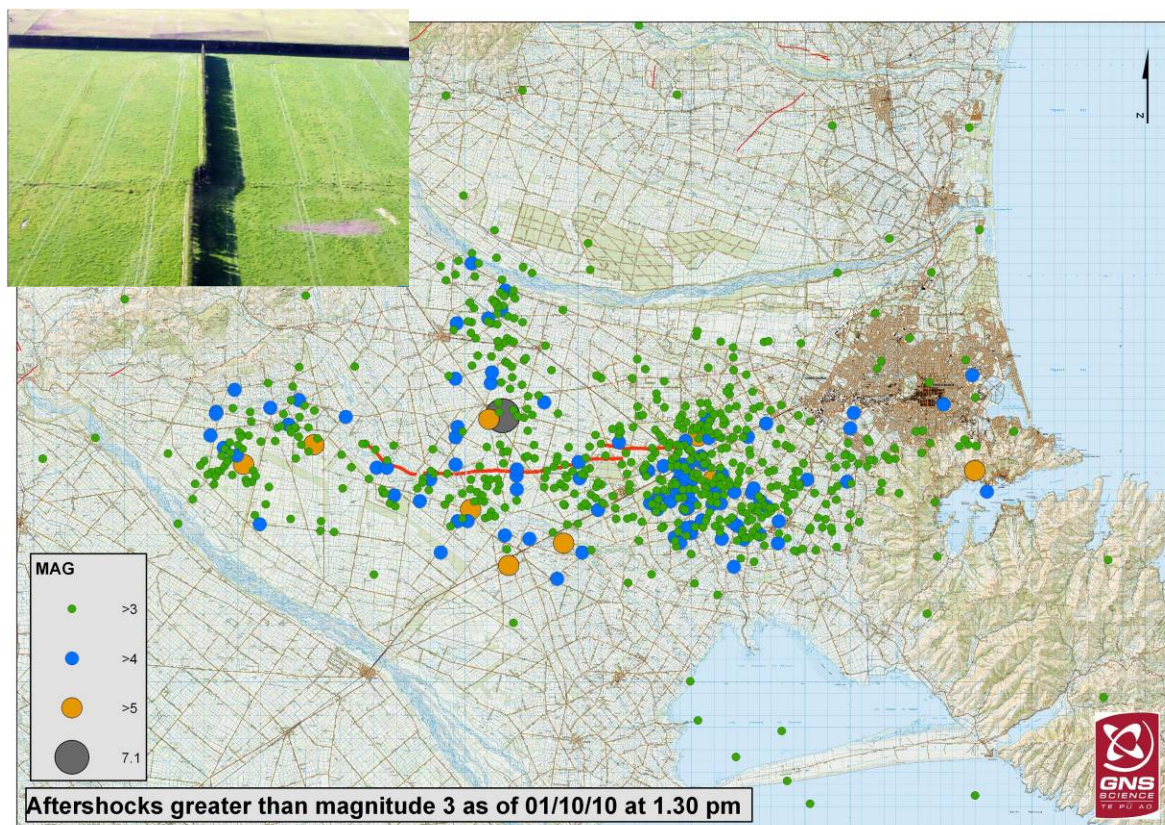
Figure A2.1 Location of the mainshock and aftershocks of the 4 September 2010 earthquake sequence, as of 1 October 2010. The surface fault rupture of the Greendale Fault is illustrated by the bold red line to the south of the M_w 7.1 mainshock. The inset shows a displaced hedge-row and wheel tracks along the strike-slip fault scar west of Rolleston. Strike-slip displacement of several metres occurred at this locality (Barrell et al., 2011; Quigley et al., 2012). Photo: R Jongens, GNS Science.

A 29-km long east-west trending fault rupture on the Canterbury Plains extended to within 18 km of the Christchurch urban area. The fault surface rupture had primarily strike-slip (sideways) motion, clearly shown by offset ground-surface features along the fault trace (Figure A2.1). However, records from strong-motion seismographs and geodetic data indicate that the subsurface fault movement was complex, including an important reverse (compressional) component. The duration of strong ground motions on sites with firm soils was about 15 seconds.

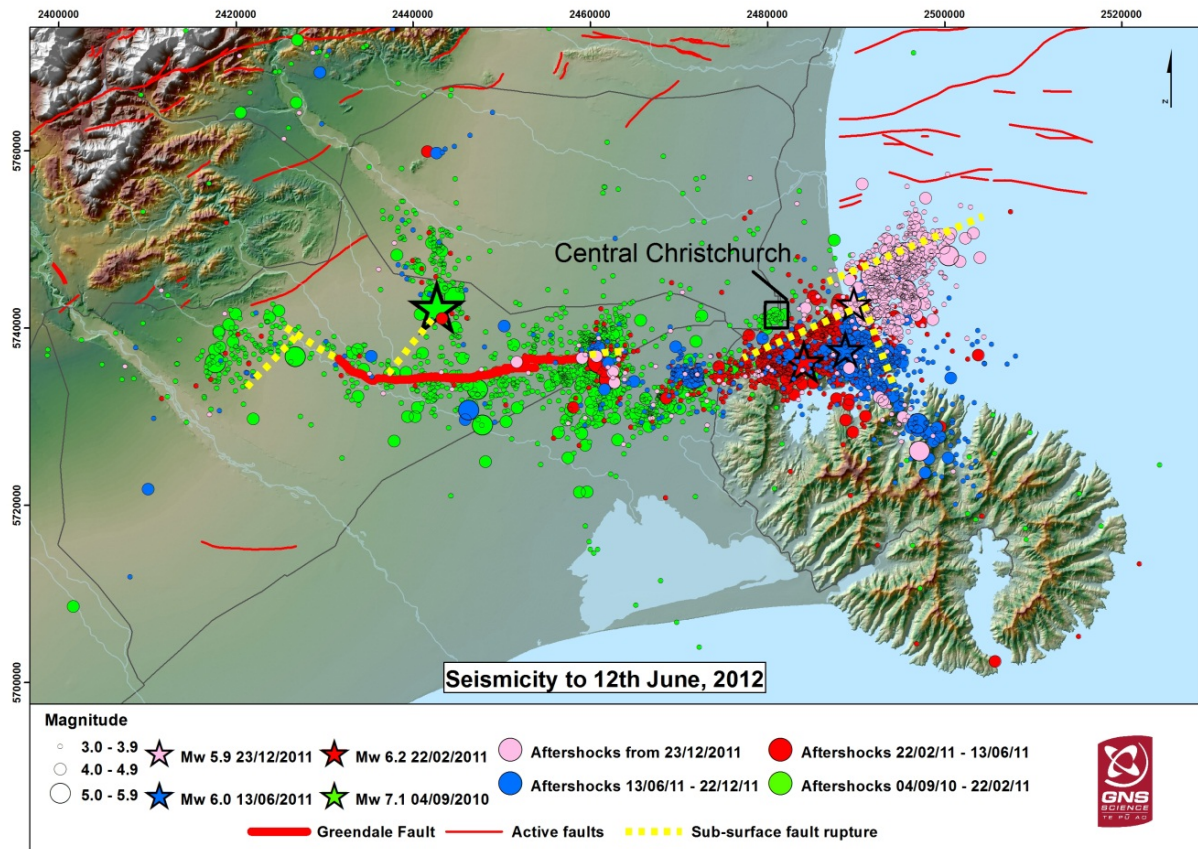
Figure A2.2 Map of the aftershocks produced after the 4 September 2010 Darfield Earthquake (green circles), 22 February 2011 Christchurch Earthquake (red circles), 13 June 2011 Christchurch 2 Earthquake (blue circles) and 23 December 2011 Christchurch 3 Earthquake (pink circles). The epicentres are shown by the coloured stars, and the surface rupture of the Darfield Earthquake is shown by the red line. Yellow dotted lines indicate the subsurface rupture of the Christchurch Earthquake in the city area (SW to NE), and the Christchurch 2 (N-S) and Christchurch 3 (SW to NE) earthquake ruptures and other inferred subsurface rupture planes of the Darfield Earthquake (Beavan et al., 2012).

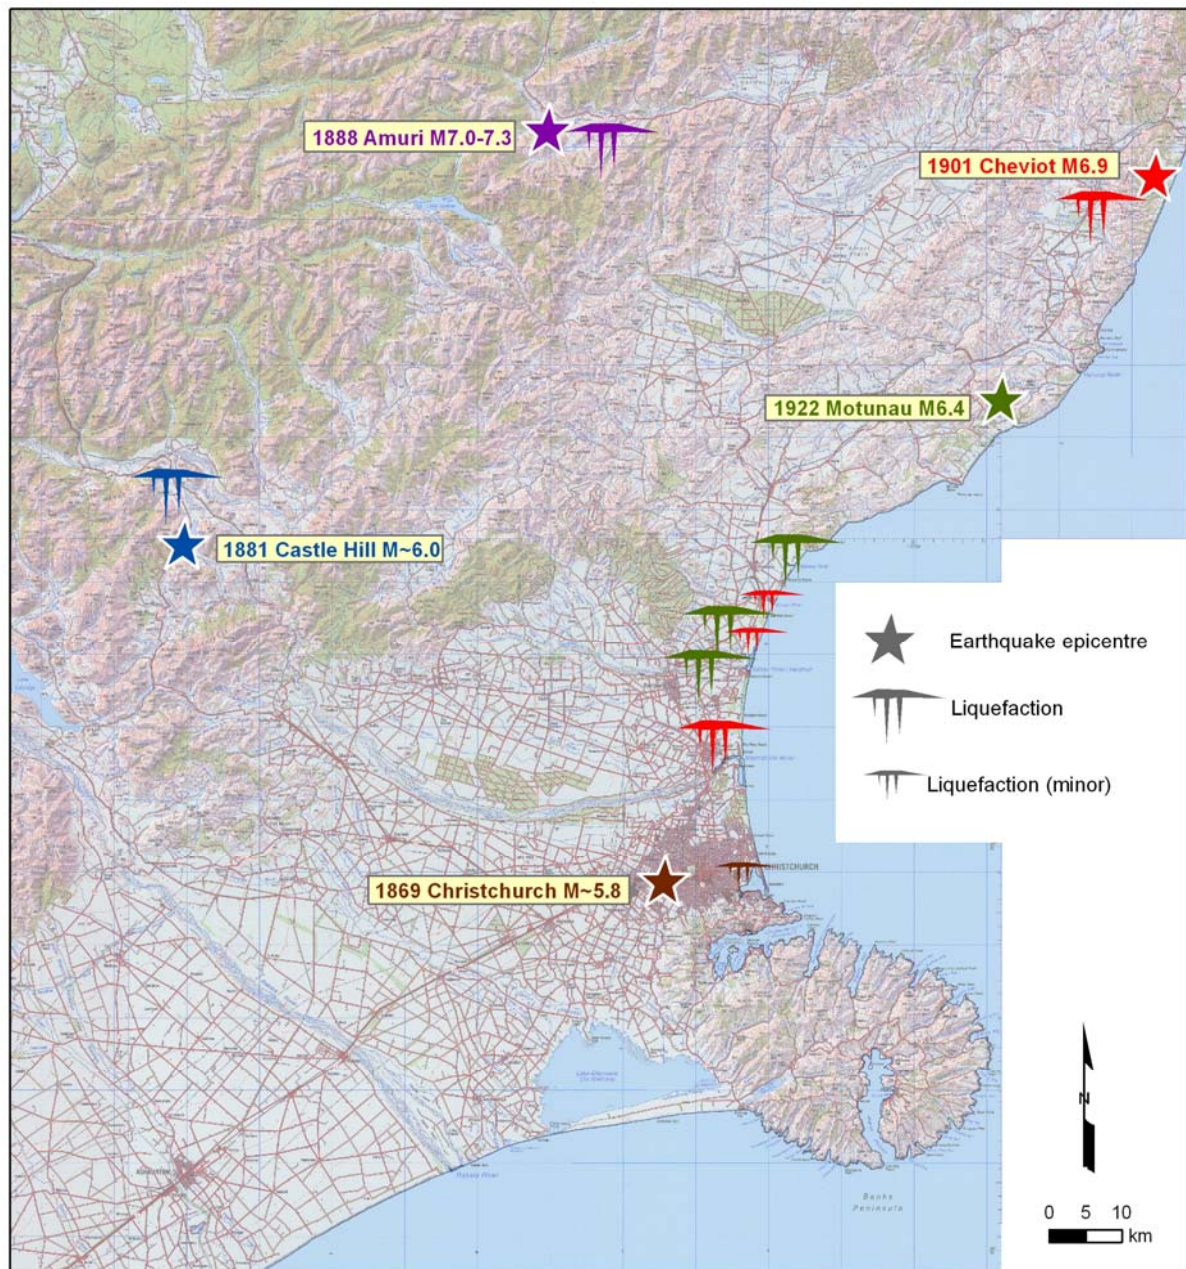
Figure A3.1 Reported historical occurrences of liquefaction in eastern Canterbury.

On five occasions prior to 2010, earthquakes have caused ground damage in parts of Canterbury, at distances of as much as 100 km from the earthquake epicentre (Figure A3.1).

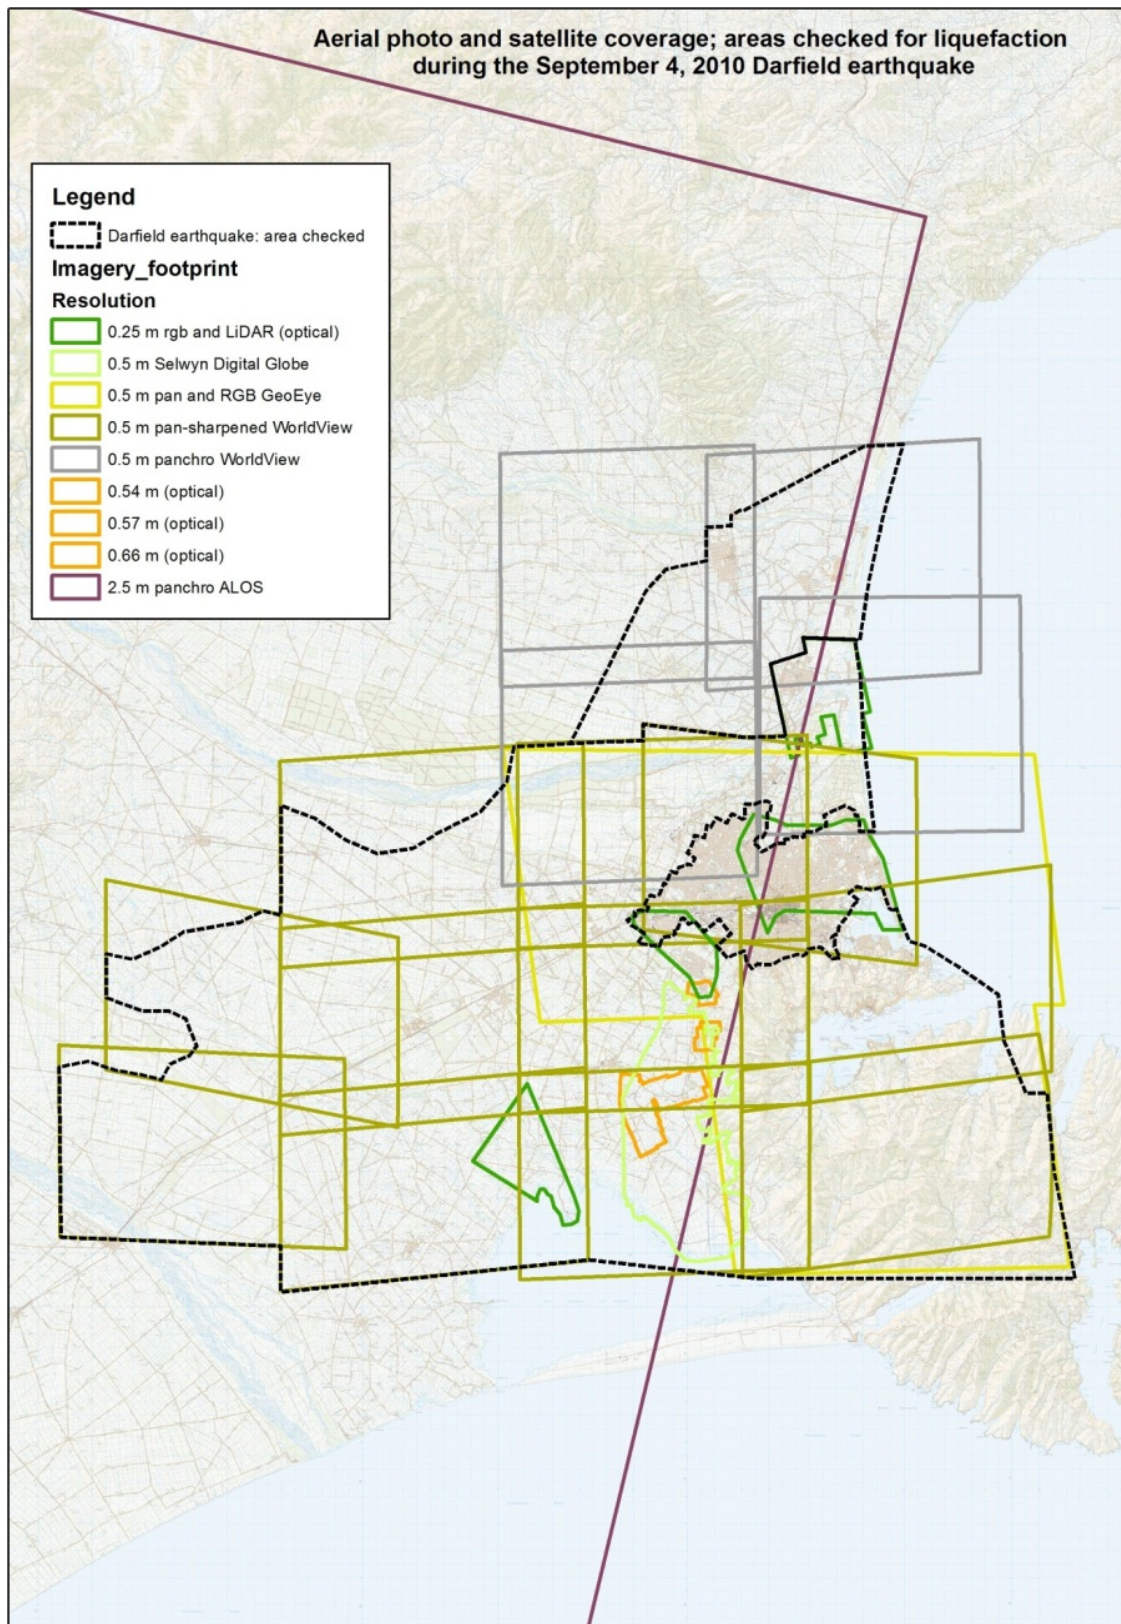
Figure A3.2 Aerial photo and satellite coverage for the 4 September 2010 Darfield Earthquake.

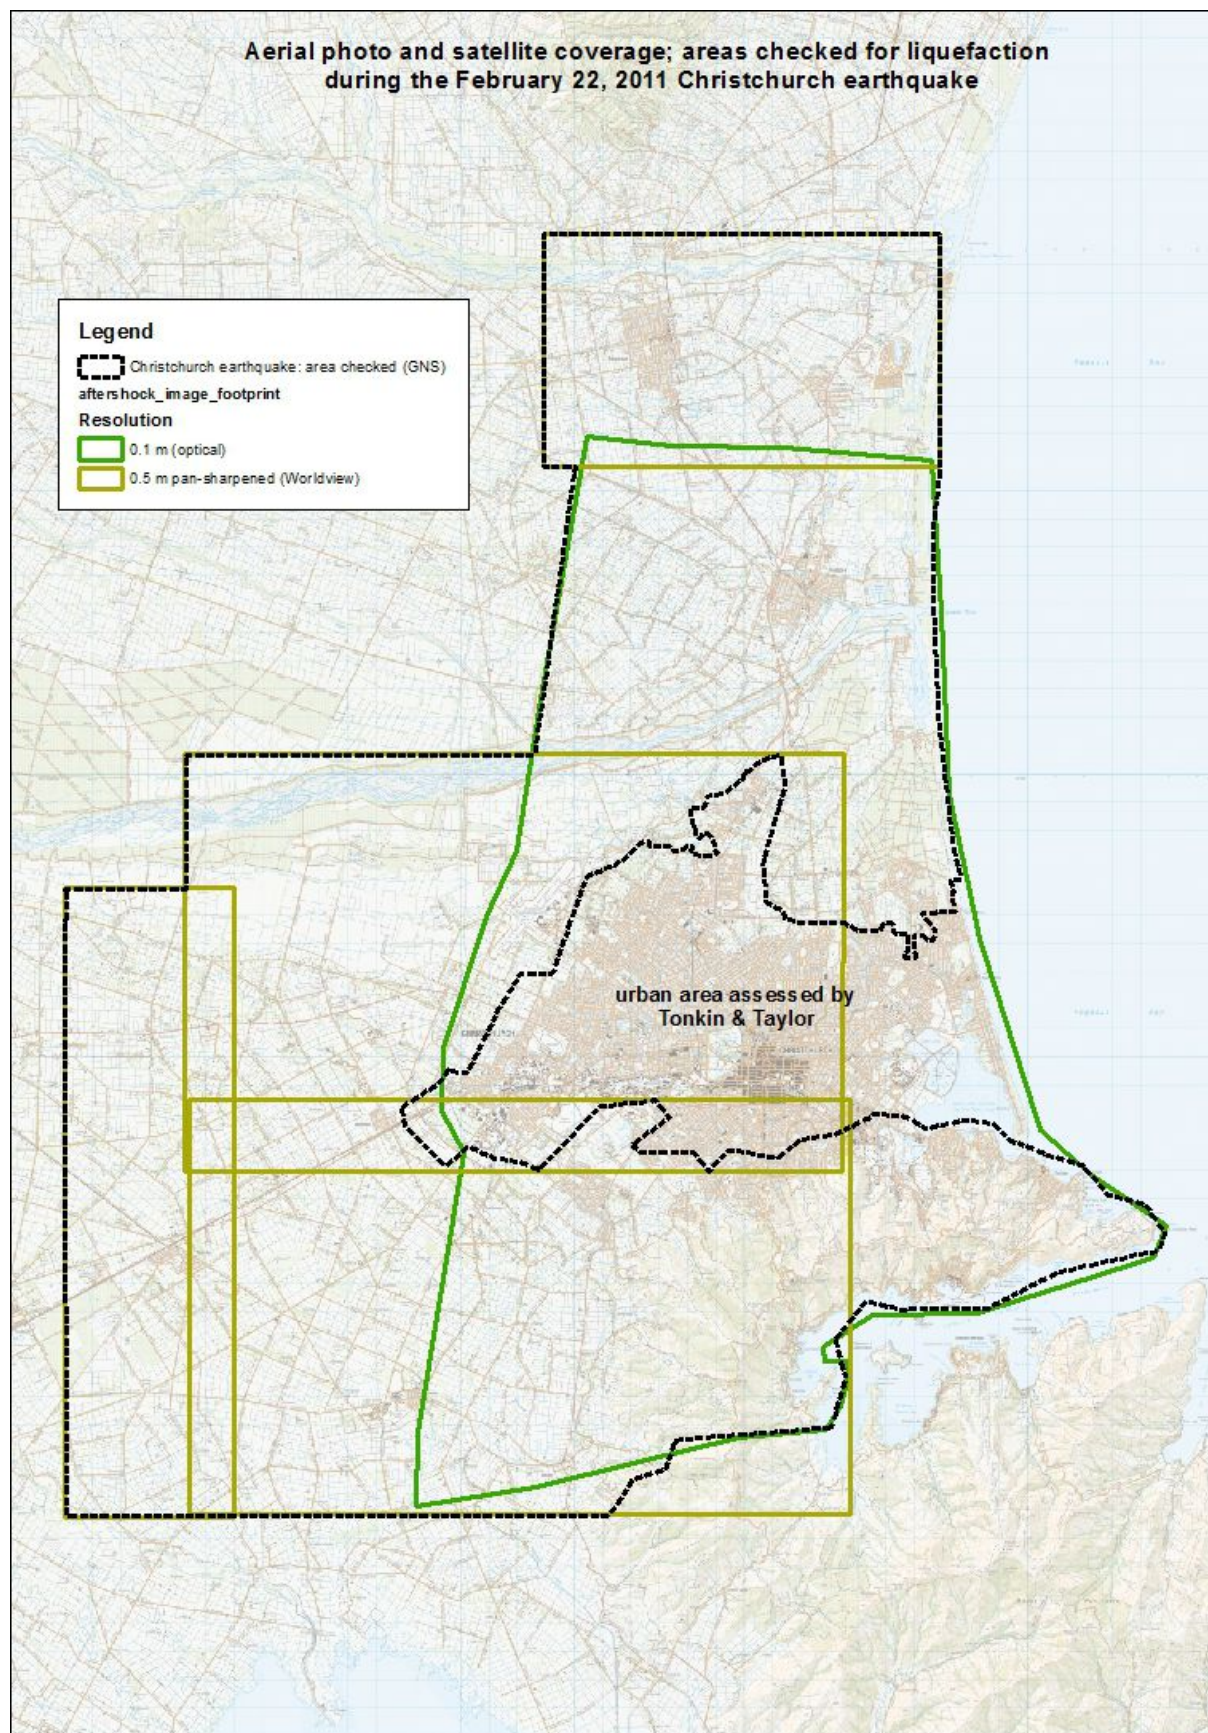
Figure A3.3 Aerial photo and satellite coverage for the 22 February 2011 Christchurch Earthquake.

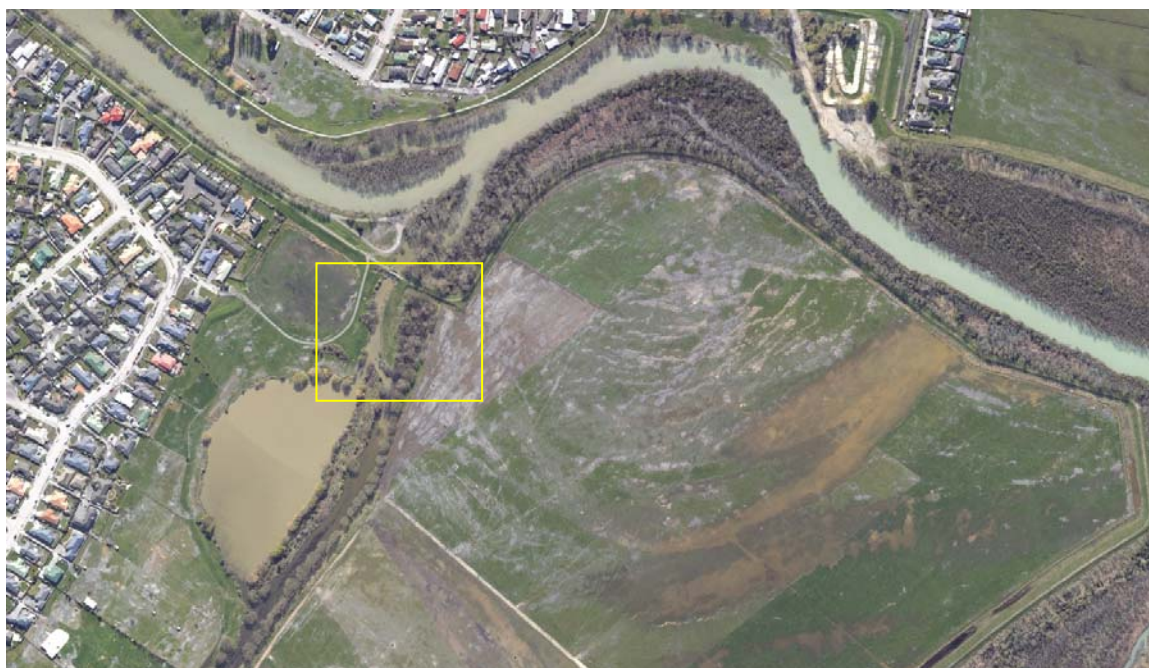
Figure A3.4.1 Liquefaction (sand boils, cracking/lateral spread and fissures) east of Kaiapoi, September 2010. Image is NZAM CANT_ortho_Kaiapoi; centre of view approximately 1573200, 5195800 (NZTM). Rectangle indicates location of detail shown in Figure A3.4.2.

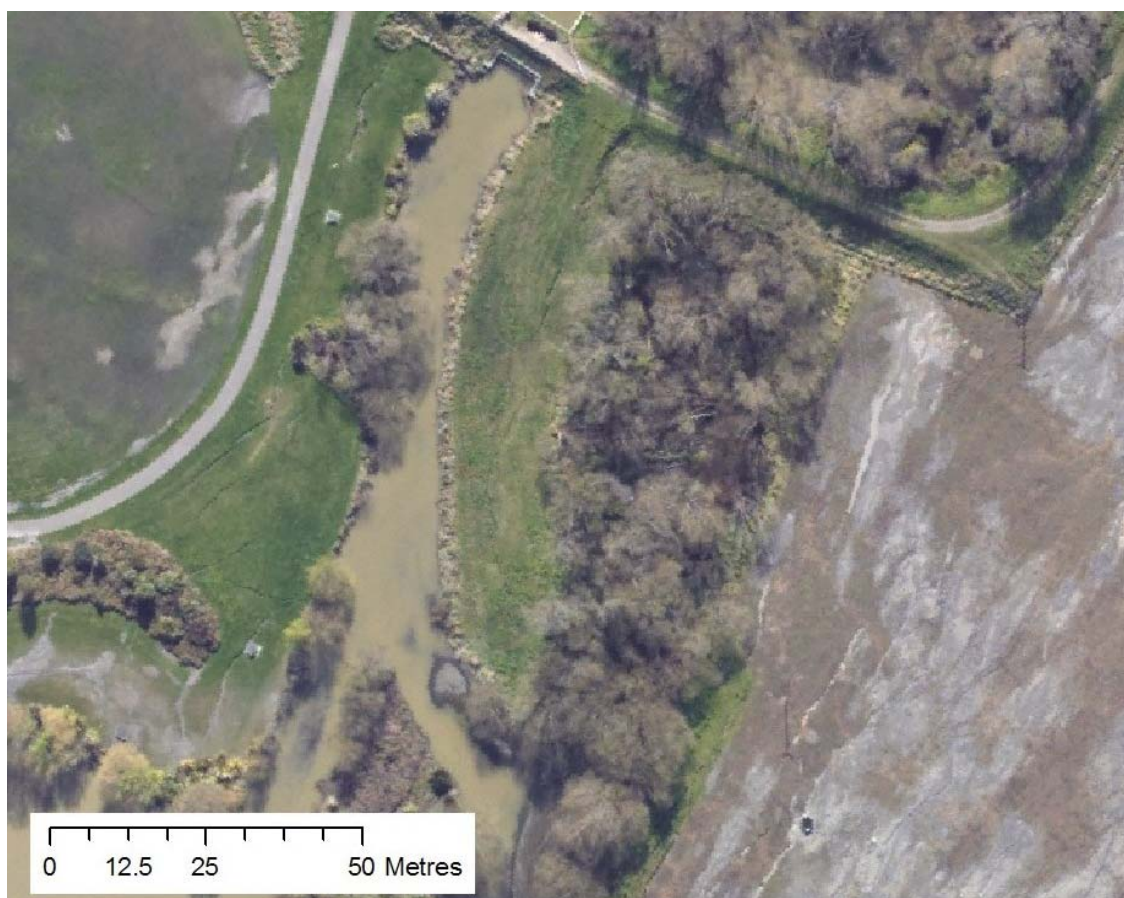
Figure A3.4.2 1:1 pixel resolution detail of Figure A3.4.1.

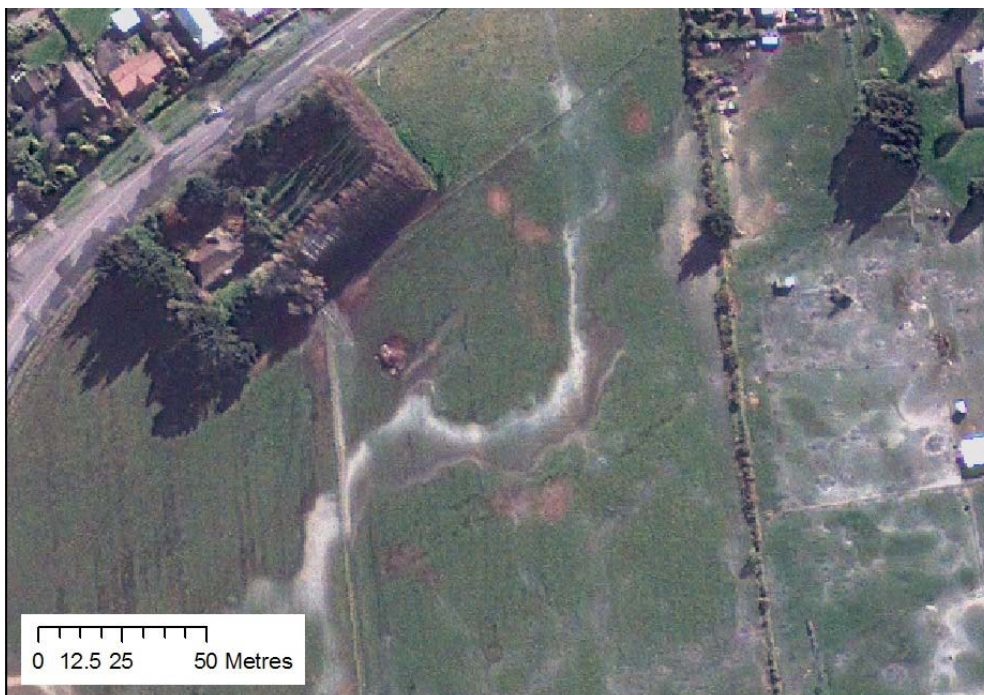
Figure A3.5 Liquefaction at Rawhiti, south of Halswell, September 2010. Damage includes cracking/lateral spread of the road, and sand boils and flooding (including sedimentation) in the paddocks (image Christchurch_GeoEye_4-9-10-All_data_Ortho.ecw; centre of view approximately 1564800, 5173000).

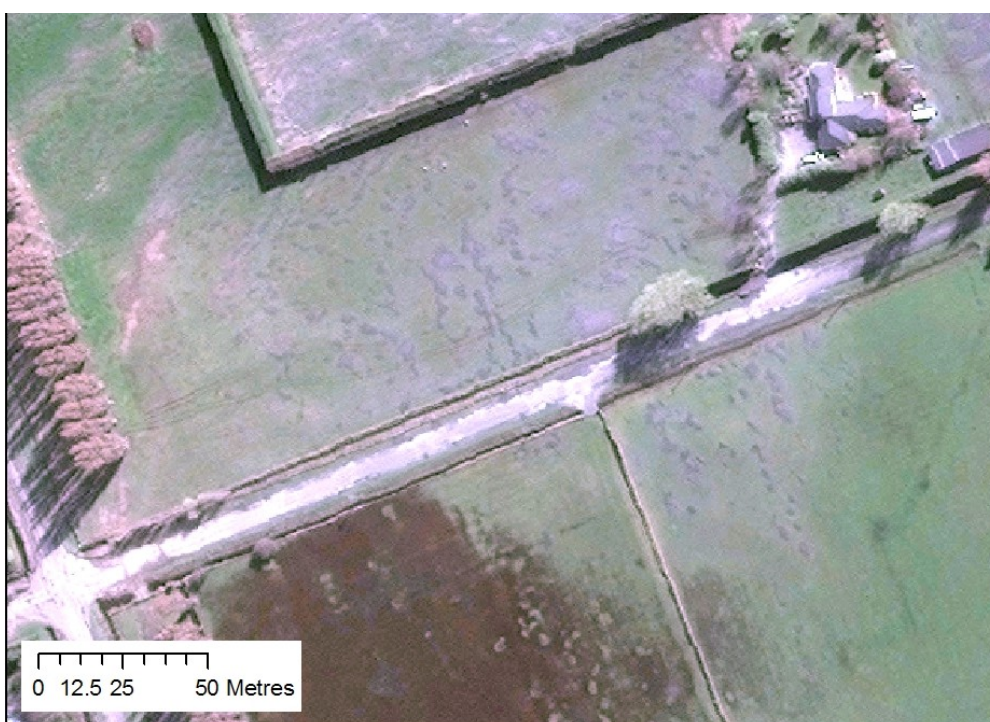
Figure A3.6 Sand boils and surface flooding across Carters Road, southwest of Tai Tapu, September 2010 (image Selwyn_DG_12_Sept_2010.img; centre of view approximately 1560000, 5164000).

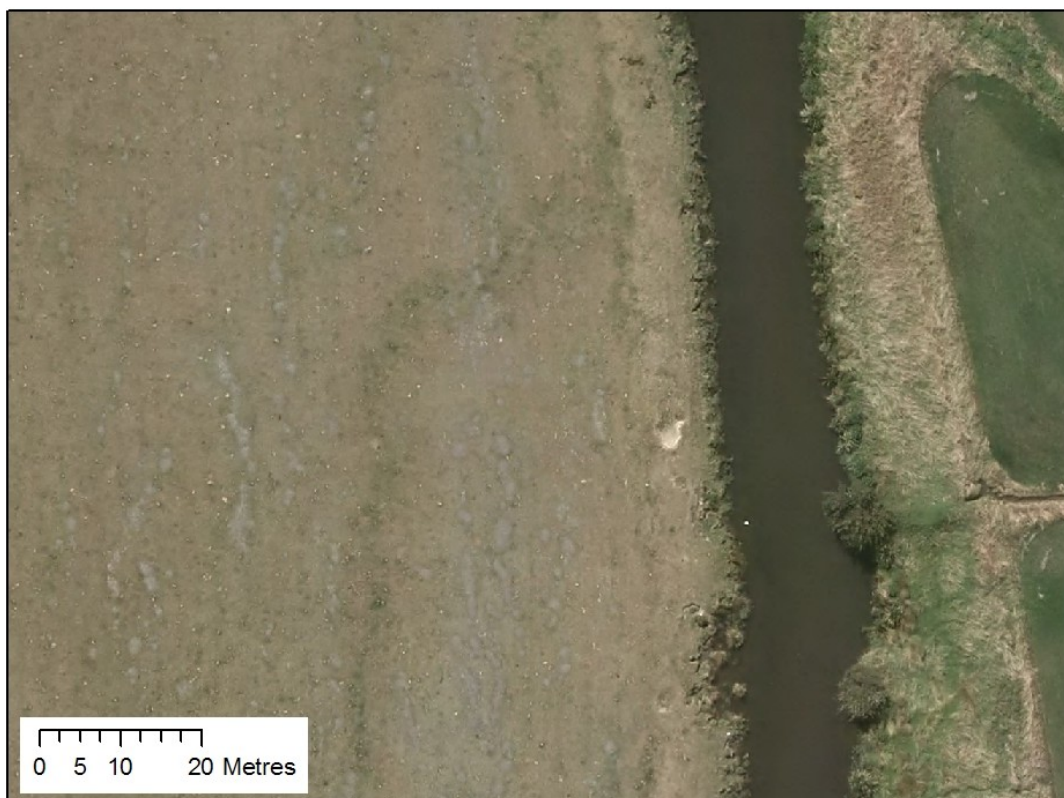
Figure A3.7 Liquefaction adjacent to the Styx River, west of Brooklands, February 2011. This area was also affected in September 2010 (image NZAM_mosaic_03_03_2011.ecw; centre of view approximately 1574970, 5194550).

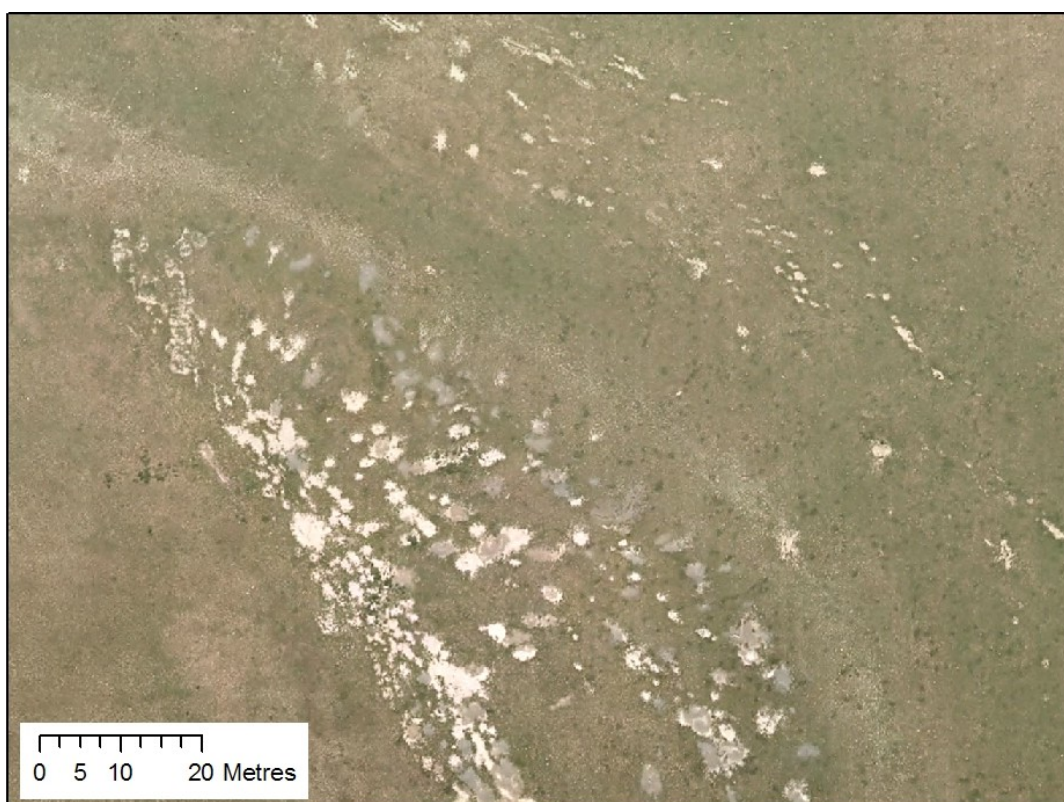
Figure A3.8 New (darker grey/wet) and old (paler grey/dry) sand boils west of Lansdowne, February 2011 (image NZAM_mosaic_03_03_2011.ecw; centre of view approximately 1565000, 5171530).

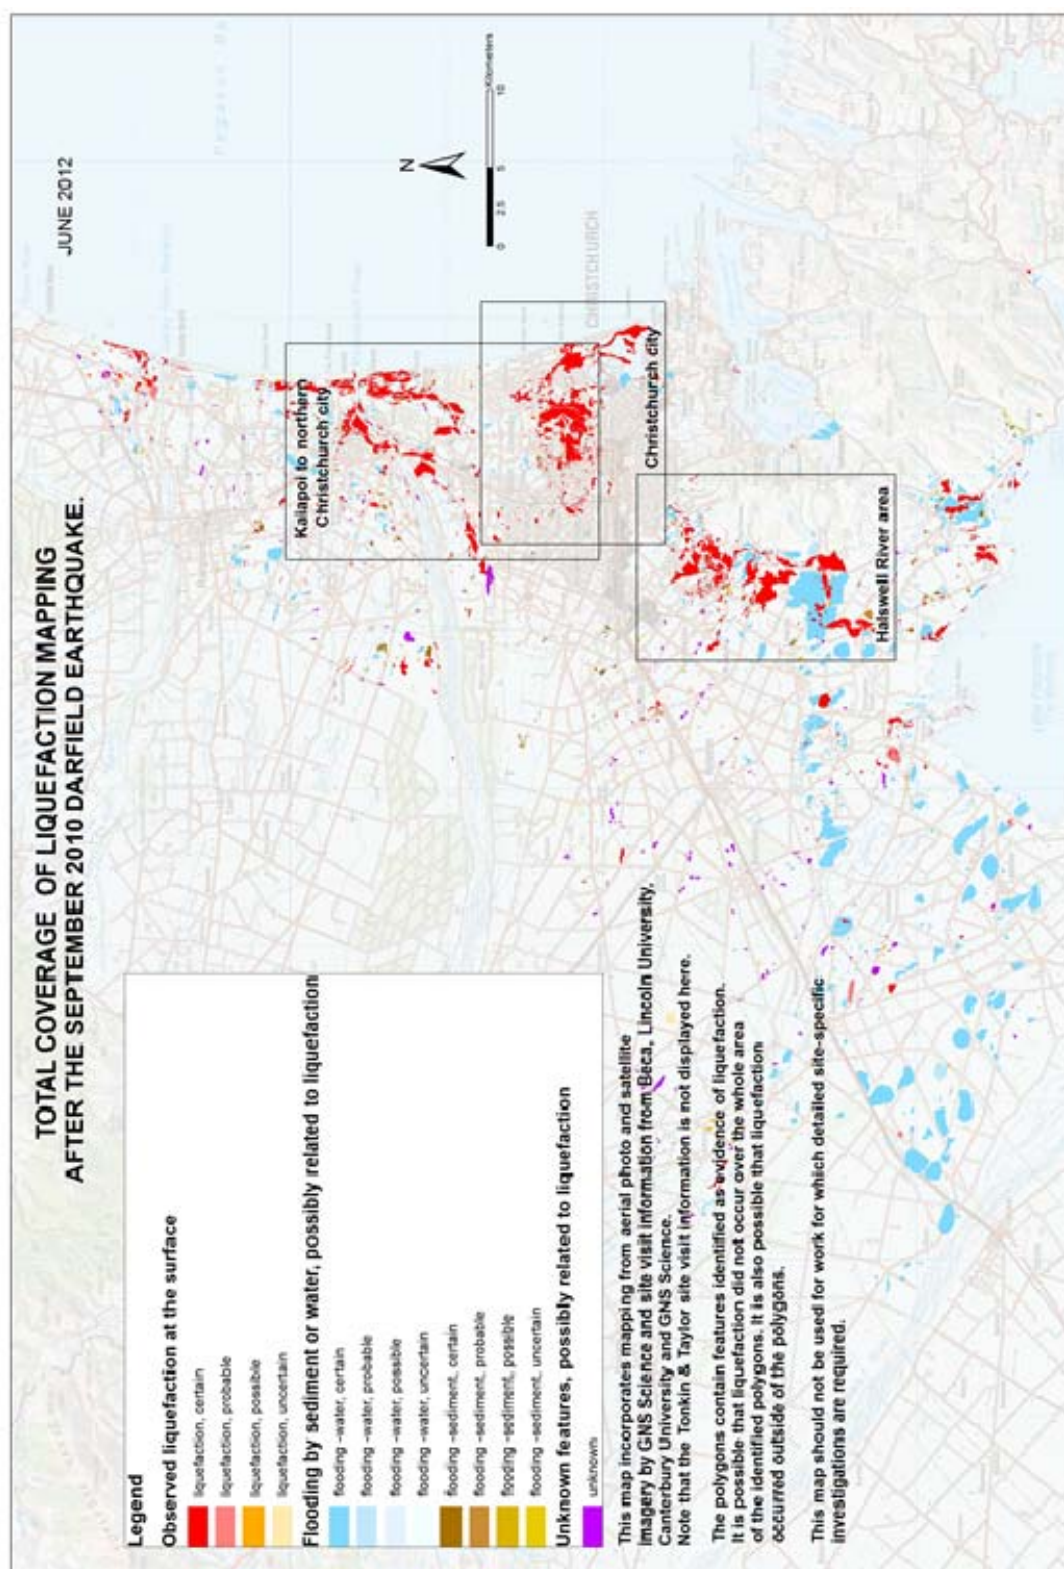
Figure A3.9a Total coverage of liquefaction mapping for the September 2010 Darfield earthquake. See following figures for detail from Kaiapoi, Christchurch city and the Halswell River area. The Tonkin & Taylor field data is not displayed on this map.

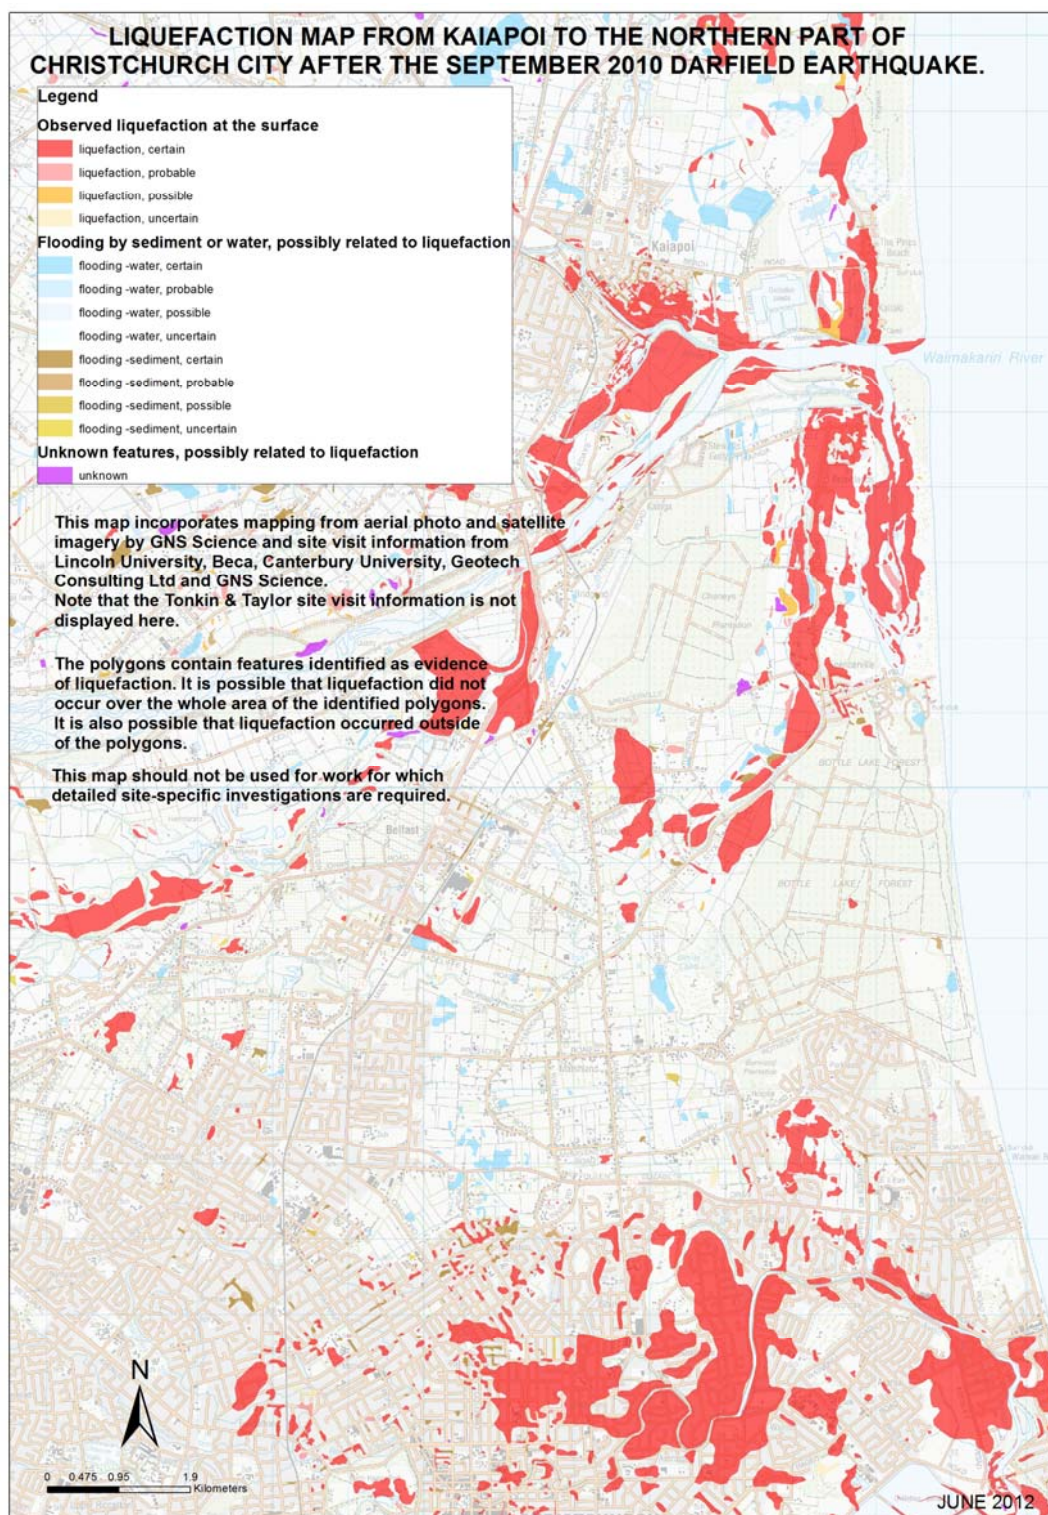
Figure A3.9b Larger view of the liquefaction map of the northern city and Kaiapoi for the September 2010 Darfield earthquake.
