**Review of liquefaction hazard
information in eastern
Canterbury, including
Christchurch City and parts of
Selwyn, Waimakariri and
Hurunui Districts**

Report No. R12/83

**Institute of Geological and Nuclear
Sciences Limited (GNS Science)**

GNS Science Consultancy Report 2012/218

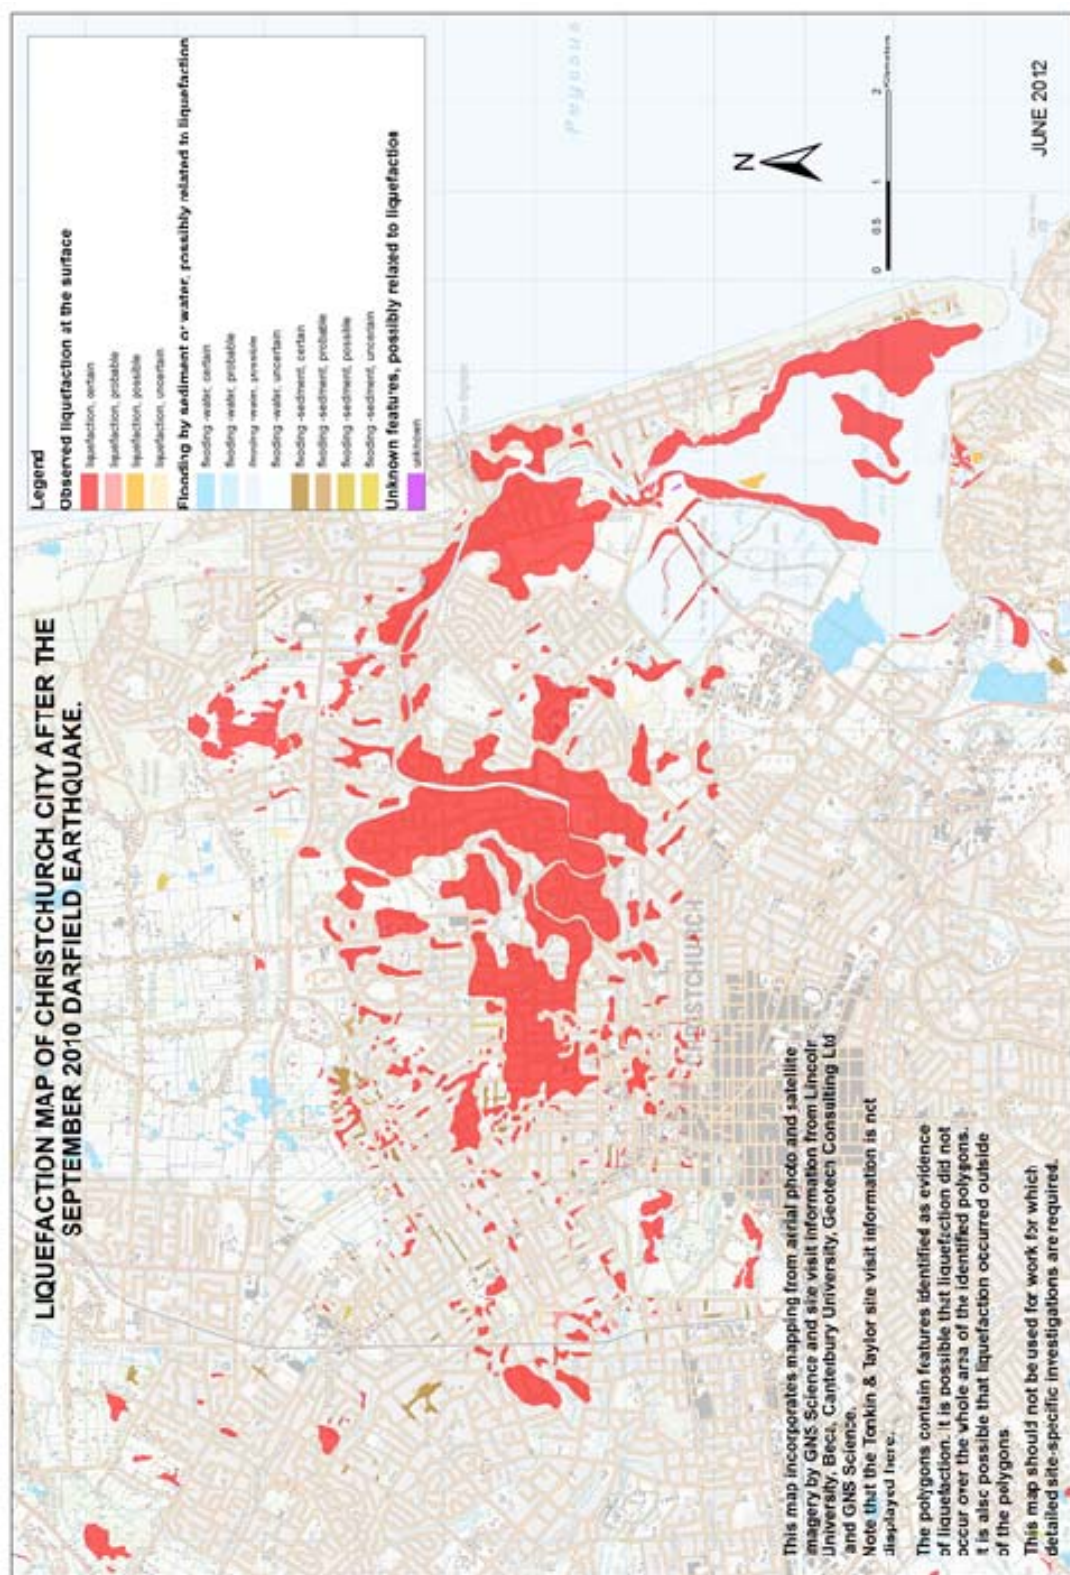
Figure A3.9c Larger view of the liquefaction map of the Christchurch CBD for the September 2010 Darfield earthquake.

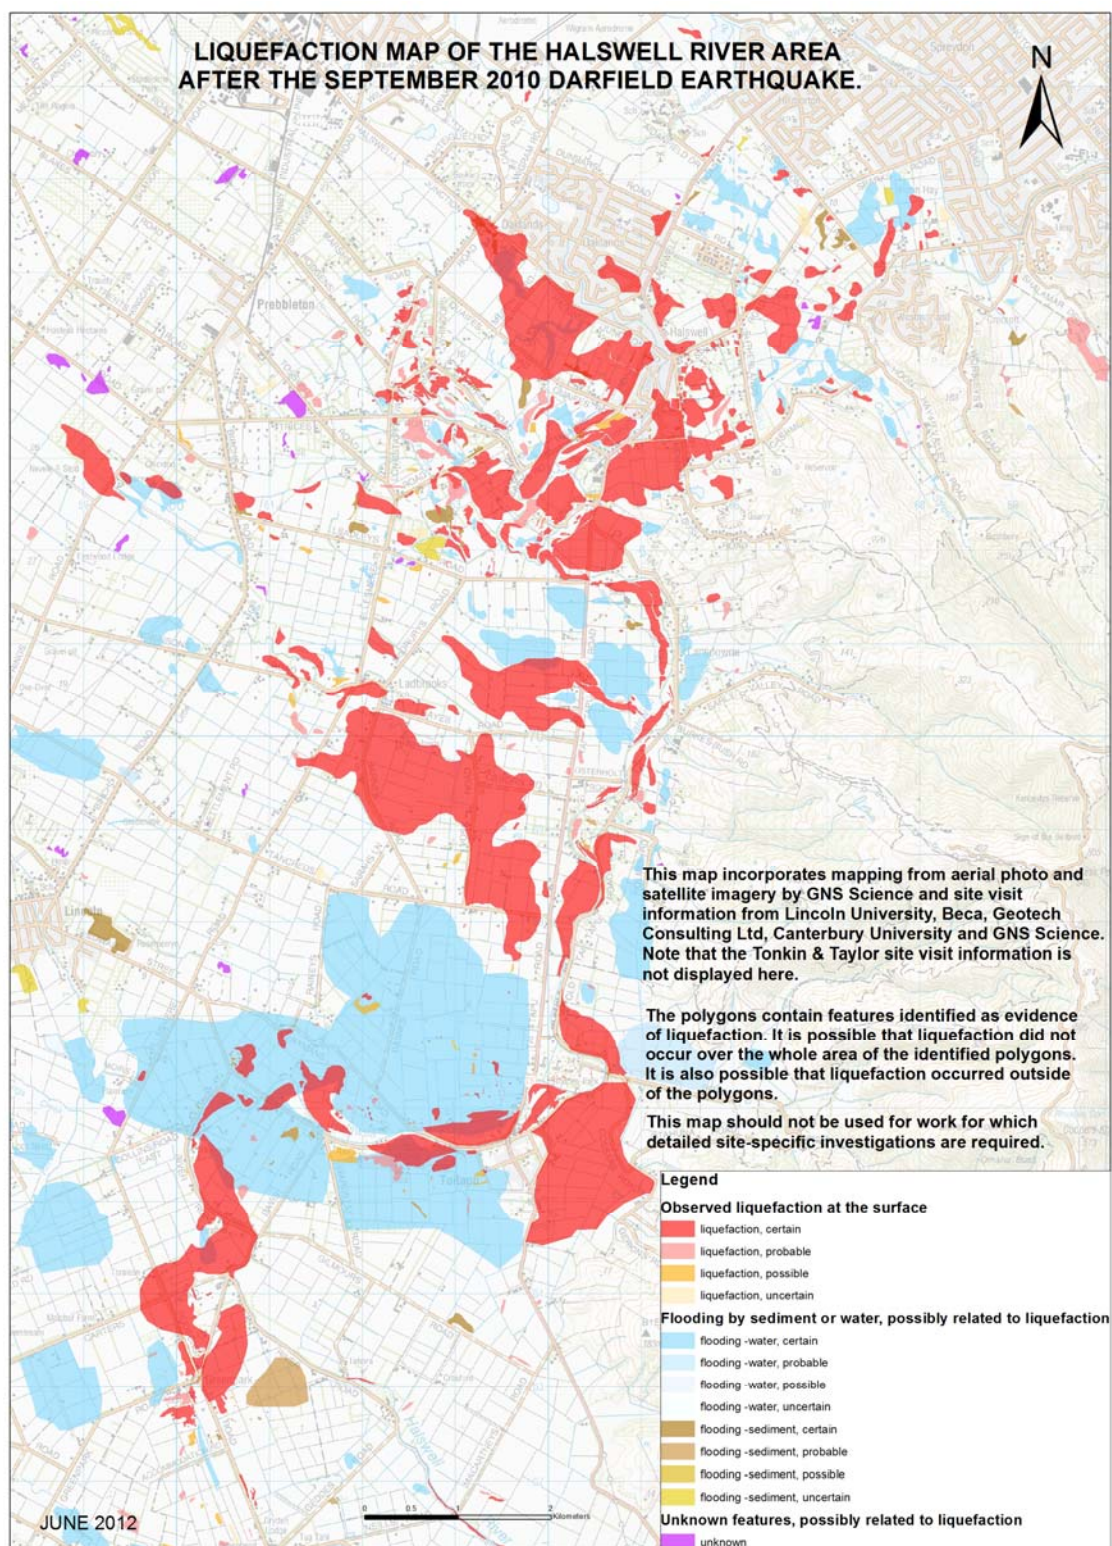
Figure A3.9d Larger view of the liquefaction map of the Halswell River area for the September 2010 Darfield earthquake.

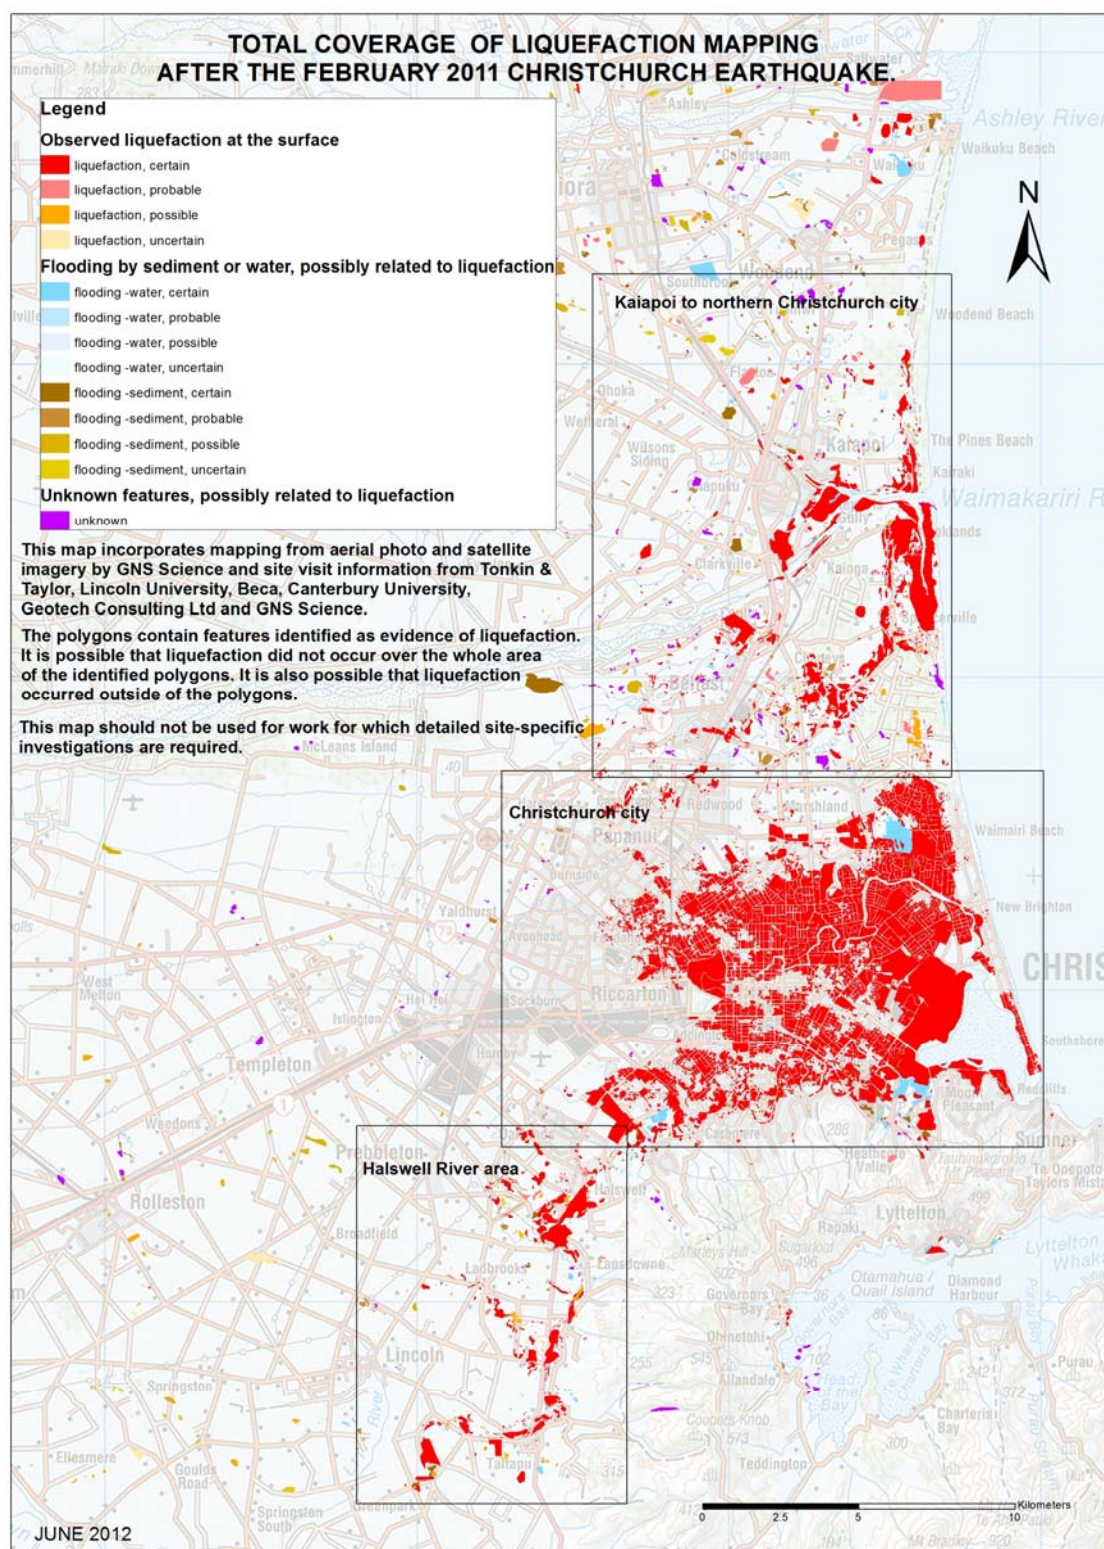
Figure A3.10a Total coverage of liquefaction mapping for the February 2011 Christchurch earthquake. See following figures for detail at Kaiapoi, Christchurch city and the Halswell River area.

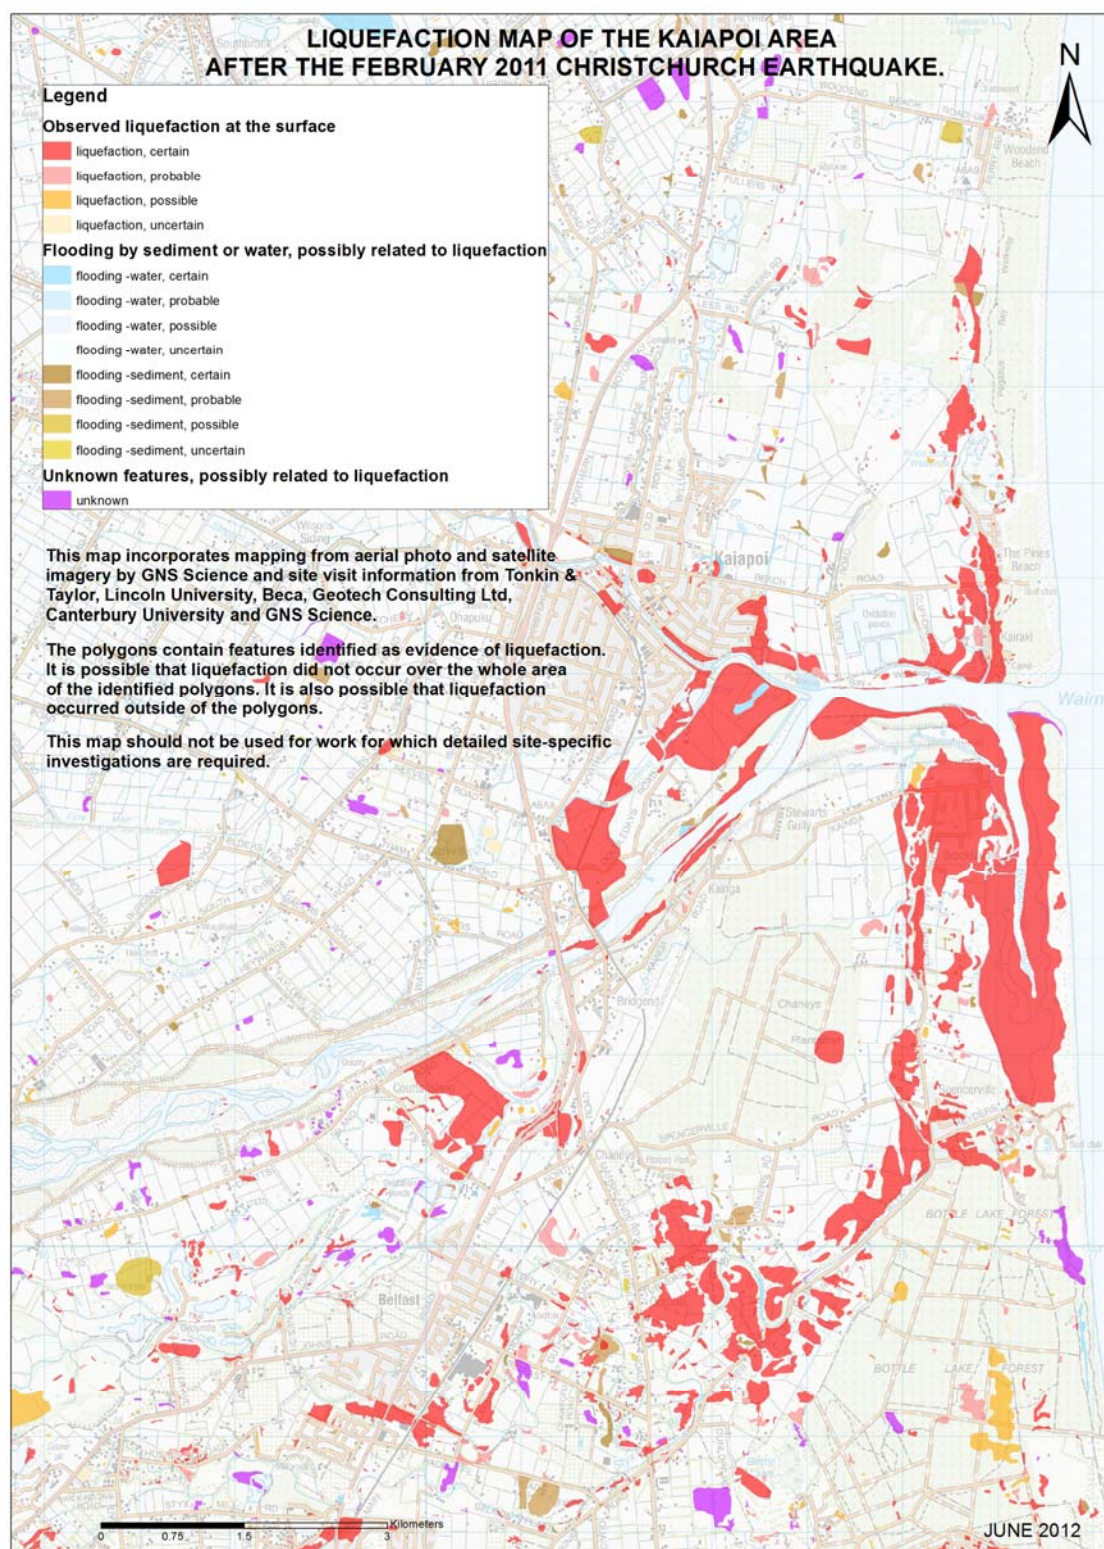
Figure A3.10b Larger view of the liquefaction map of the Kaiapoi area for the February 2011 Christchurch earthquake.

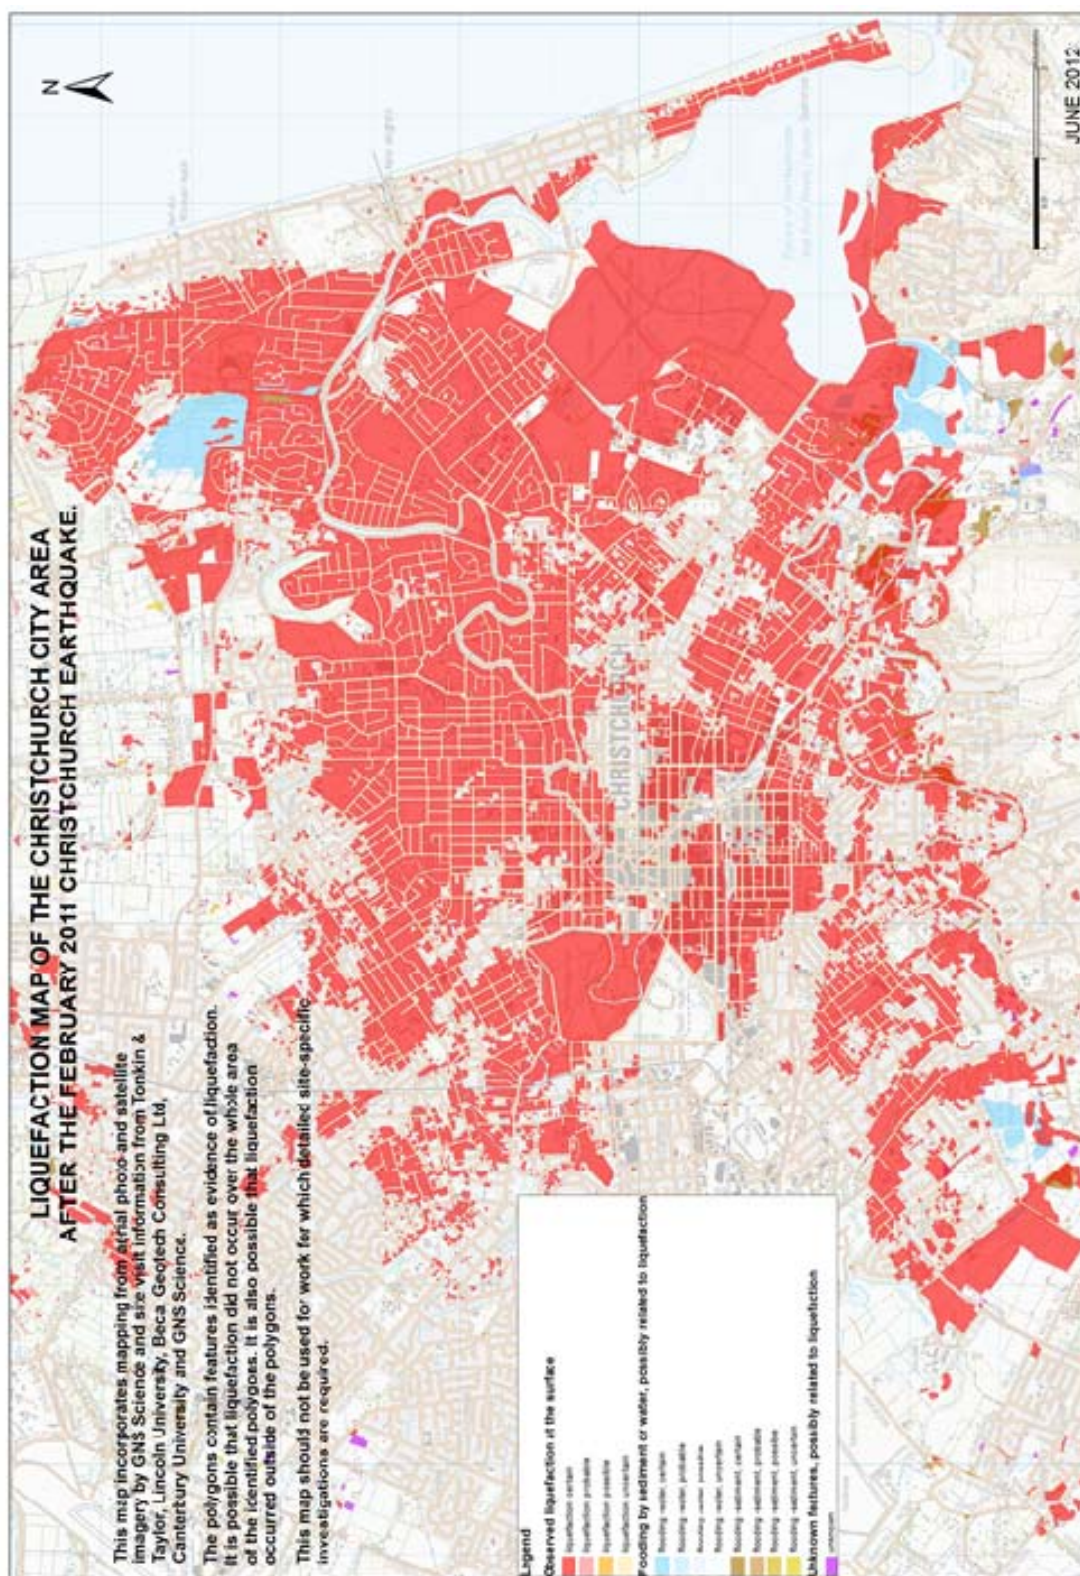
Figure A3.10c Larger view of the liquefaction map of Christchurch city for the February 2011 Christchurch earthquake. Mapping for this area is mostly from Tonkin & Taylor site visit information.

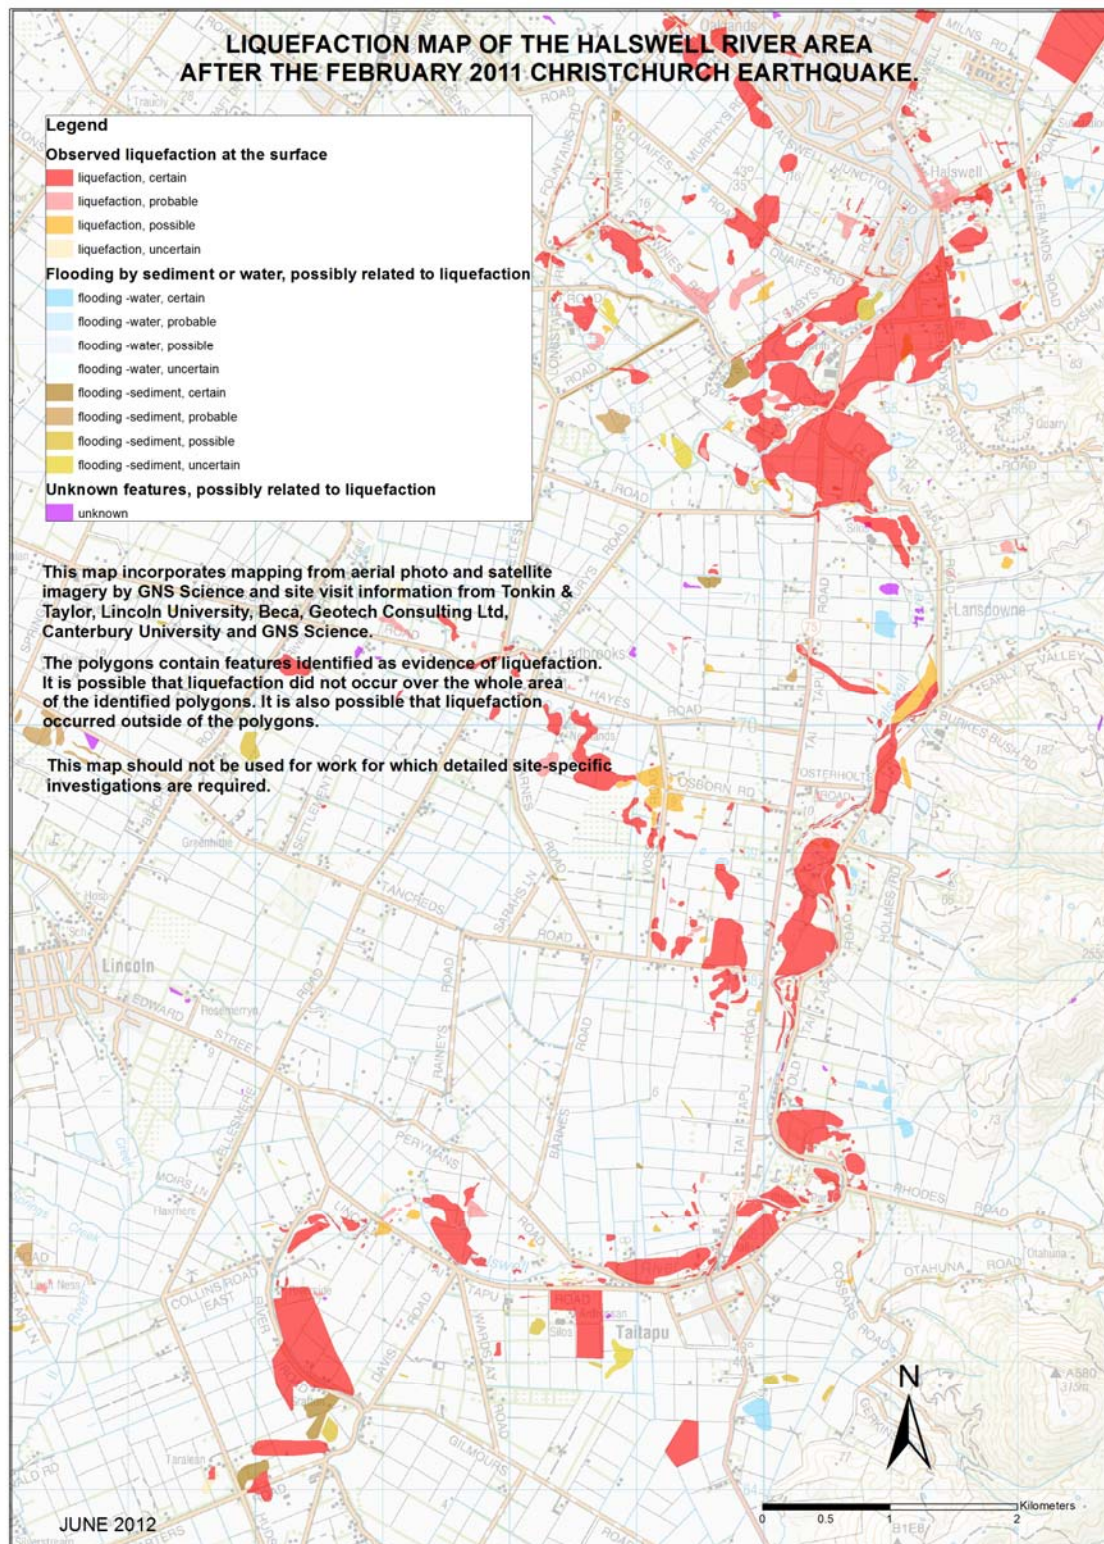
Figure A3.10d Larger view of the liquefaction map of the Halswell River area for the February 2011 Christchurch earthquake.
