Geotechnical Assessment

19 November 2010 Project No. 1078102449

PROFESSIONAL SERVICES: GEOTECHNICAL ASSESSMENT OF SUITABILITY OF LAND FOR RESIDENTIAL DEVELOPMENT

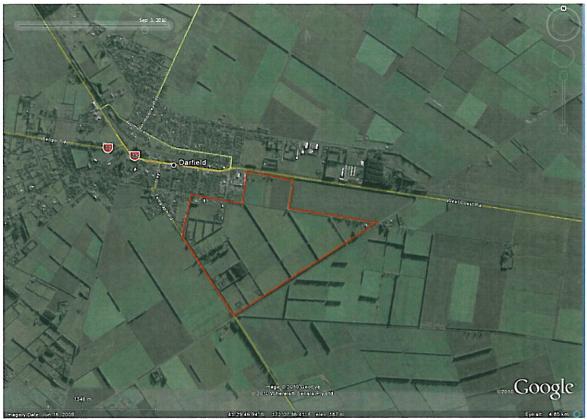
Figure 1: Site location (approximate)

This letter summarises the results of our geotechnical assessment of your Darfield site. The land area covered by this report is indicated by the red outline in Figure 1.
