### **GEOTECHNICAL ASSESSMENT REPORT**

# Plan Change (Rural Outer Plains to Living 1), High Street, Southbridge

Report Number.

1078107\_287

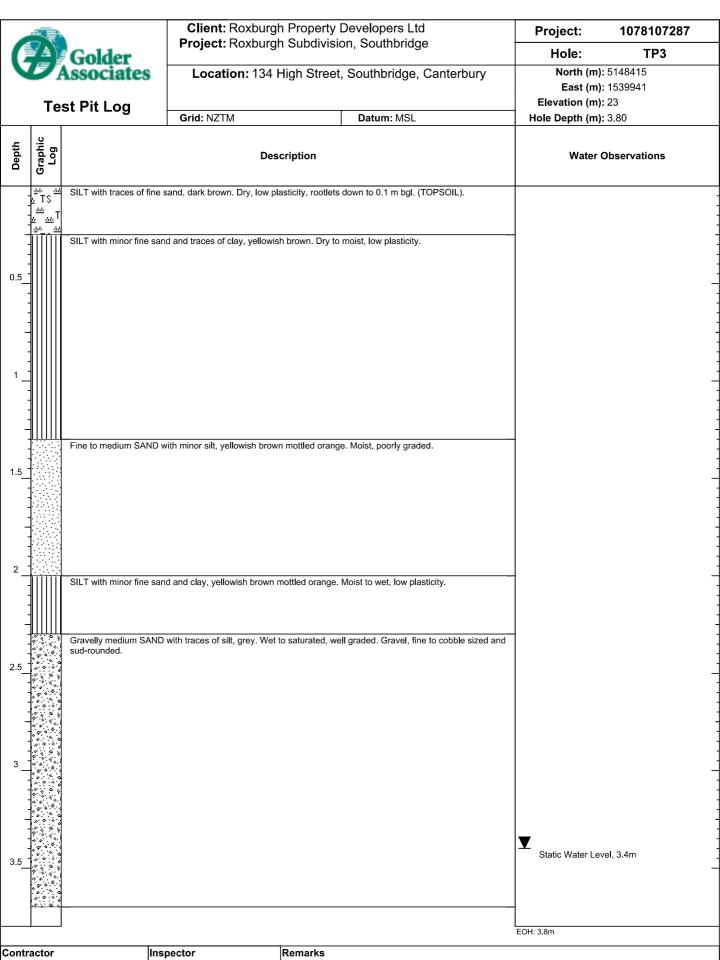
Contractor	Inspector	Remarks
Ellesmere Excavation and Aggregate	DG	Termination at target depth of 4.0 m bgl with collapse of material below water table.table.
Machine	Checked By	
Excavator	JF	
Length (m): 2.5	Date	
Width (m): 1	04/00/0040	
Orientation (°): 90	21/02/2012	Notes: Test Pit logged in accordance with NZGS guideline "Field description of soil and rock" 2005 Page 1 of 1

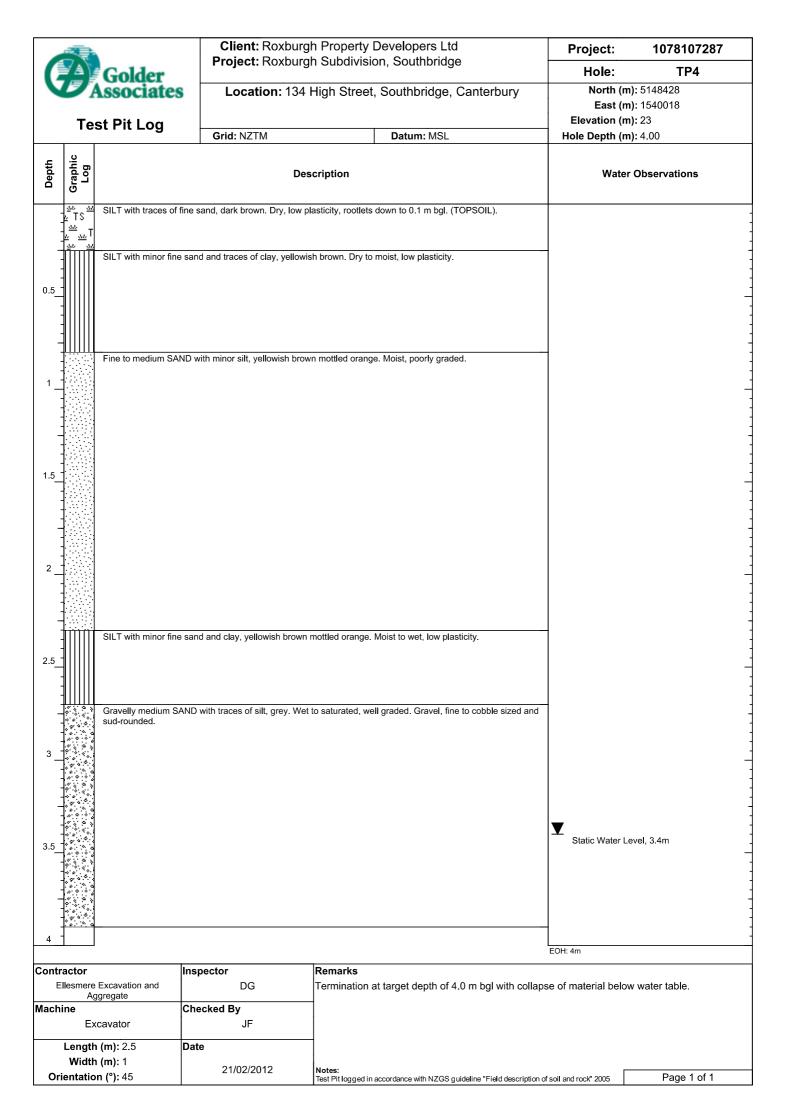
Contractor	Inspector	Remarks	
Ellesmere Excavation and Aggregate	DG	Termination at target depth of 4.0 m bgl with collapse of material below water table.	
Machine	Checked By		
Excavator	JF		
Length (m): 2.5	Date		
Width (m): 1	21/02/2012		
Orientation (°): 95	21/02/2012	Notes: Test Pit logged in accordance with NZGS guideline "Field description of soil and rock" 2005 Page 1 of 1

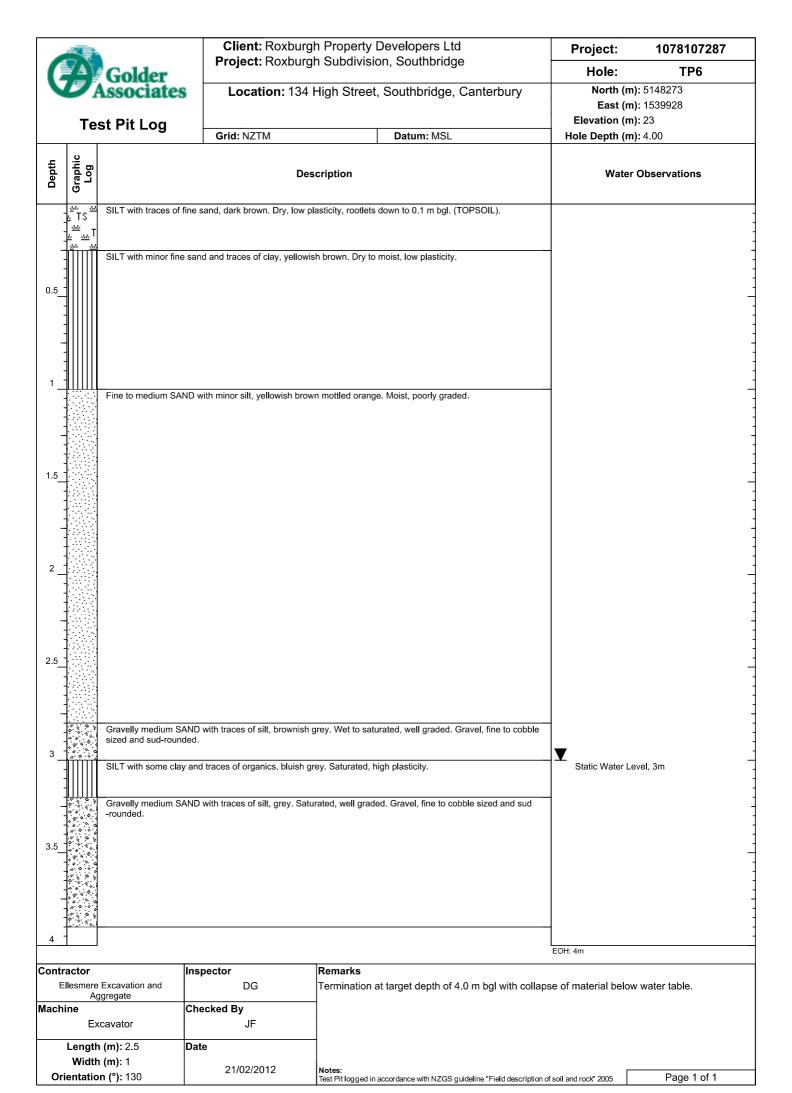
Contractor	Inspector	Remarks
Ellesmere Excavation and Aggregate	DG	Termination at target depth of 4.0 m bgl with collapse of material below water table.
Machine Checked By		
Excavator	JF	
Length (m): 2.5	Date	
Width (m): 1	04/00/0040	
Orientation (°): 110	21/02/2012	Notes: Test Pit logged in accordance with NZGS guideline "Field description of soil and rock" 2005 Page 1 of 1

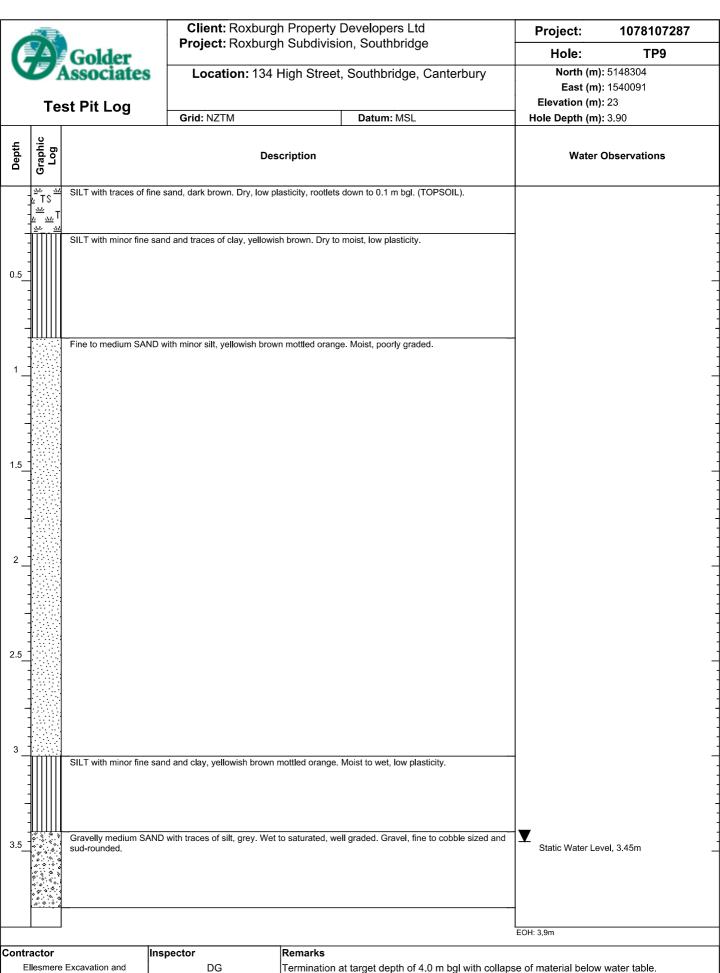
Contractor	Inspector	Remarks
Ellesmere Excavation and Aggregate	DG	Termination at target depth of 4.0 m bgl with collapse of material below water table.
Machine	Checked By	
Excavator	JF	
Length (m): 2.5	Date	
Width (m): 1	04/00/0040	
Orientation (°): 45	21/02/2012	Notes: Test Pit logged in accordance with NZGS guideline "Field description of soil and rock" 2005  Page 1 of 1

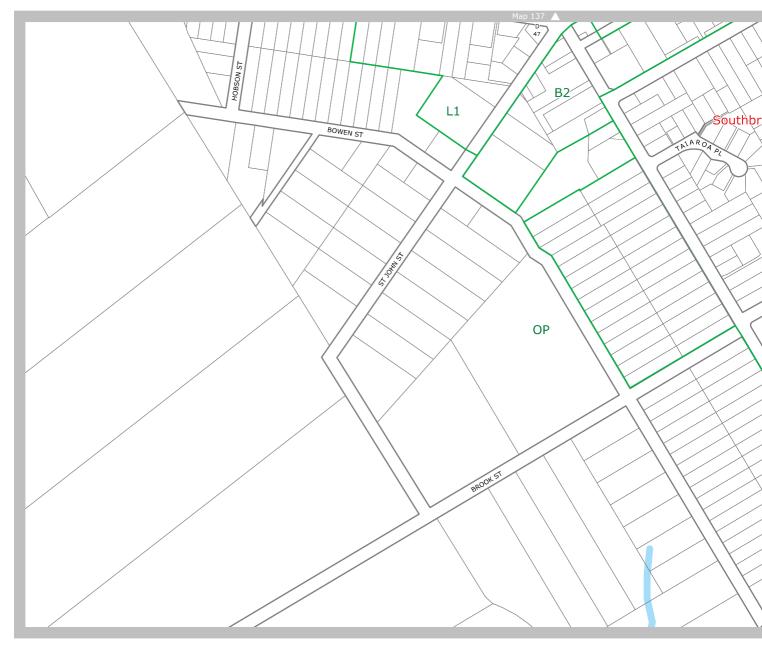
**Amended Planning Maps 138 and 004**

138 SHEET 1

SELWYN DISTRICT PLAN Scale: 1:4,000 at A3
