Transport Assessment Carriageway Consultants

Proposed Plan Change: Dairy Processing Management Area, Darfield

Further to our various emails and correspondence, we have reviewed the potential traffic and transportation aspects of a proposed plan change for a Dairy Processing Management Area ("DPMA") at Darfield.

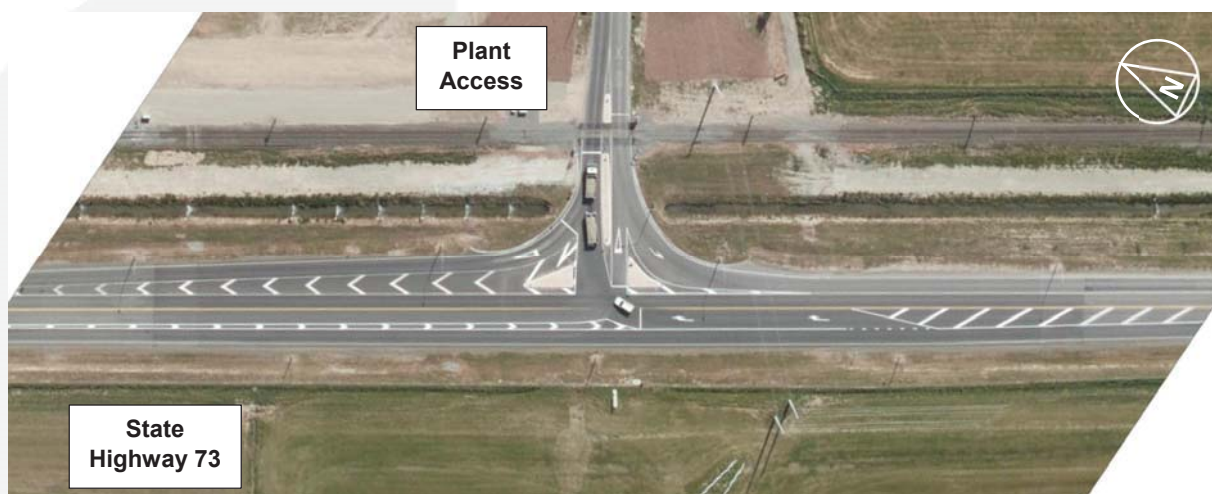
Figure 1: Current Site Access to Fonterra Darfield Plant

Several years ago, resource consents were granted for the construction and operation of a milk processing plant approximately 4km northwest of Darfield and on the eastern side of State Highway 73. As part of those consent applications, detailed evaluations of the (then) proposed site access arrangements were undertaken. The analyses that were produced, agreed with NZTA (as the road controlling authority for the highway) and accepted by the independent commissioner hearing the resource consent application culminated in the construction of a large priority intersection on the highway, with auxiliary left-turn-out, left-turn-in and right-turn-in traffic lanes. The auxiliary right-turn lane was constructed to be 52m in length, sufficient for two tanker+trailer units to wait clear of the northbound through-traffic lane.

Based on the traffic flows prevailing at the time and expected rates of growth up to the year 2020, this arrangement was considered to be appropriate for volumes of up to 170 vehicles emerging from the site access within a (peak) 30-minute period. A sensitivity test was carried out which

Since the traffic flows remain within the expected parameters, we consider that the intersection will continue to operate with a high level of service provided that the plan change does not give rise to cumulative volumes of more than 170 vehicles emerging from the site in any 30-minute period.
