# Private Plan Change Request – Hughes Developments Limited Appendix E – Preliminary Site Investigation, Soil Contamination

RE: Summary of Environmental Investigations - Faringdon Southeast, Rolleston,

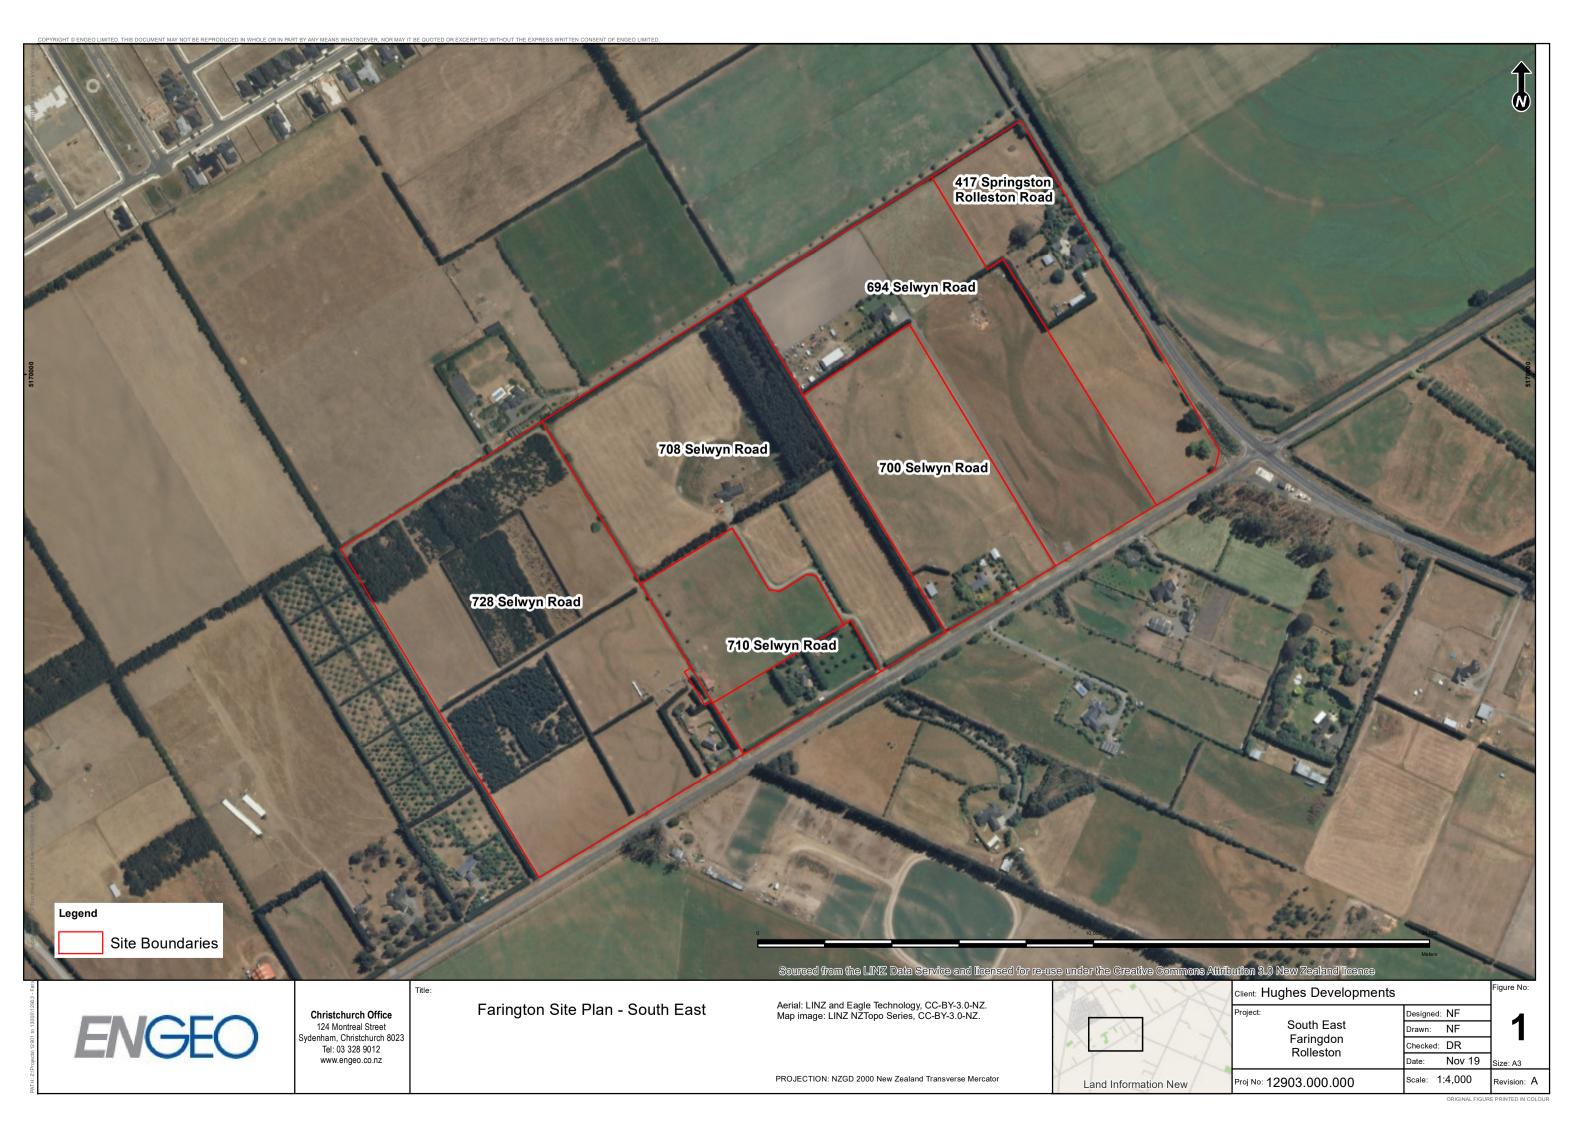
Figure of Sites

We understand that the Faringdon Southeast development is the area bordered by Selwyn and Springston Rolleston Roads, southeast of the existing Faringdon Development. The approximate site location is shown in Appendix 1 of this report. ENGEO has previously completed the following environmental reports within this site:
