Geotechnical Assessment

Geotechnical Report for Proposed Plan Change

Wilfield Subdivision Proposed Southern Extension

Miyamoto Ref: **200509-RP-001[A]**

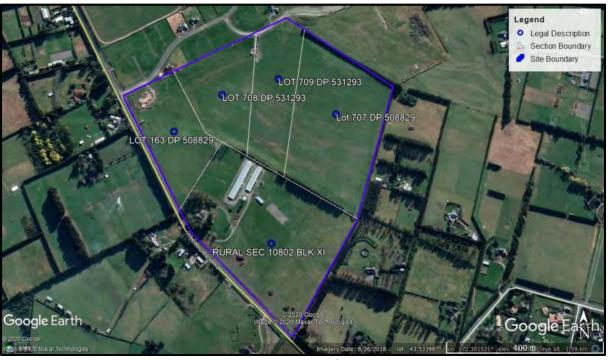
Figure 1: Site Location / Layout Plan

The site (approximately 32 hectares in area) is located in a rural setting in West Melton, Selwyn, directly south of the existing Wilfield residential subdivision, and encompasses the following land parcels (as shown in Figure 1):

The site is predominantly flat with a global elevation difference of 3.0 m to 4.0 m (increasing to the west) and a step up (probable terrace feature) in the topography approximately through the middle of the site running northwest-southeast. The land is predominantly grass covered farmland with two existing residential dwellings, a pump station and a chicken farm currently located on the site.

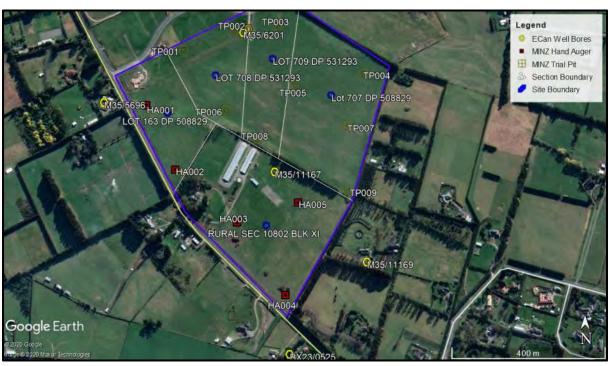
Figure 2: Ground Investigation Location Plan

The test locations are shown in Figure 2, the general details of the ground investigations are summarised in Table 1, and the engineering and well bore logs are presented in Appendix A.

Miyamoto undertook a site-specific ground investigation on 9 November 2020, comprising:

• 9No. machine excavated trial pits (referenced TP001 to TP009);

- 5No. hand-augered boreholes (referenced HA001 to HA005) with in-situ shear vane testing;
- 14No. Dynamic Cone Penetrometer (DCP) tests associated with the above exploratory holes.

As part of the Wilfield subdivision, directly north of the site, Davie Lovell Smith undertook a ground investigation comprising 32No. Trial Pits, the data collected from which has been used in our assessment. Additionally, a number of ECan well bore logs available for the surrounding area have been referenced in our assessment.

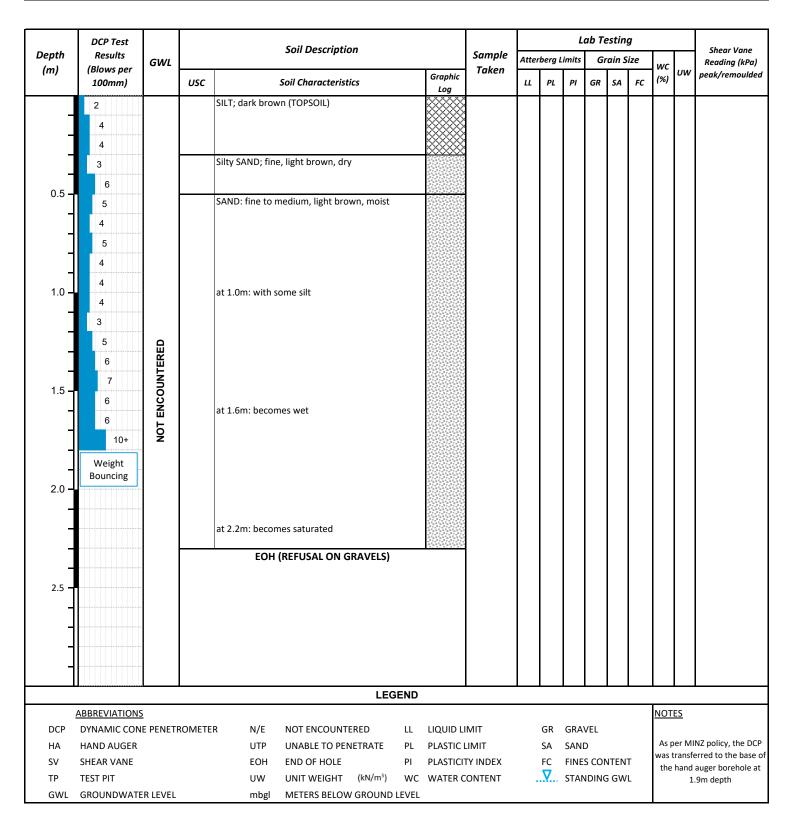
SHALLOW GROUND INVESTIGATION LOG

PROJECT:	Wilfield Subdivision	Vilfield Subdivision, West Melton					
LOGGED BY:	CG/CMD	TOTAL TESTING DEPTH:	2.3 mbgl	HOLE DIAMETER: 50	0 mm		
PROCESSED BY:	CG	TESTING METHOD:	HA + DCP	SHEAR VANE NUMBER:	-		
LOCATION:	REFER TO SITE PLAN	GROUNDWATER LEVEL:	N/E	This report may only be reproduced in full

It is noted that saturated soil was encountered at 2.2 mbgl in HA001 and water was noted at 3.5 mbgl in Davis Lovell Smith TP021.

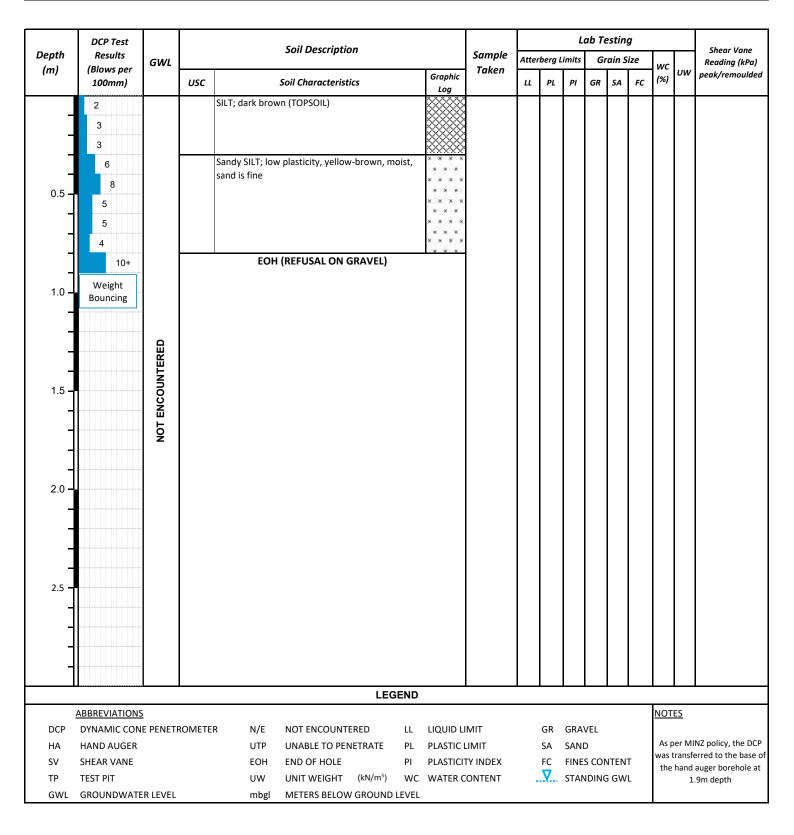
SHALLOW GROUND INVESTIGATION LOG

PROJECT:	Wilfield Subdivisi	Vilfield Subdivision, West Melton					
LOGGED BY:	CG/CMD	TOTAL TESTING DEPTH:	0.9	mbgl	HOLE DIAMETER:	50 mm	
PROCESSED BY:	CG	TESTING METHOD:	HA + DO	P	SHEAR VANE NUMBER:	-	
LOCATION:	REFER TO SITE PLAN	GROUNDWATER LEVEL:	N/E	mbgl	This report may only be reproduced in full

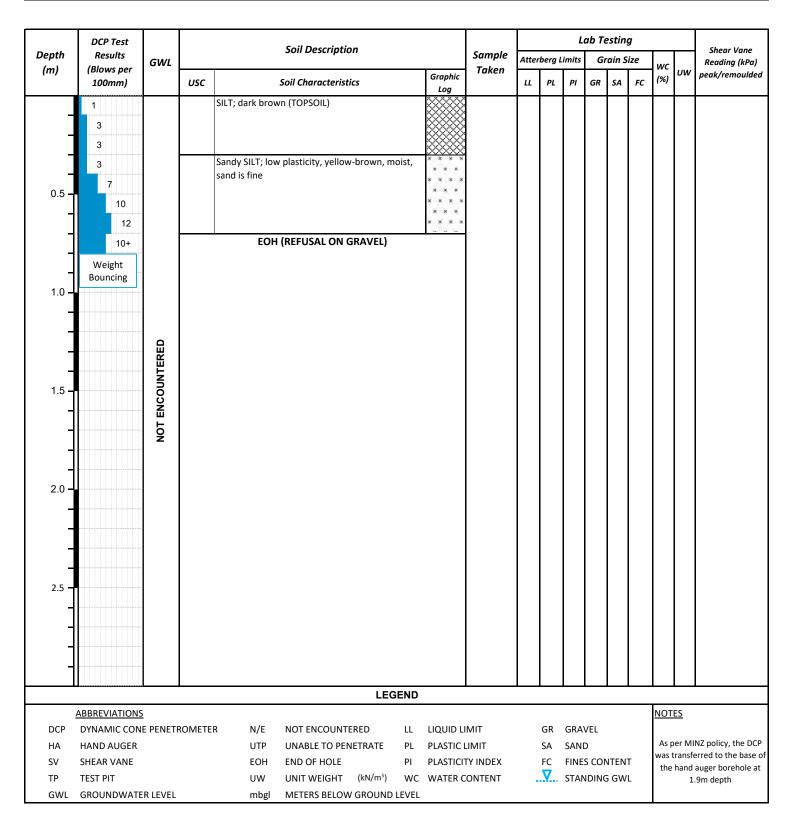
SHALLOW GROUND INVESTIGATION LOG

PROJECT:	Wilfield Subdivisi	Vilfield Subdivision, West Melton					
LOGGED BY:	CG/CMD	TOTAL TESTING DEPTH:	0.8 mbgl	HOLE DIAMETER: 5	50 mm		
PROCESSED BY:	CG	TESTING METHOD:	HA + DCP	SHEAR VANE NUMBER:	-		
LOCATION:	REFER TO SITE PLAN	GROUNDWATER LEVEL:	N/E	This report may only be reproduced in full

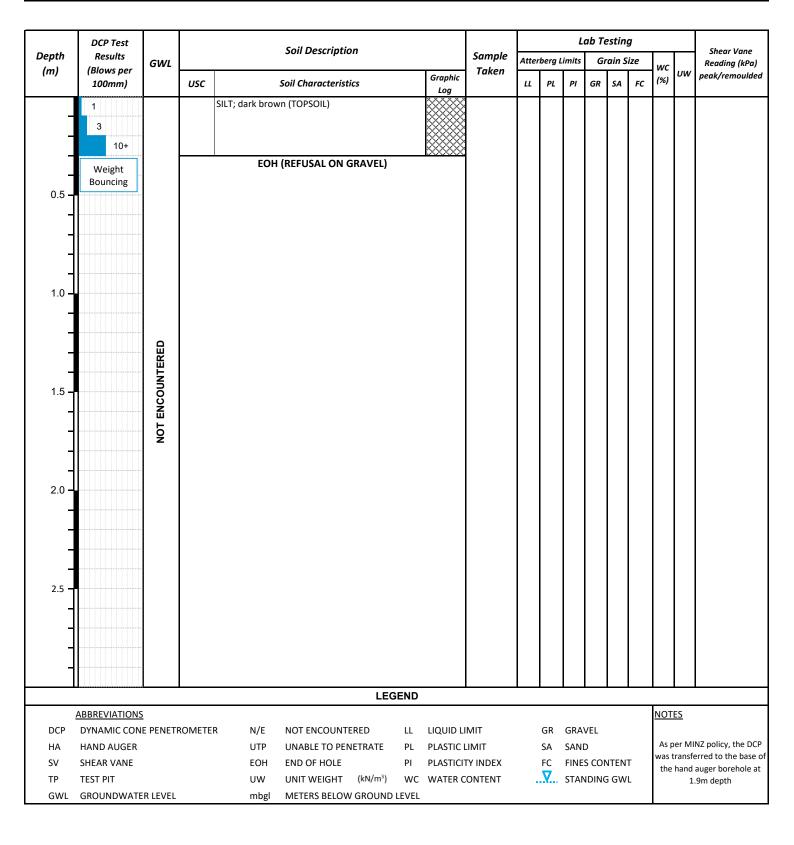
SHALLOW GROUND INVESTIGATION LOG

PROJECT:	Wilfield Subdivisi	Wilfield Subdivision, West Melton					
LOGGED BY:	CG/CMD	TOTAL TESTING DEPTH:	0.3 mbgl	HOLE DIAMETER: 50 I	mm		
PROCESSED BY:	CG	TESTING METHOD:	HA + DCP	SHEAR VANE NUMBER:	-		
LOCATION:	REFER TO SITE PLAN	GROUNDWATER LEVEL:	N/E	This report may only be reproduced in full

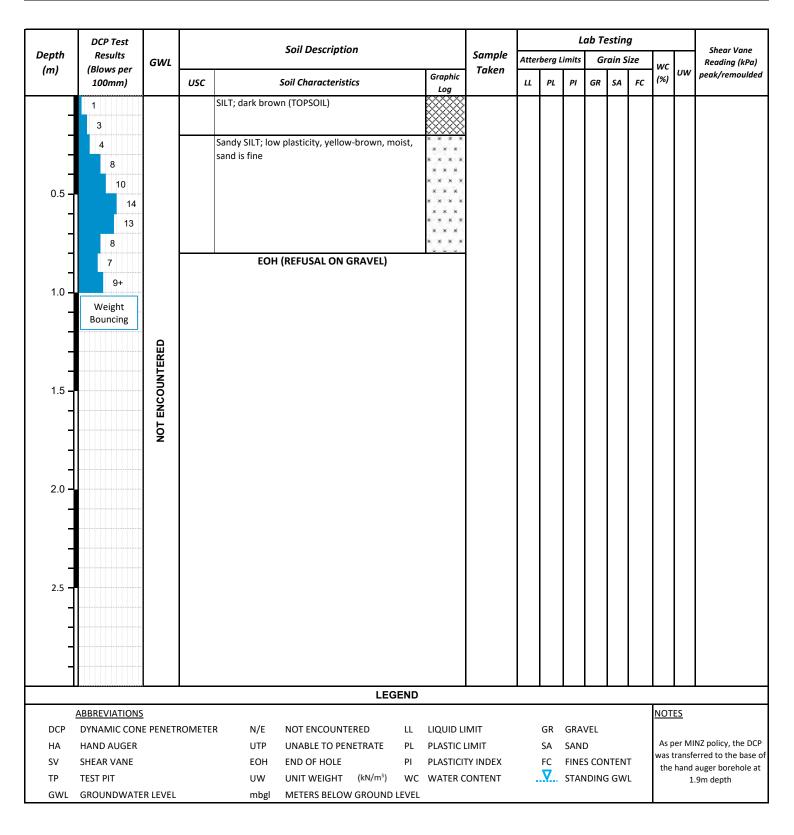
SHALLOW GROUND INVESTIGATION LOG

PROJECT:	Wilfield Subdivisi	Vilfield Subdivision, West Melton					
LOGGED BY:	CG/CMD	TOTAL TESTING DEPTH:	1.0 mbgl	HOLE DIAMETER: 50	0 mm		
PROCESSED BY:	CG	TESTING METHOD:	HA + DCP	SHEAR VANE NUMBER:			
LOCATION:	REFER TO SITE PLAN	GROUNDWATER LEVEL:	N/E	This report may only be reproduced in full

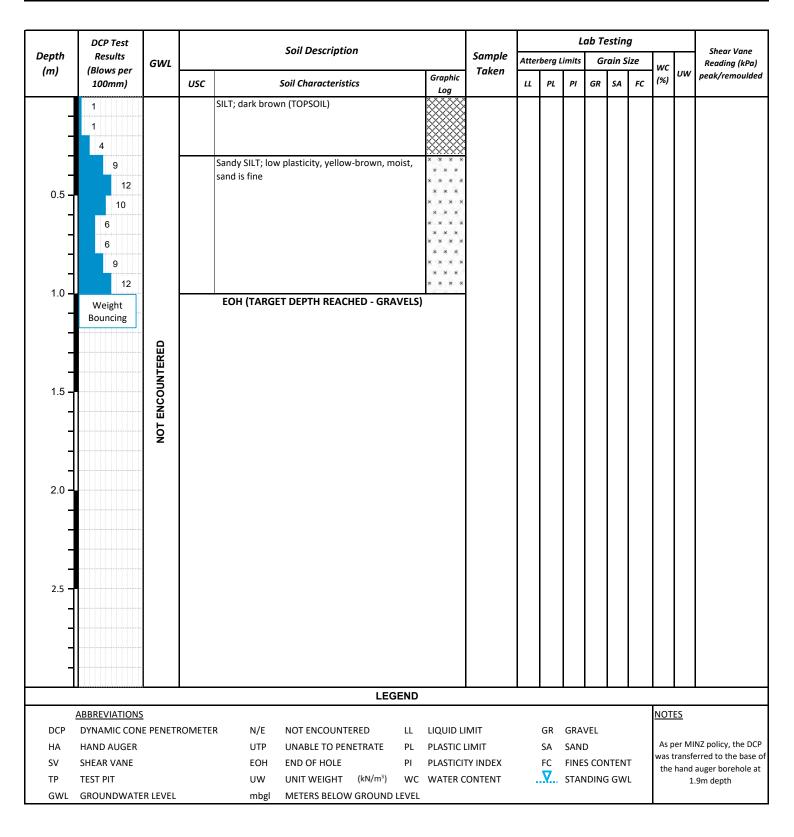
SHALLOW GROUND INVESTIGATION LOG

PROJECT:	Wilfield Subdivision	Vilfield Subdivision, West Melton					
LOGGED BY:	CG/CMD	TOTAL TESTING DEPTH:	1.0	mbgl	HOLE DIAMETER:	50 mm	
PROCESSED BY:	CG	TESTING METHOD:	TP + D	СР	SHEAR VANE NUMBER:	-	
LOCATION:	REFER TO SITE PLAN	GROUNDWATER LEVEL:	N/E		This report may only be reproduced in full

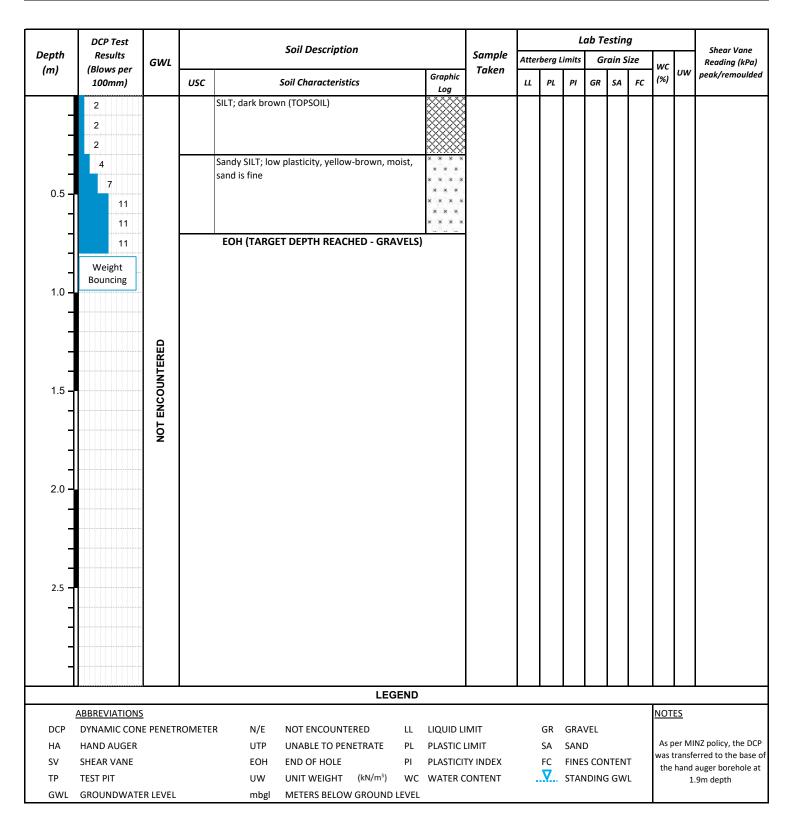
SHALLOW GROUND INVESTIGATION LOG

PROJECT:	Wilfield Subdivision	Vilfield Subdivision, West Melton					
LOGGED BY:	CG/CMD	TOTAL TESTING DEPTH:	0.8	mbgl	HOLE DIAMETER:	50 mm	
PROCESSED BY:	CG	TESTING METHOD:	TP + DO	CP	SHEAR VANE NUMBER:	-	
LOCATION:	REFER TO SITE PLAN	GROUNDWATER LEVEL:	N/E		This report may only be reproduced in full

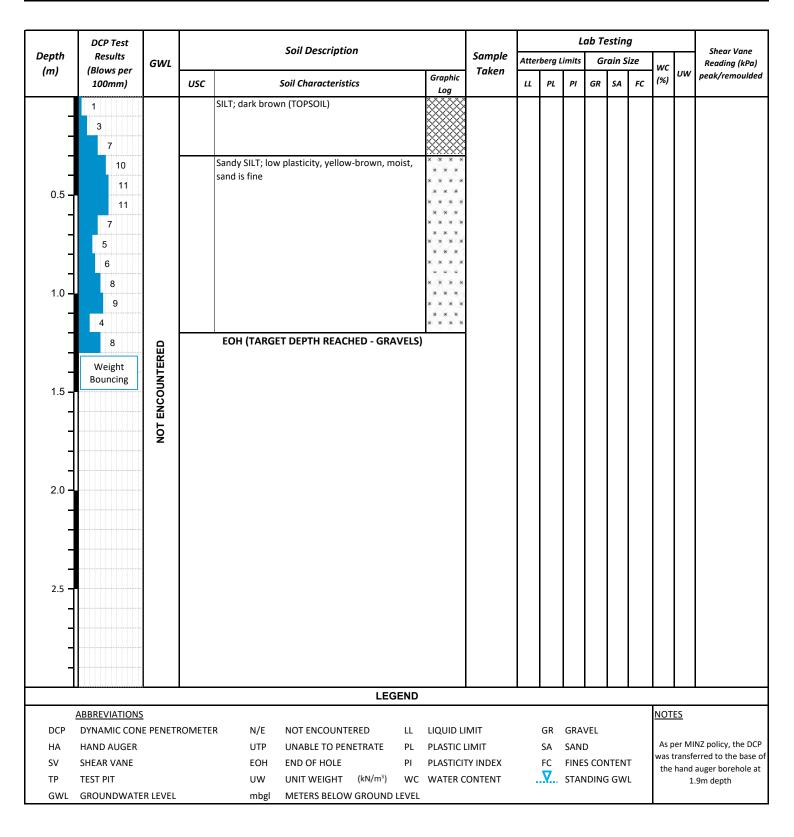
SHALLOW GROUND INVESTIGATION LOG

PROJECT:	Wilfield Subdivisi	Vilfield Subdivision, West Melton					
LOGGED BY:	CG/CMD	TOTAL TESTING DEPTH:	1.3 mbgl	HOLE DIAMETER:	50 mm		
PROCESSED BY:	CG	TESTING METHOD:	TP + DCP	SHEAR VANE NUMBER:	-		
LOCATION:	REFER TO SITE PLAN	GROUNDWATER LEVEL:	N/E	This report may only be reproduced in full

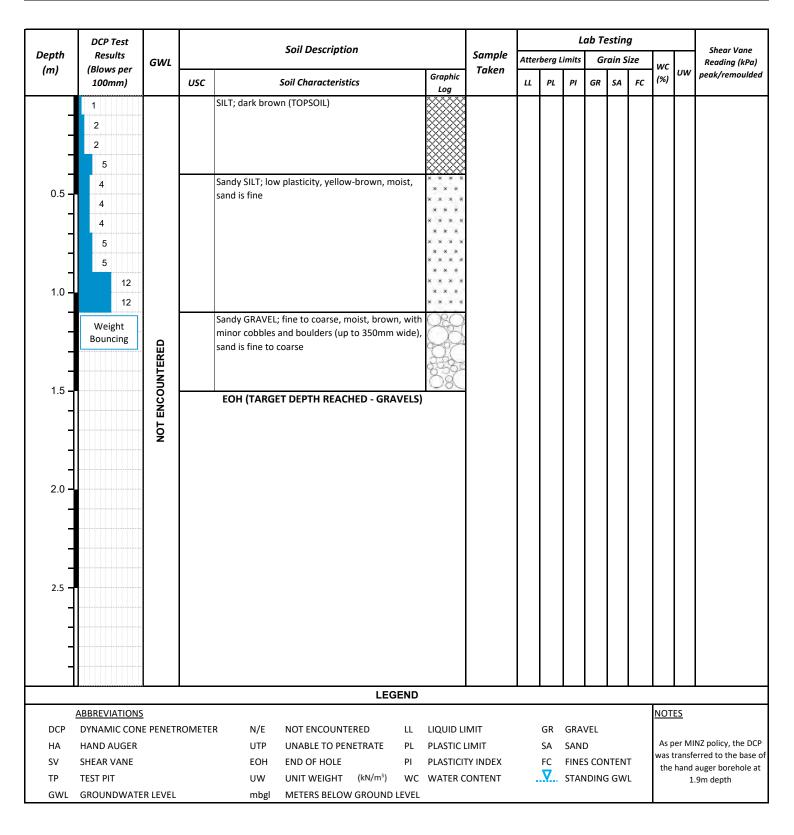
SHALLOW GROUND INVESTIGATION LOG

PROJECT:	Wilfield Subdivision	Vilfield Subdivision, West Melton						
LOGGED BY:	CG/CMD	TOTAL TESTING DEPTH:	1.5	mbgl	HOLE DIAMETER:	50 mm		
PROCESSED BY:	CG	TESTING METHOD:	TP + DO	CP	SHEAR VANE NUMBER:	-		
LOCATION:	REFER TO SITE PLAN	GROUNDWATER LEVEL:	N/E		This report may only be reproduced in full

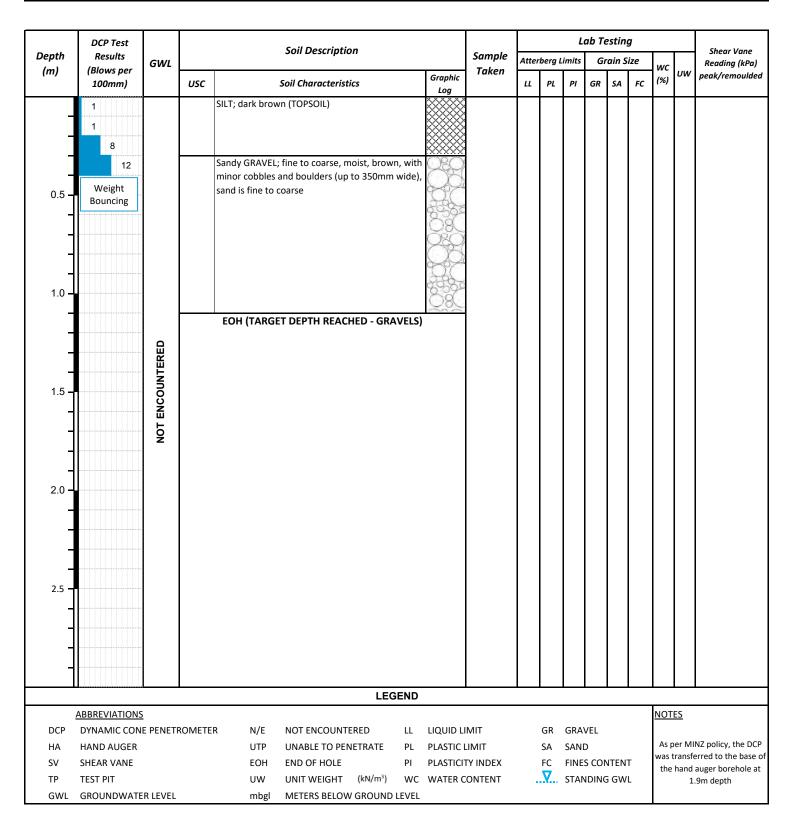
SHALLOW GROUND INVESTIGATION LOG

PROJECT:	Wilfield Subdivision	Vilfield Subdivision, West Melton						
LOGGED BY:	CG/CMD	TOTAL TESTING DEPTH:	1.1	mbgl	HOLE DIAMETER:	50 mm		
PROCESSED BY:	CG	TESTING METHOD:	TP + DC	P	SHEAR VANE NUMBER:	-		
LOCATION:	REFER TO SITE PLAN	GROUNDWATER LEVEL:	N/E		This report may only be reproduced in full

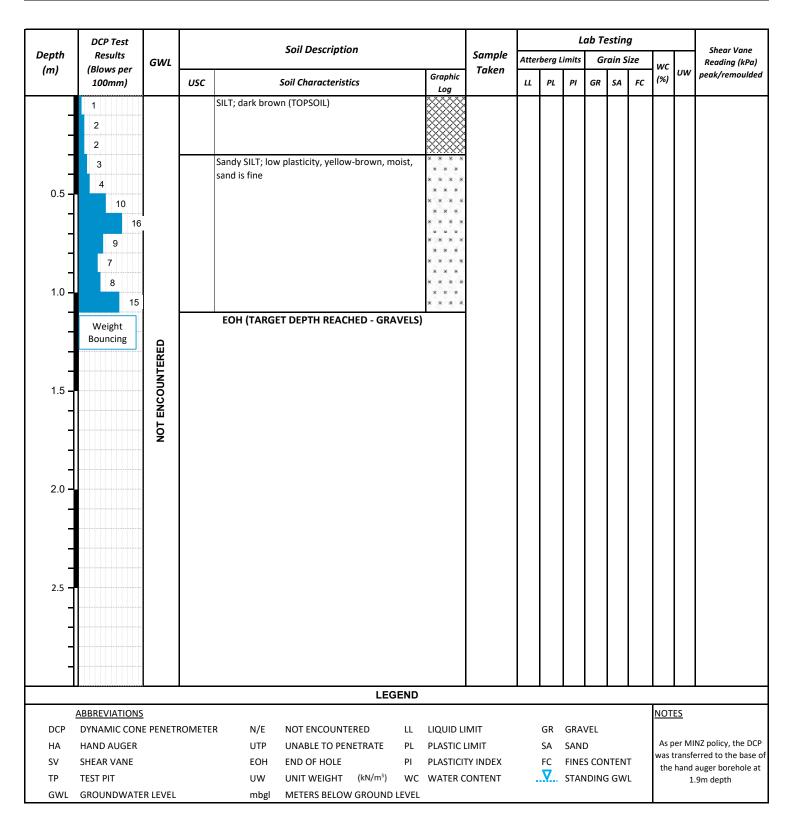
SHALLOW GROUND INVESTIGATION LOG

PROJECT:	Wilfield Subdivision	Vilfield Subdivision, West Melton						
LOGGED BY:	CG/CMD	TOTAL TESTING DEPTH:	1.1	mbgl	HOLE DIAMETER:	50 mm		
PROCESSED BY:	CG	TESTING METHOD:	TP + DCF)	SHEAR VANE NUMBER:	-		
LOCATION:	REFER TO SITE PLAN	GROUNDWATER LEVEL:	N/E		This report may only be reproduced in full

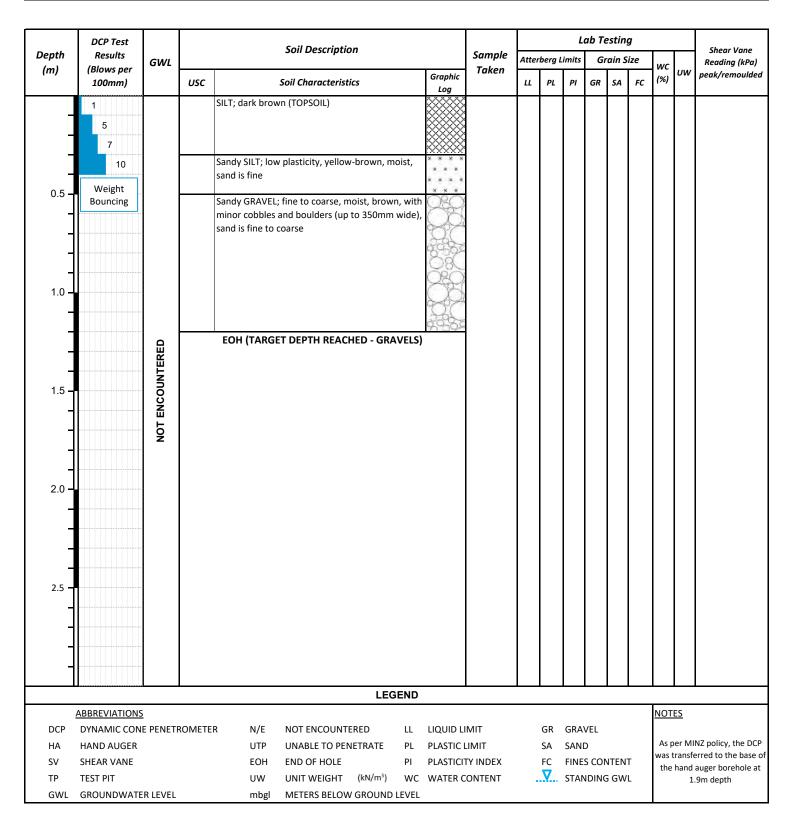
SHALLOW GROUND INVESTIGATION LOG

PROJECT:	Wilfield Subdivisi	/ilfield Subdivision, West Melton						
LOGGED BY:	CG/CMD	TOTAL TESTING DEPTH:	1.2 mbgl	HOLE DIAMETER: 50	0 mm			
PROCESSED BY:	CG	TESTING METHOD:	TP + DCP	SHEAR VANE NUMBER:				
LOCATION:	REFER TO SITE PLAN	GROUNDWATER LEVEL:	N/E	This report may only be reproduced in full

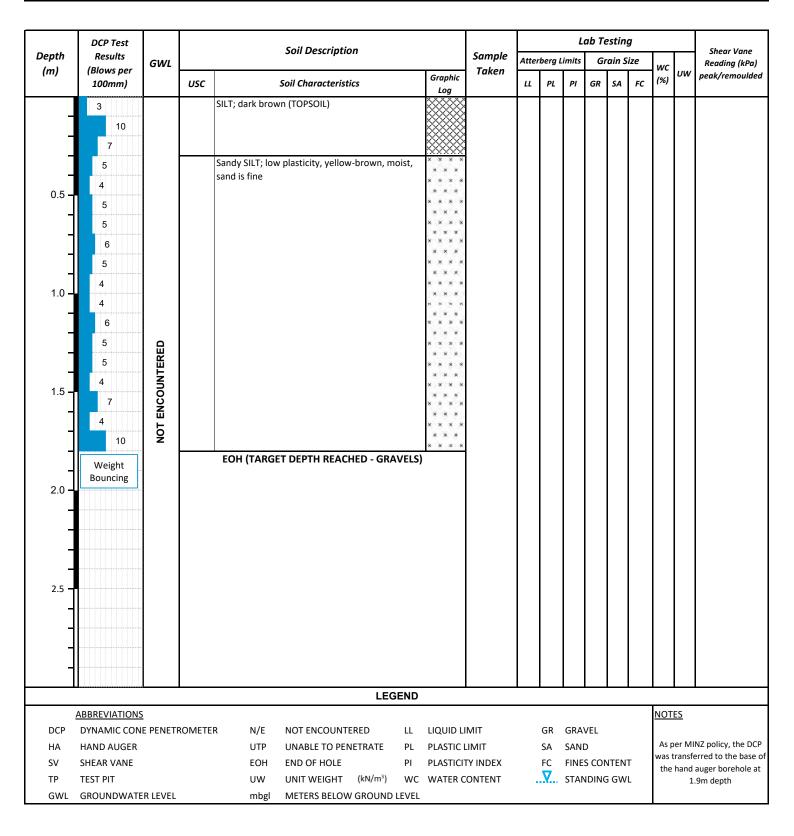
SHALLOW GROUND INVESTIGATION LOG

PROJECT:	Wilfield Subdivision	/ilfield Subdivision, West Melton						
LOGGED BY:	CG/CMD	TOTAL TESTING DEPTH:	1.8 mbgl	HOLE DIAMETER:	50 mm			
PROCESSED BY:	CG	TESTING METHOD:	TP + DCP	SHEAR VANE NUMBER:	-			
LOCATION:	REFER TO SITE PLAN	GROUNDWATER LEVEL:	N/E	This report may only be reproduced in full

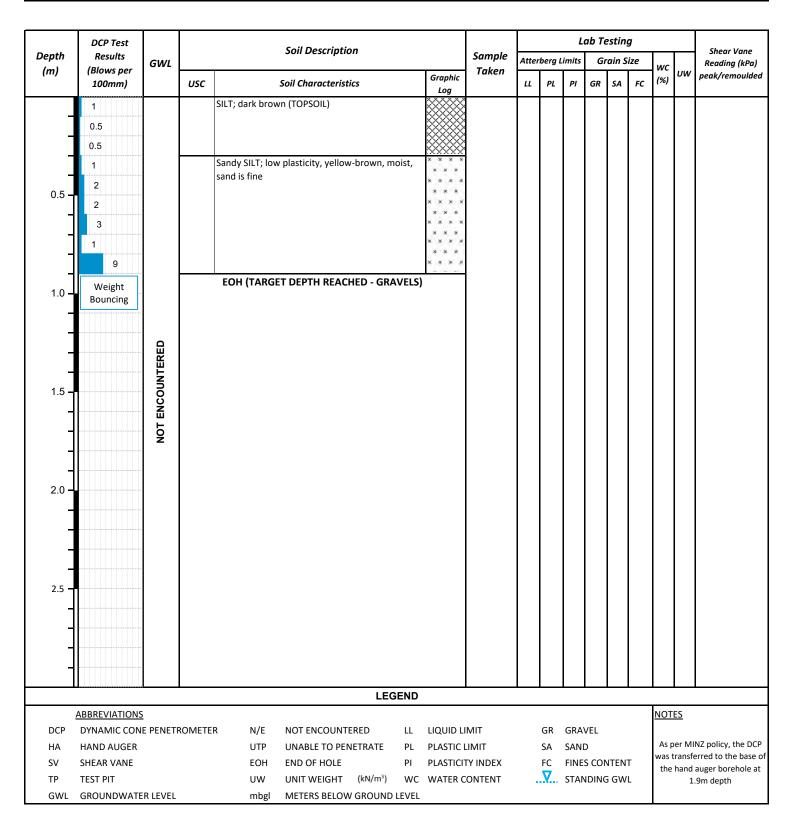
SHALLOW GROUND INVESTIGATION LOG

PROJECT:	Wilfield Subdivisi	Vilfield Subdivision, West Melton						
LOGGED BY:	CG/CMD	TOTAL TESTING DEPTH:	0.9 mbgl	HOLE DIAMETER:	50 mm			
PROCESSED BY:	CG	TESTING METHOD:	TP + DCP	SHEAR VANE NUMBER:	-			
LOCATION:	REFER TO SITE PLAN	GROUNDWATER LEVEL:	N/E	This report may only be reproduced in full

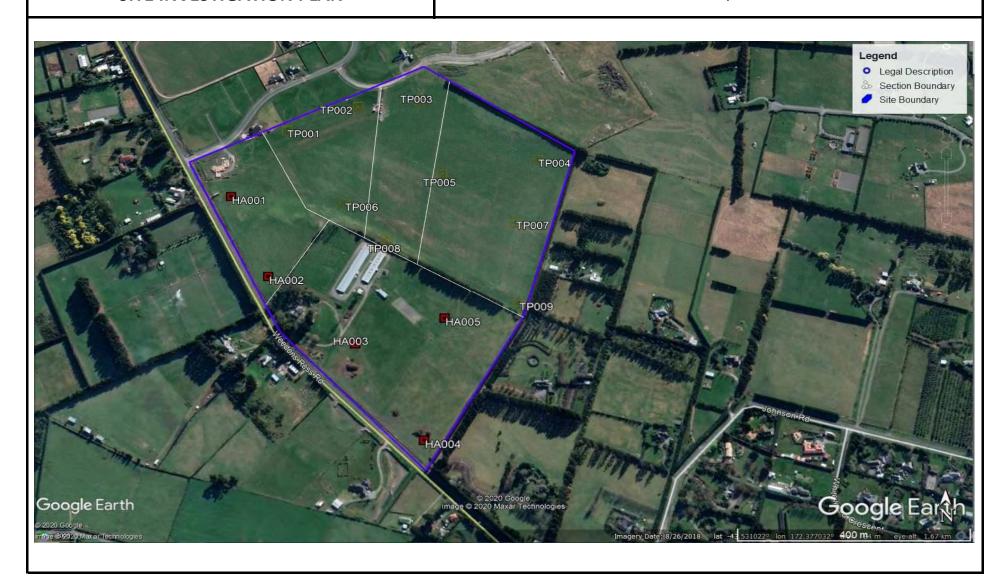
SITE INVESTIGATION PLAN

Wilfield Subdivision, West Melton

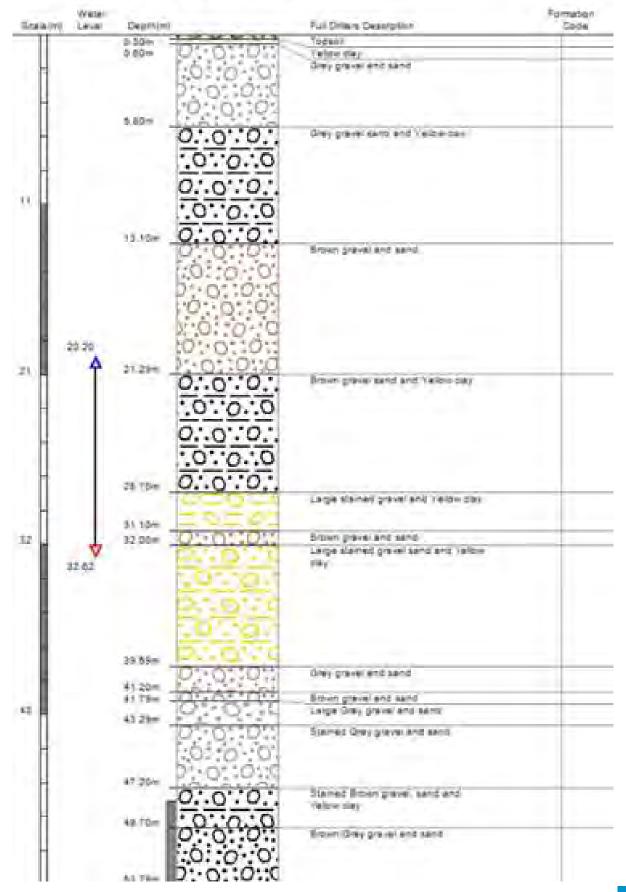
Borelog for well BX23/0829

Grid Reference (NZTM): 1549894 mE . 5180029 mN

Boxelog Depth 533 m Dnill Date 30-Jun-1971

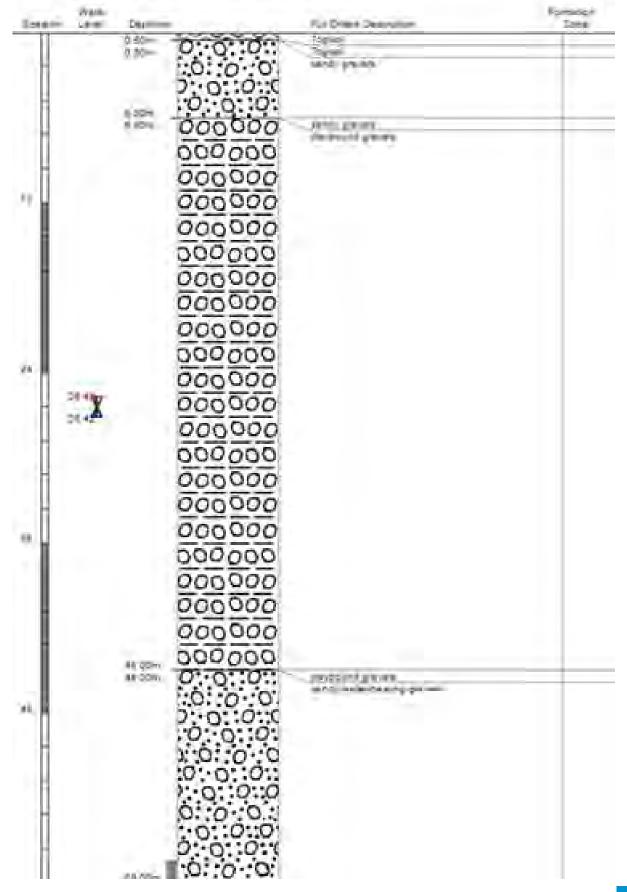
Borelog for well M35/11167

Grid Reference (NZTM): 1549957 mE, 5179666 mN

Borelog Depth 60 0 m Drill Date 15-Feb-2006

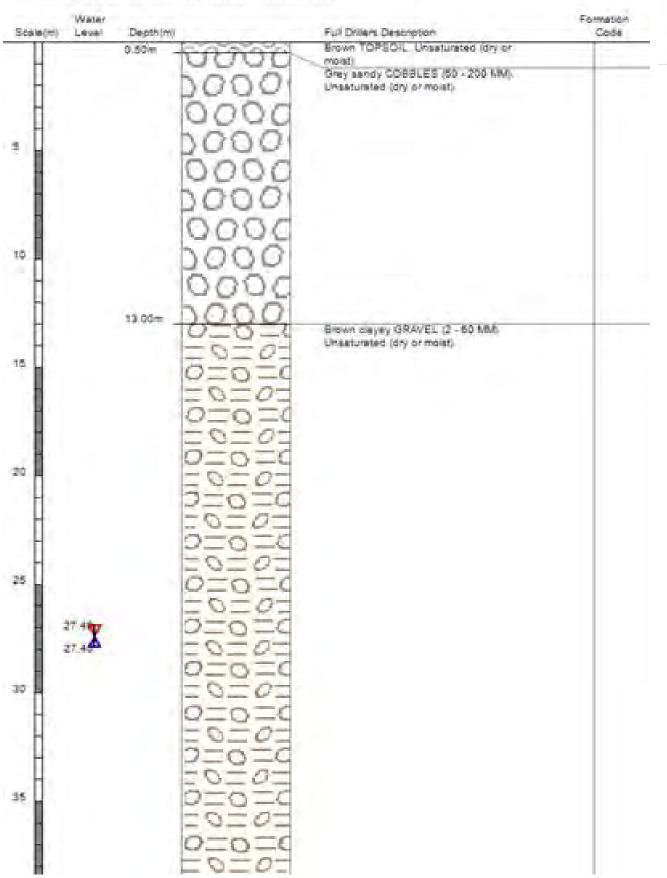
Borelog for well BX23/0525

Grid Reference (NZTM): 1550000 mE, 5179207 mN

Borelog Depth: 42.0 m Drill Date: 14-Sep-2015
