GEOTECHNICAL INVESTIGATION REPORT

FOR PROPOSED LAND USE CHANGE

139 Levi Road, Rolleston

Project Reference: LTC20264

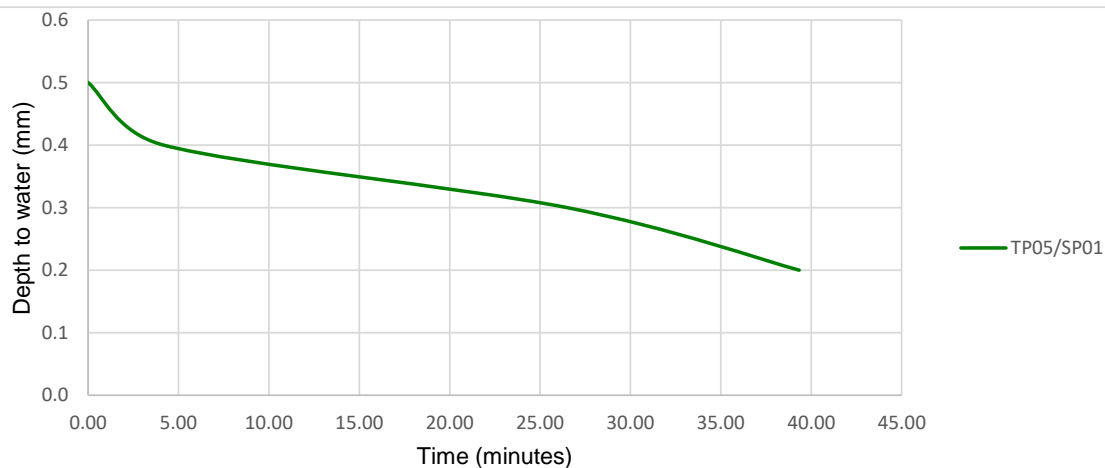
Soakage Test Results

3) Calculate percolation rate

10 L/m²/min
587 L/m²/hr

Following the testing silt was loaded in the base to a thickness of around 0.2m thick which likely impeded the flow. While the Test pit was being filled the maximum height above the base the water level rose to was 0.5m, at a flow rate of 833L/min or 520L/m²/min. This shows that infiltration from the side walls contributes a considerable amount to the drainage.
