GEOTECHNICAL INVESTIGATION REPORT

FOR PROPOSED LAND USE CHANGE

274 & 294 Lincoln Rolleston Road, Rolleston

Project Reference: LTC20428 Revision: Revision A

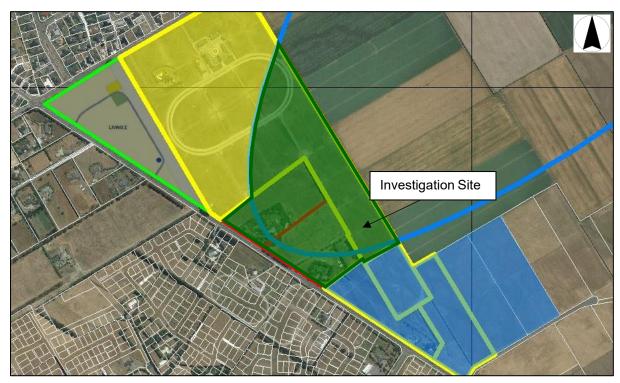
Figure 1: Aerial photograph of investigation site.

Previously the yellow and blue shaded area have been subject to a geotechnical investigation for Land Use Change. This Land Use Change report covers the land in between, shaded in green. The location of the investigated area and approximate location of the decibel restrictions is shown on the attached drawings LTC20428/1.

The investigation site is accessed from Lincoln Rolleston Road in Rolleston. The site is indicated in Figure 1 below, and is located approximately 1.4km to the south east of the Rolleston Township. The site comprises part of 139 Levi Road, and all of 274 & 294 Lincoln Rolleston Road, Rolleston. The legal descriptions and areas are shown below in table 1 below.

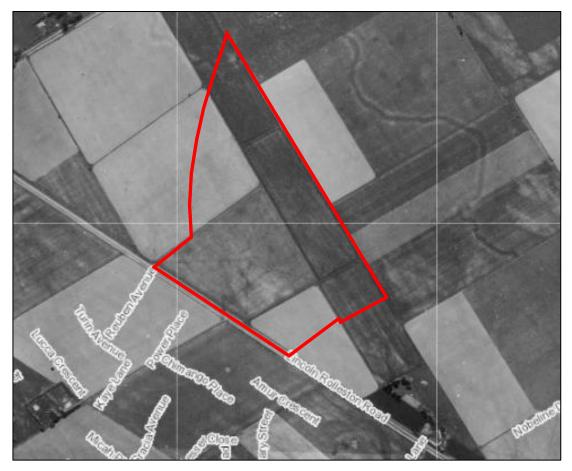
Figure 3: Aerial photograph of investigation site (source: https://mapviewer.canterburymaps.govt.nz/, accessed 15 February 2021)

• A review of historical photograph of the site from between 1940 and 2004 has been carried out on information available from Canterbury Maps. Imagery from 1940 to 1944 (shown below in Figure 3), shows evidence of paleo river channels near the northern corner of the investigation site. It is therefore possible additional channels are present within the investigation site. Some historic infilling of these paleo channels could have taken place as part of farming activities. However, our investigation found limited evidence of filling having taken place across the general area investigated for the proposed Land Use Change.

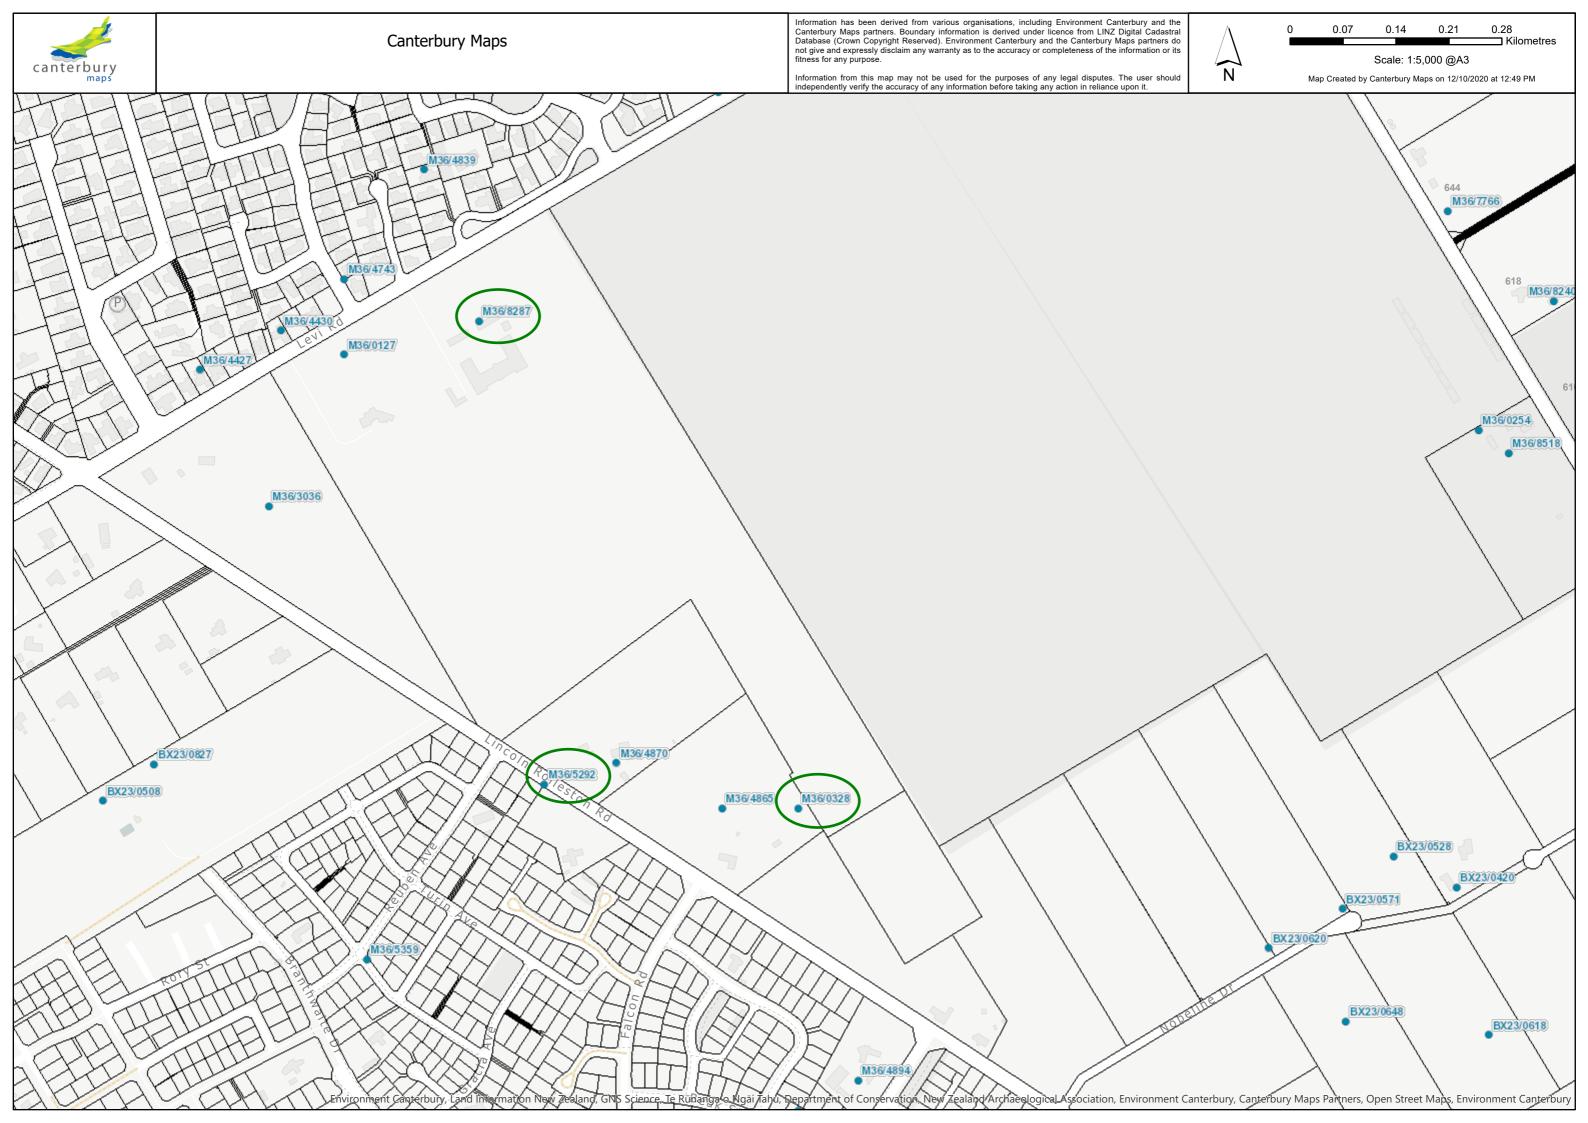
Borelog for well M36/5292

Scale(m)	Water Level	Depth(m)		Full Drillers Description	Formation Code
				Earth and clay	SP
5		1.20m _ 1.20m	000000 00000 00000 00000 00000 00000	Earth and clay Claybound gravel	SP SP-RI
	13.48 4 14.34	14.00m _ 14.00m _	000000 000000 000000 000000 0:0:0:0:0:0	Claybound gravel Rough sandy gravel	SP-RI RI
20					
Ц		23.50m _ 23.50m	0::0::0::	Rough sandy gravel Sandy claybound gravel	RI BR?
25		24.70m _ 24.70m	20.22.22	Sandy daybound gravel	BR?
		24.70m	00	Sandy claybound gravel, less clay, more sand	BR?
		26.79m _ 26.79m	<u> </u>	Sandy claybound gravel, less clay, more sand	BR?
		28.60m		Free gravel and sand	BR?

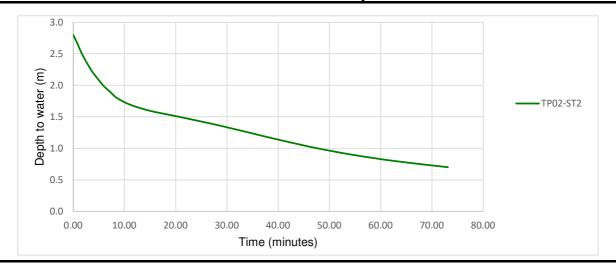
3) Calculate percolation rate

6 L/m2/min 347 L/m2/hr
