GEOTECHNICAL INVESTIGATION REPORT

FOR PROPOSED LAND USE CHANGE

Lincoln Rolleston Road, Rolleston

Project Reference: LTC20265

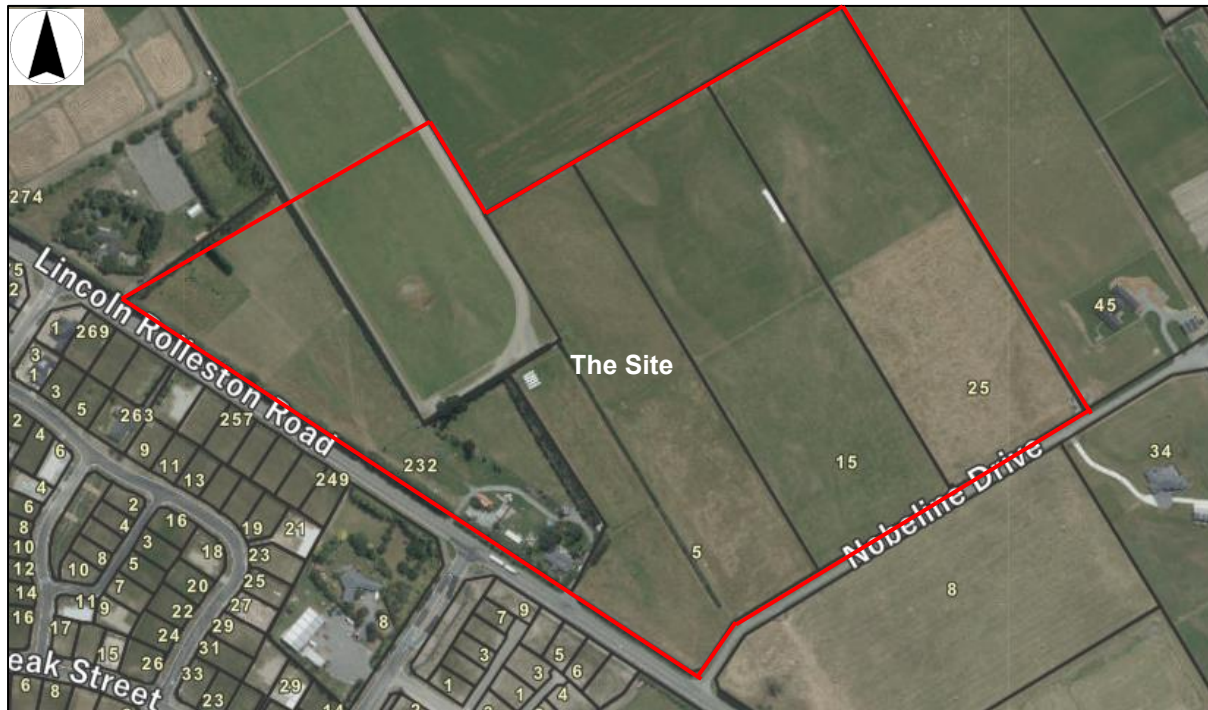
Figure 1: Aerial photograph of investigation site (source: <https://mapviewer.canterburymaps.govt.nz/>, accessed 29 September 2020)

The investigation site is located on the corner of Lincoln Rolleston Road and Nobeline Drive in Rolleston. The site is indicated in Figure 1 below, and is located approximately 1.7km to the south east of the Rolleston Township. The site comprised four existing lots and the southern end of a property accessed from Levi Road to the North. Legal Descriptions of properties within the investigation site are given below in Table 1.

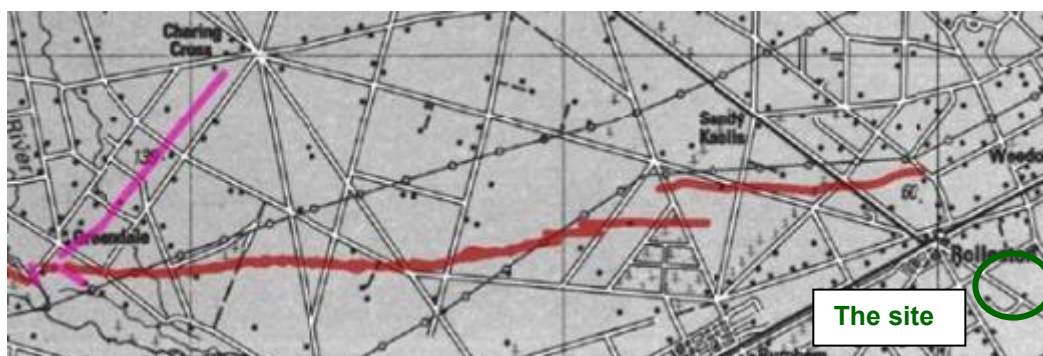
Figure 2: shows excerpt from figure A.1e of the referenced report (red line is a definite or likely fault).

The reference report gives a general outline of the nature of geologically active areas within the Selwyn District. Figure 6 in the referenced report indicates that the investigation site is located within 10km of the mapped Greendale Fault, to the northwest.

The Greendale Fault and associated blind faults of the Darfield earthquake sequence have been defined by GNS Science via field inspection, aerial photograph interpretation and regional geologic mapping. The reference source indicates that these faults were unknown prior to 2010 and the ages of previous ruptures are also not known. This leaves the potential for further unmapped faults to exist within the locality of the investigation site.

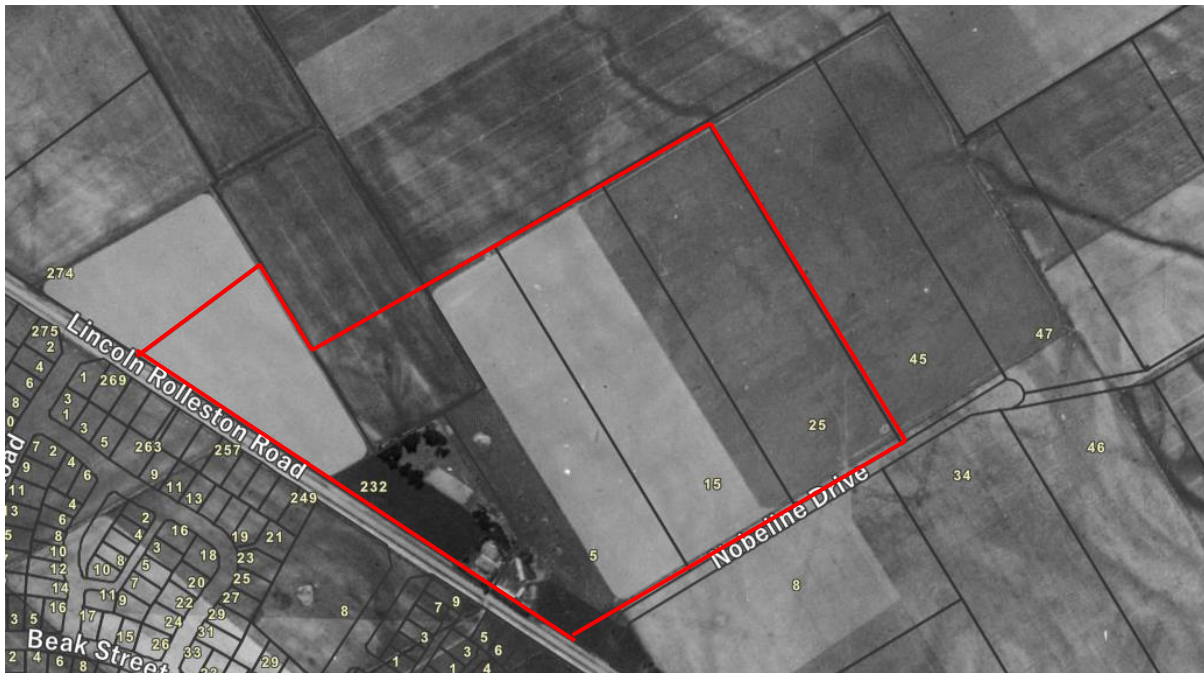
Figure 3: Aerial photograph of investigation site (source: <https://mapviewer.canterburymaps.govt.nz/>, accessed 07 September 2020)

- A review of historical photograph of the site from between 1940 and 2004 has been carried out on Canterbury Maps. Imagery from 1940 to 1944 (shown overleaf in Figure 3), shows evidence of paleo river channels near the northern corner of the site, it is possible additional channels are present within the investigation site. Some historic infilling of these paleo channels could have taken place as part of farming activities. However, our investigation found limited evidence of filling having taken place across the general subdivision site.

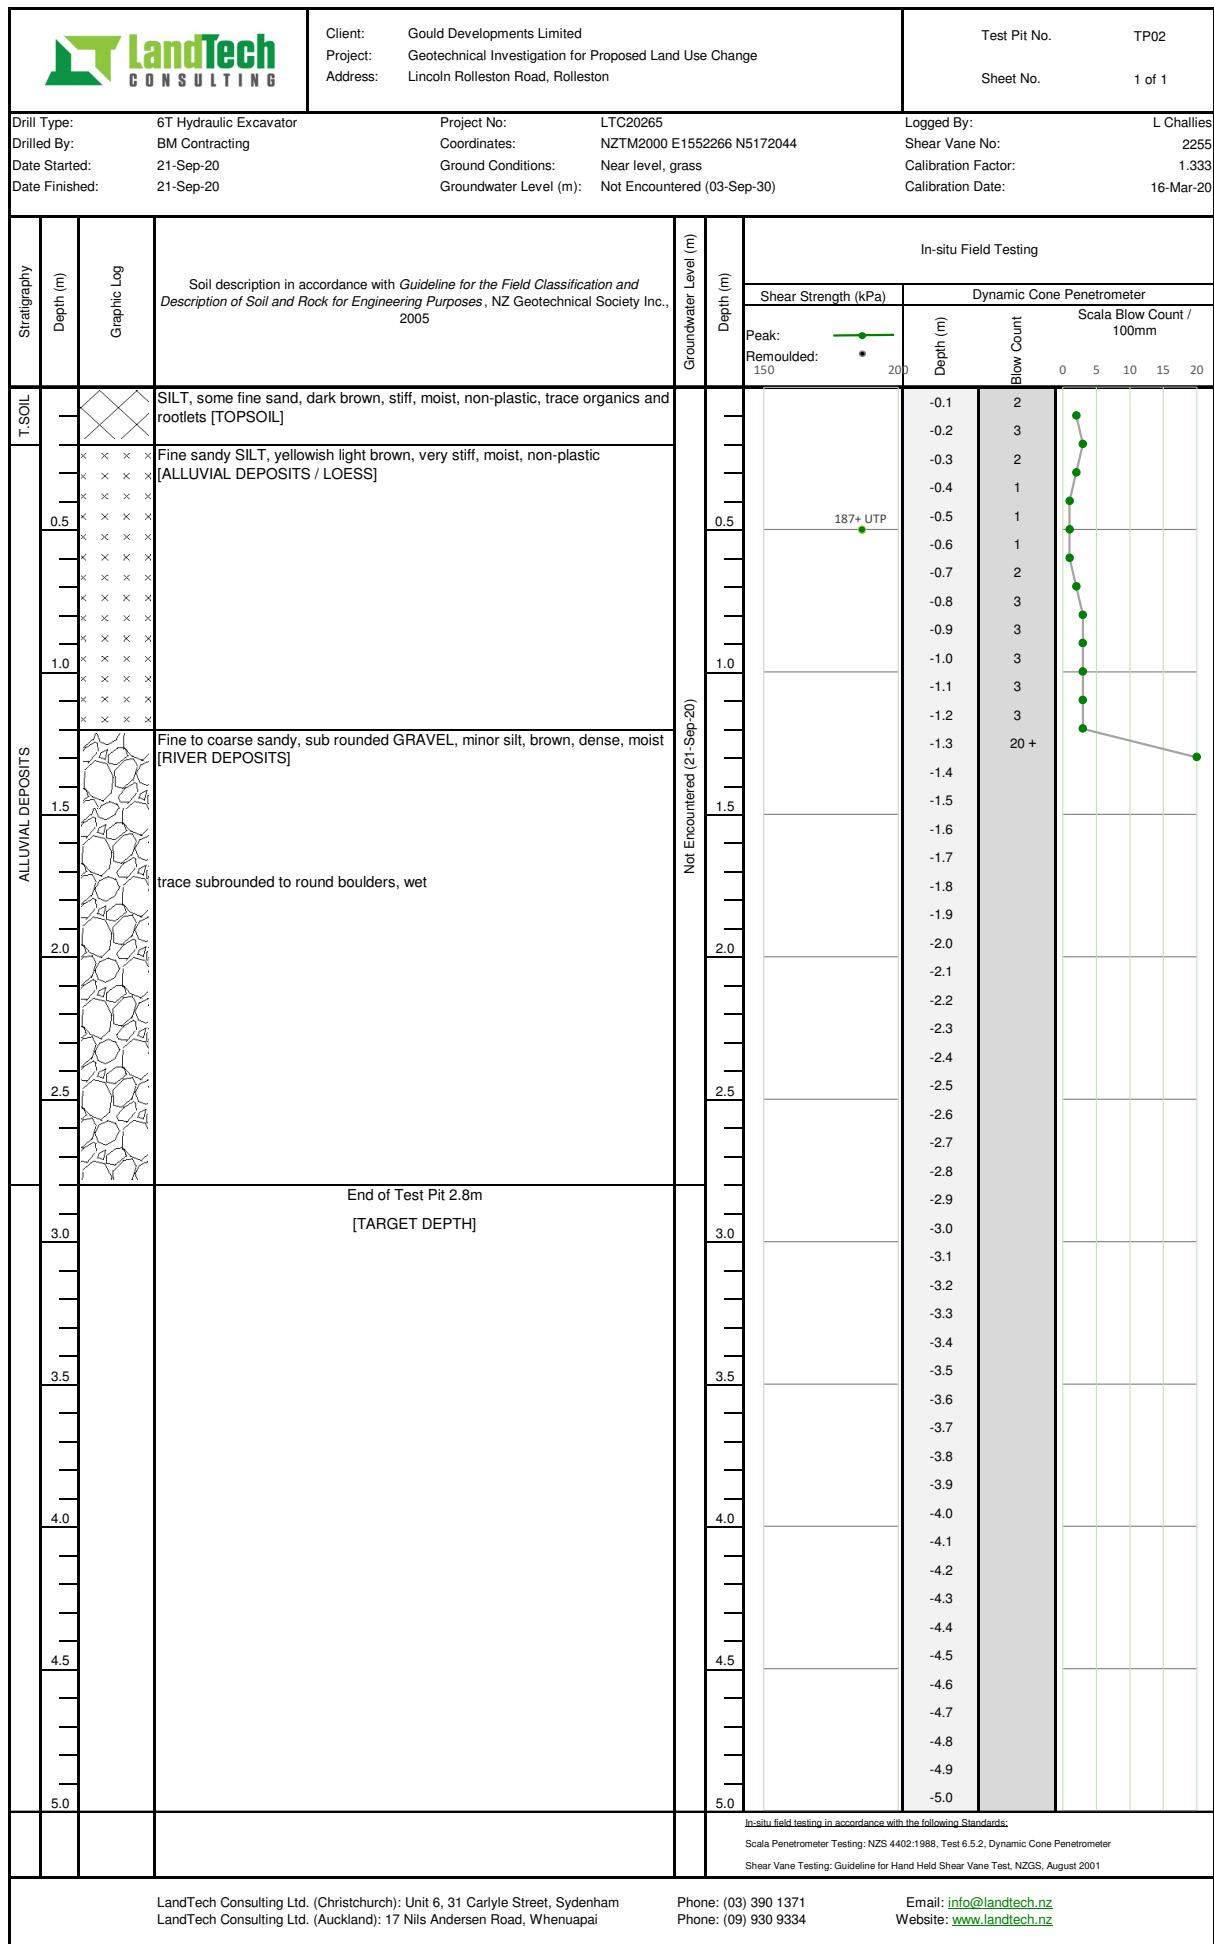
Drill Type:	6T Hydraulic Excavator	Project No:	LTC20265	Logged By:	L Challies
Drilled By:	BM Contracting	Coordinates:	NZTM2000 E1552067 N5172037	Shear Vane No:	2255
Date Started:	21-Sep-20	Ground Conditions:	Near level, grass	Calibration Factor:	1.333
Date Finished:	21-Sep-20	Groundwater Level (m):	Not Encountered (03-Sep-30)	Calibration Date:	16-Mar-20

The soil conditions encountered within the hand augerholes and test pits were logged by LandTech field staff in accordance with New Zealand Geotechnical Society *Guideline for the Description of Soil and Rock for Engineering Purposes* (2005). The test pit logs and corresponding photographs are attached in Appendix B, while the hand augerhole logs are within Appendix C.

Soil deposits comprising either alluvial soils or loessal soils were present above the river deposits at depth. The depth of these soils ranged from between 0.5m (TP06) and 1.2m (TP02) below ground level, and typically comprised a moist fine sandy silt.

Scala penetrometer testing within the soils ranged from 1 and 20 Blows / 100mm penetration. Higher blow counts may be due to gravels within the soil at the test location. Typically the Scala blow counts ranged from between 1 and 6 Blows / 100mm of penetration indicating a loose to medium dense soil.

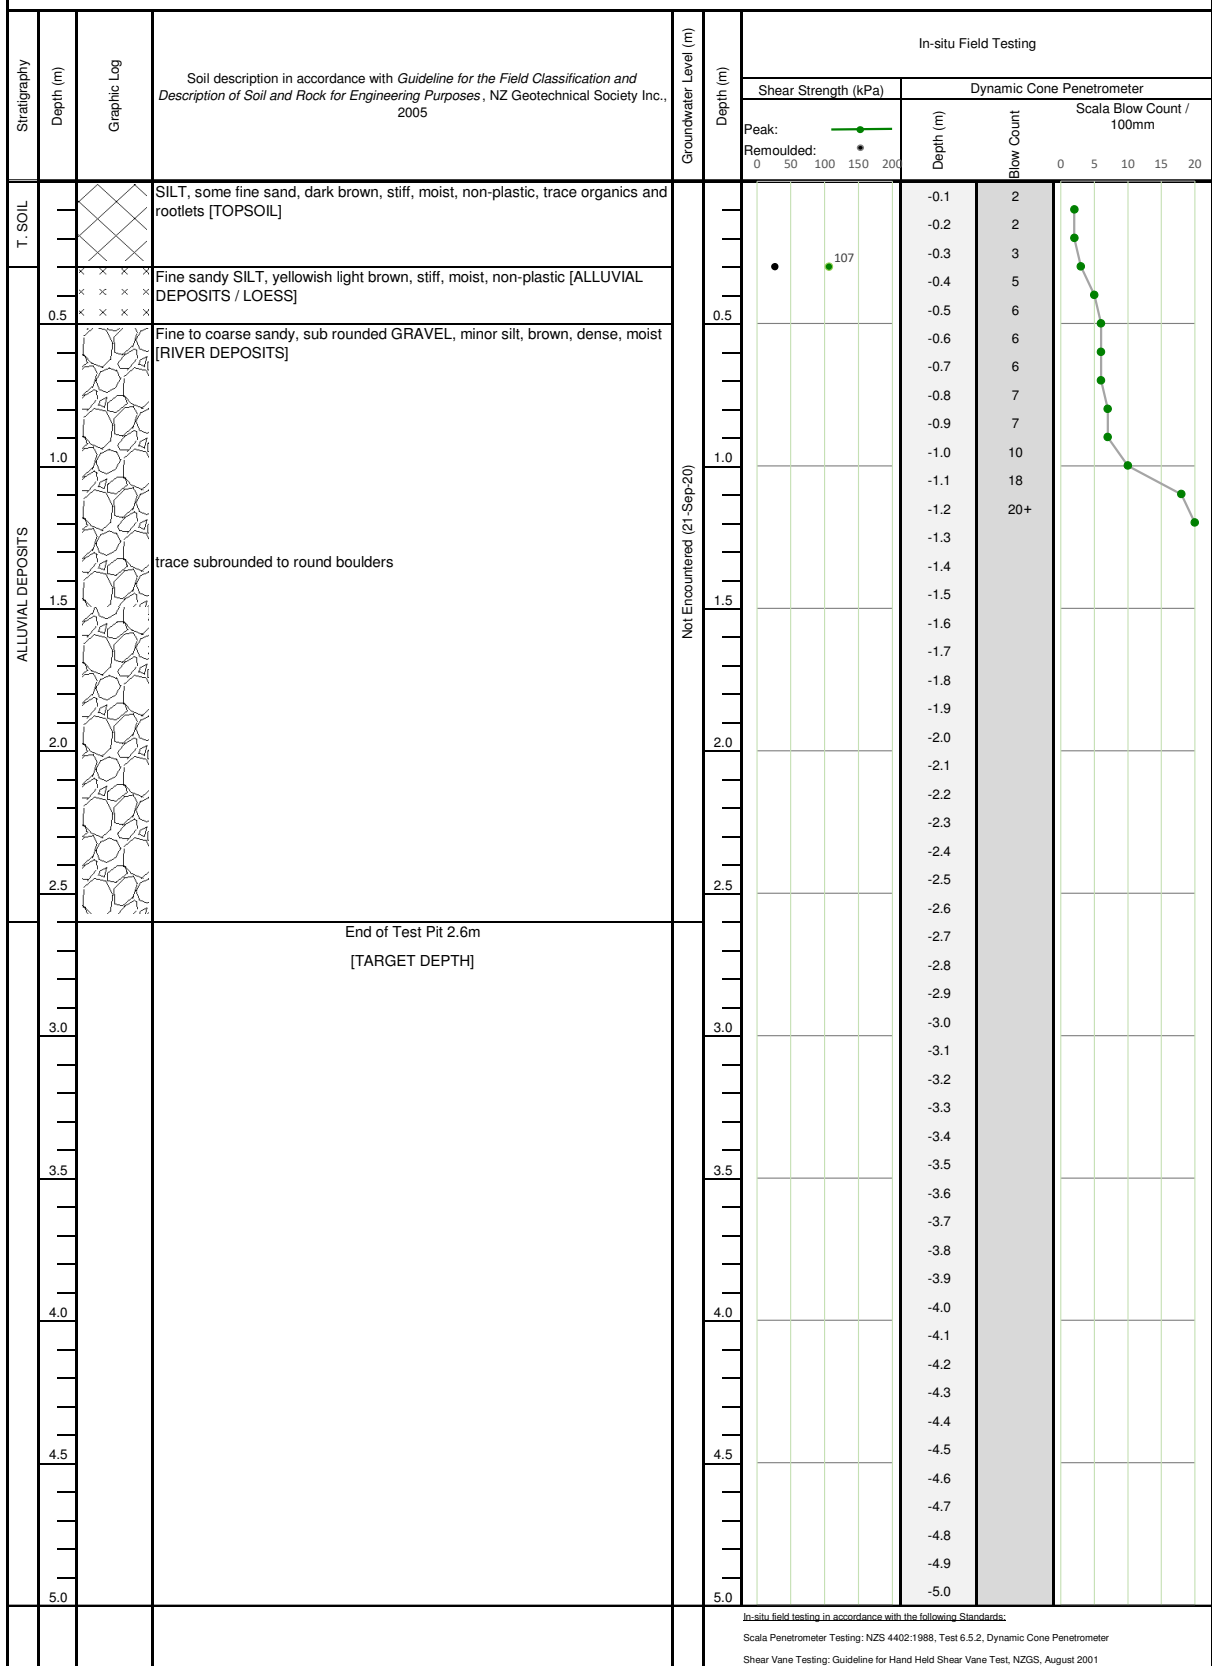
Drill Type:	6T Hydraulic Excavator	Project No:	LTC20265	Logged By:	L Challies
Drilled By:	BM Contracting	Coordinates:	NZTM2000 E1552565 N5172038	Shear Vane No:	2255
Date Started:	21-Sep-20	Ground Conditions:	Near level, grass	Calibration Factor:	1.333
Date Finished:	21-Sep-20	Groundwater Level (m):	Not Encountered (21-Sep-30)	Calibration Date:	16-Mar-20

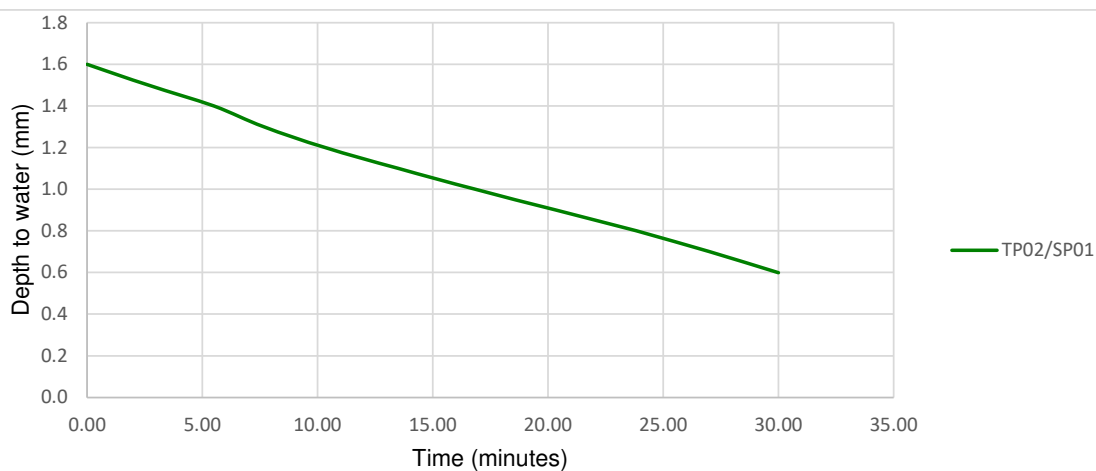
Soakage Test Results

3) Calculate percolation rate

13 L/m²/min
771 L/m²/hr
