GEOTECHNICAL INVESTIGATION REPORT

FOR PROPOSED LAND USE CHANGE

139 Levi Road, Rolleston

Project Reference: LTC20264

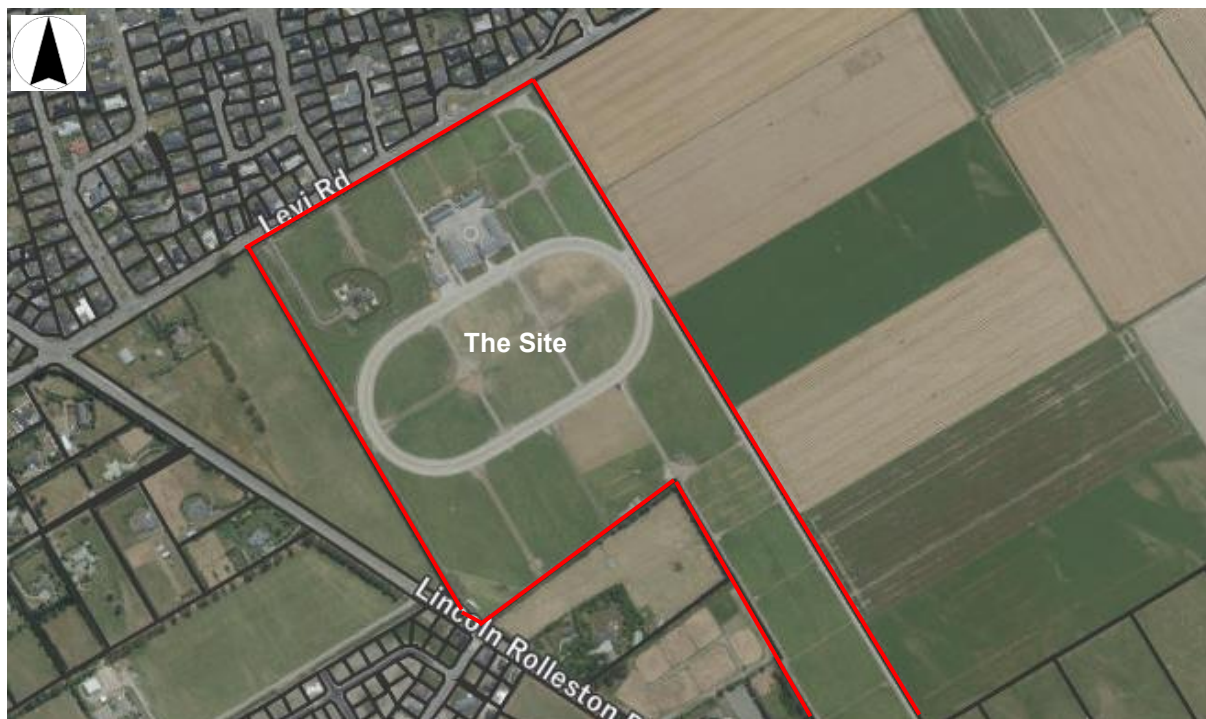
Figure 1: Aerial photograph of investigation site (source: <https://mapviewer.canterburymaps.govt.nz/>, accessed 11 September 2020)

The property is generally flat and is currently used for horse training, and a stables and associate building are located in the northern portion of the site near Levi Road, along with a dwelling in the western corner. A training oval occupies the centre of the property, along with several tracks providing accesses to the paddocks. The land is essentially flat with no obvious changes in elevations and undulations.

The investigation site is located near the corner of Levi Road and Lincoln Rolleston Road in Rolleston. The site is indicated in Figure 1 below, and is located approximately 1.1km to the south east of the Rolleston Township. The site comprises part of 139 Levi Road, legally described as Lot 2 DP416195 and Lot 2 DP 322710, and covers a total area of 30.43ha (sourced from <https://mapviewer.canterburymaps.govt.nz/> on 11 October 2020).

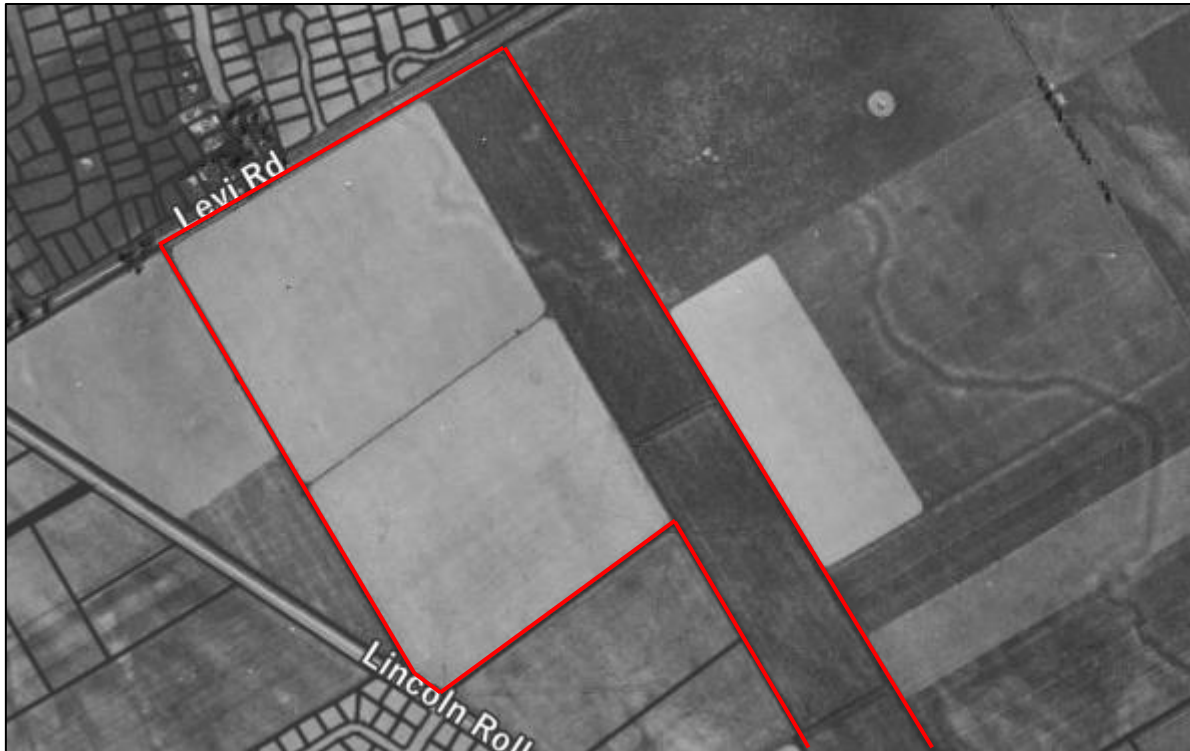
Figure 3: Aerial photograph of investigation site (source: <https://mapviewer.canterburymaps.govt.nz/>, accessed 11 September 2020)

- A review of historical photograph of the site from between 1940 and 2004 has been carried out on information available from Canterbury Maps. Imagery from 1940 to 1944 (shown overleaf in Figure 3), shows evidence of paleo river channels near the northern corner of the site. It is therefore possible additional channels are present within the investigation site. Some historic infilling of these paleo channels could have taken place as part of farming activities. However, our investigation found limited evidence of filling having taken place across the general subdivision site.

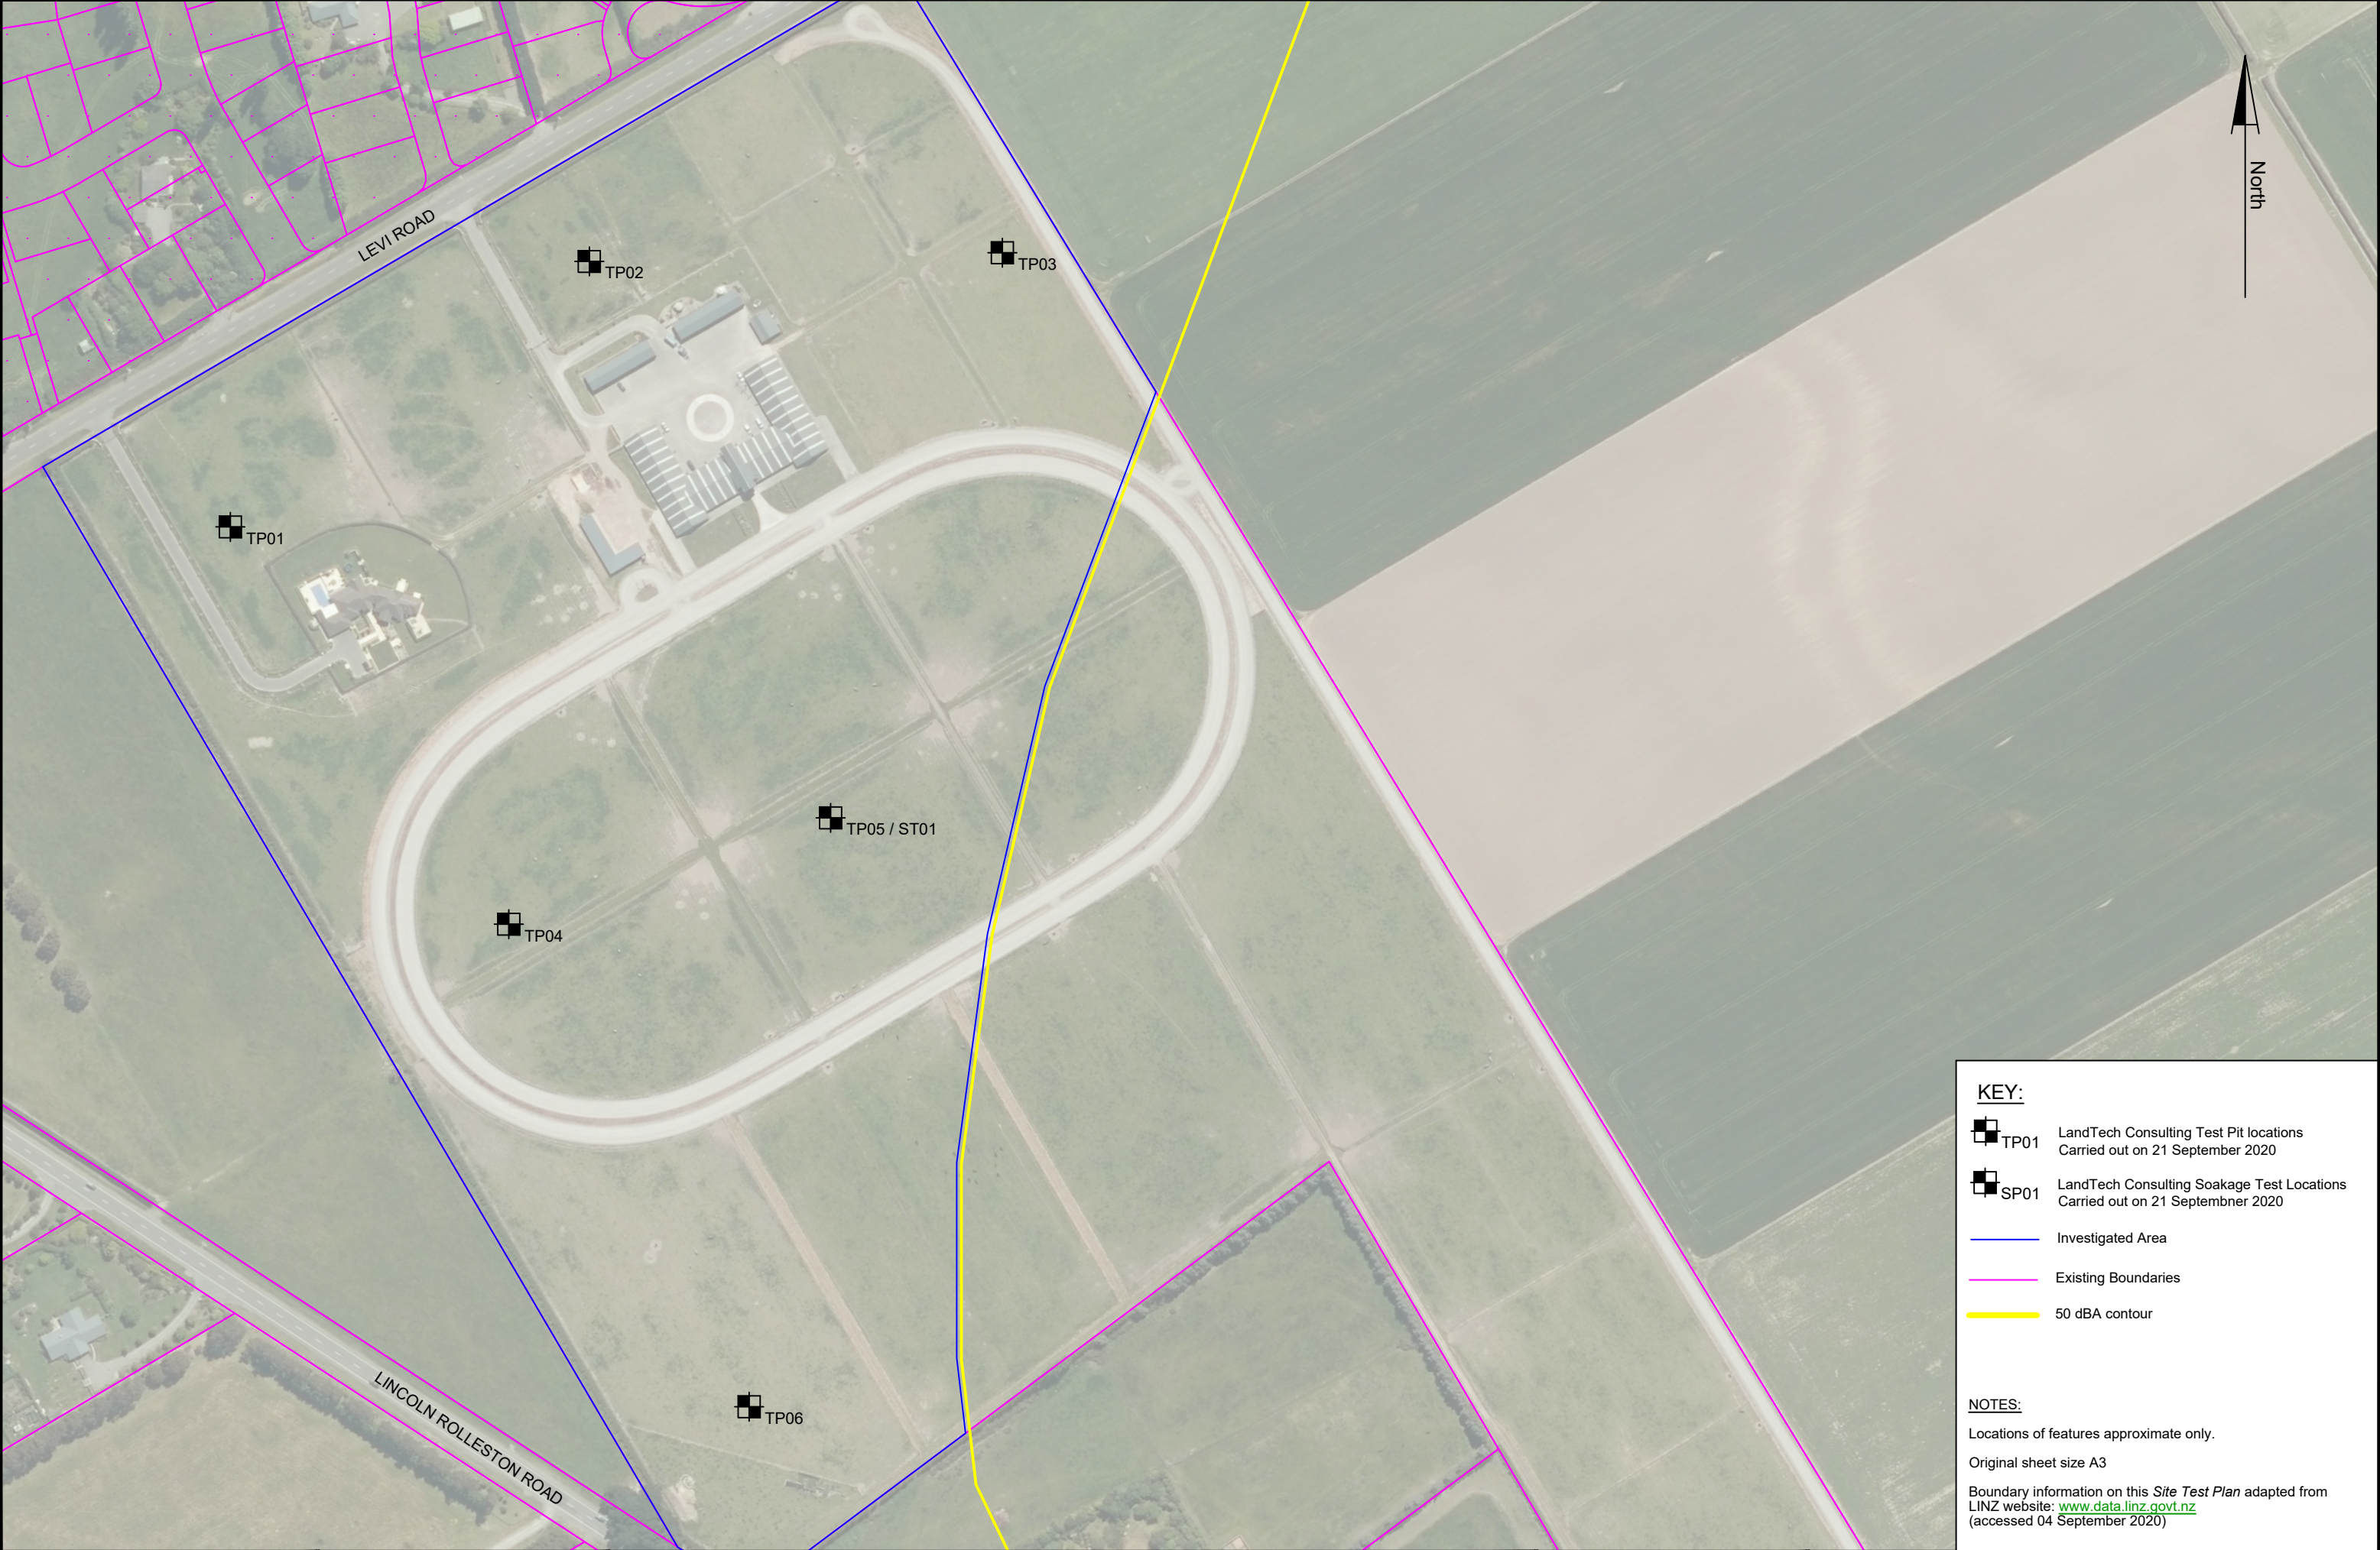
LandTech Site Test Plan

- TP01 LandTech Consulting Test Pit locations
Carried out on 21 September 2020
- SP01 LandTech Consulting Soakage Test Locations
Carried out on 21 Septembner 2020
- Investigated Area
- Existing Boundaries
- 50 dBA contour

Due the zoning of a decibel restriction associated with the Christchurch Airport extending into the eastern portion of the property, only the northern and western portion of the property has been investigated for the Land Use Change Application. The location of the investigated area and approximate location of the decibel restrictions is shown on the attached drawings LTC20264/1.
