GEOTECHNICAL INVESTIGATION REPORT

FOR PROPOSED LAND USE CHANGE

274 & 294 Lincoln Rolleston Road, Rolleston

Project Reference: LTC20428 Revision: Revision A

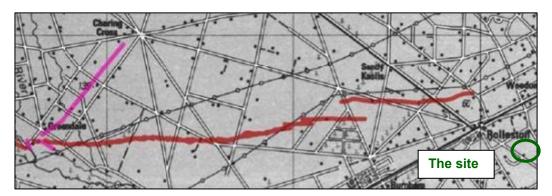
Figure 2: shows excerpt from figure A.1e of the referenced report (red line is a definite or likely fault).

The reference report gives a general outline of the nature of geologically active areas within the Selwyn District. Figure 6 in the referenced report indicates that the investigation site is located within 10km of the mapped Greendale Fault, to the northwest.

The Greendale Fault and associated blind faults of the Darfield earthquake sequence have been defined by GNS Science via field inspection, aerial photograph interpretation and regional geologic mapping. The reference source indicates that these faults were unknown prior to 2010 and the ages of previous ruptures are also not known. This leaves the potential for further unmapped faults to exist within the locality of the investigation site.

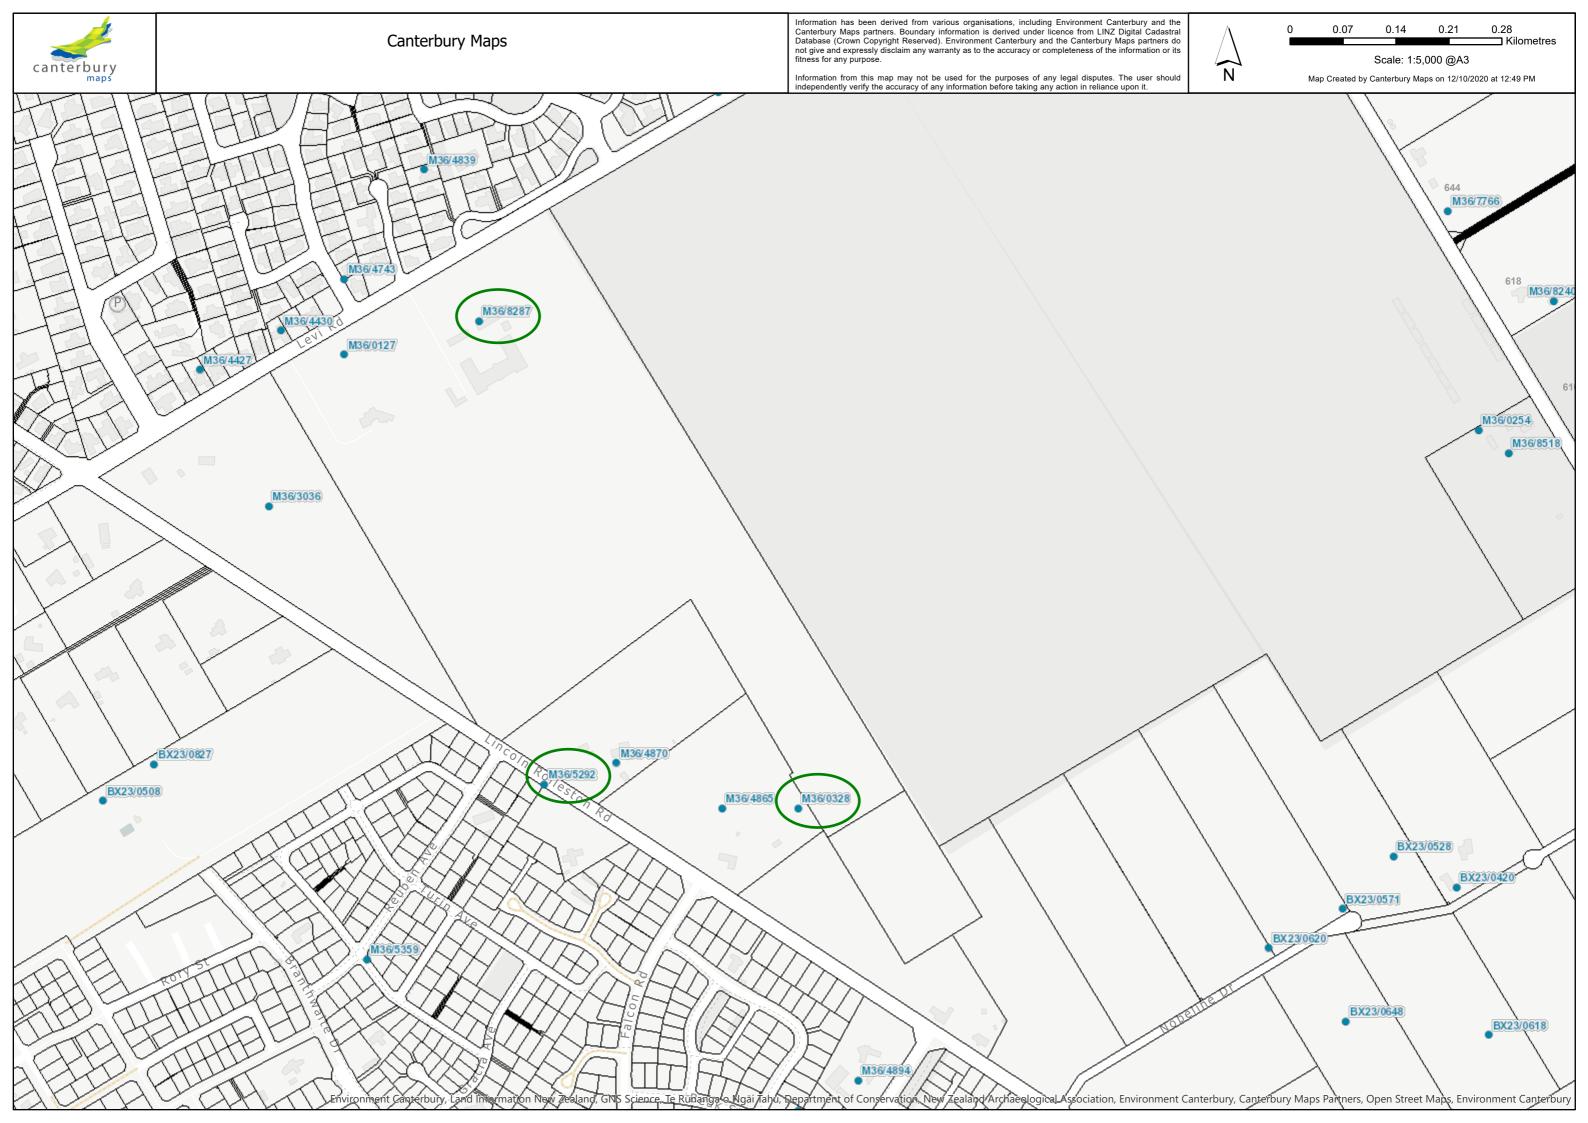
Borelog for well M36/5292

Grid Reference (NZTM): 1551672 mE, 5172222 mN

Scale(m)	Water Level	Depth(m)		Full Drillers Description	Formation Code
				Earth and clay	SP
5		1.20m _ 1.20m	000000 00000 00000 00000 00000 00000	Earth and clay Claybound gravel	SP SP-RI
	13.48 4 14.34	14.00m _ 14.00m _	000000 000000 000000 000000 0:0:0:0:0:0	Claybound gravel Rough sandy gravel	SP-RI RI
20					
Ц		23.50m _ 23.50m	0::0::0::	Rough sandy gravel Sandy claybound gravel	RI BR?
25		24.70m _ 24.70m	20.22.22	Sandy daybound gravel	BR?
		24.70m	00	Sandy claybound gravel, less clay, more sand	BR?
		26.79m _ 26.79m	<u> </u>	Sandy claybound gravel, less clay, more sand	BR?
		28.60m		Free gravel and sand	BR?

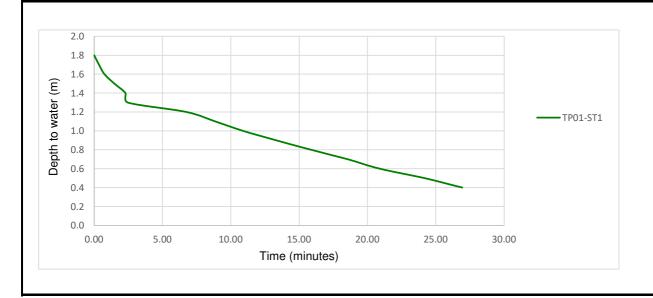
3) Calculate percolation rate
30 L/m2/min

30 L/m2/mir 1777 L/m2/hr
