Appendix B

Geotechnical Assessment

Executive Summary: Rolleston West – Geotechnical Assessment to support a Plan Change application

Rolleston West Plan Change

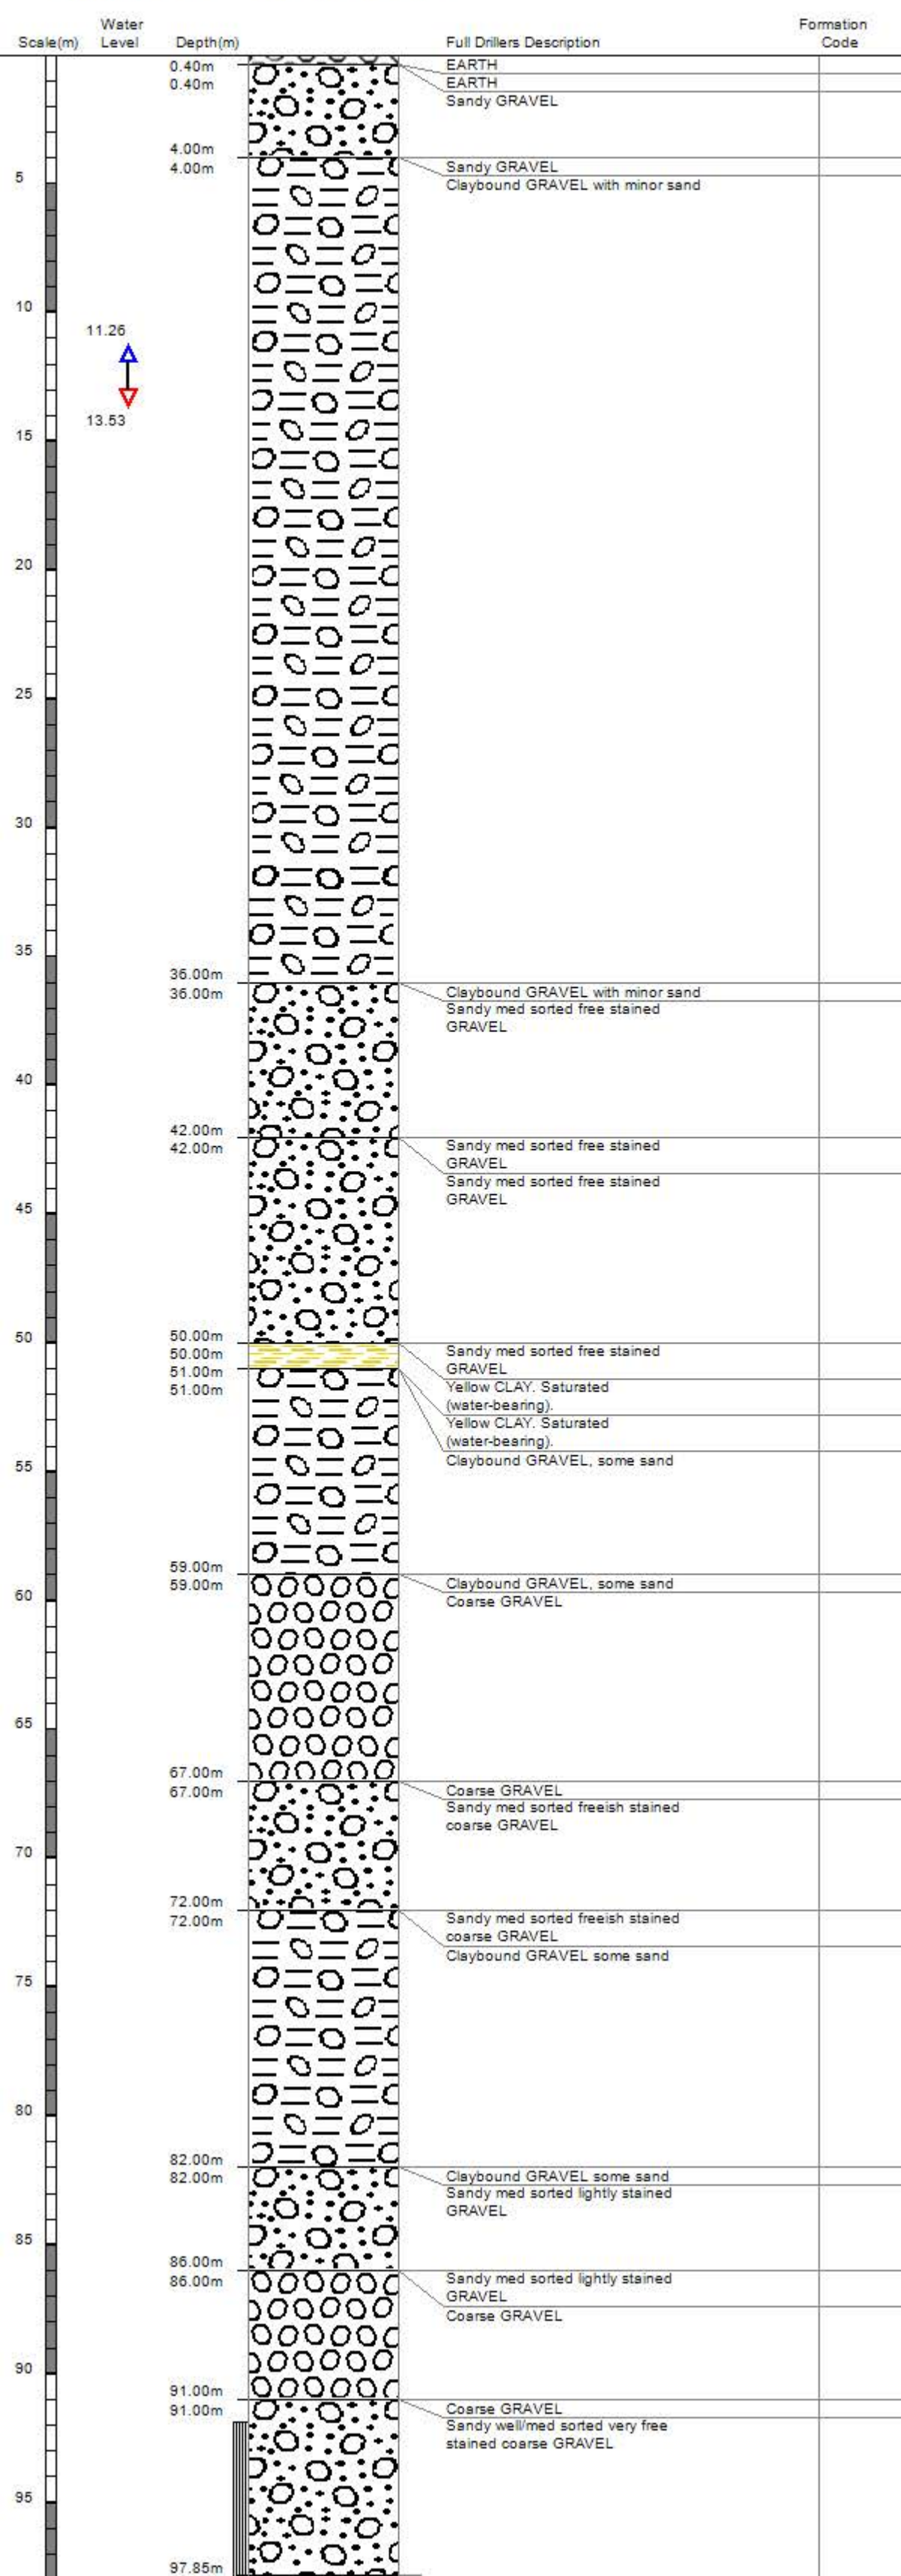
Borelog for well M36/8581

Grid Reference (NZTM): 1547469 mE, 5171189 mN
Location Accuracy: 10 - 50m
Ground Level Altitude: 48.9 m +MSD Accuracy: < 0.5 m
Driller: McMillan Drilling Ltd
Drill Method: Rotary/Percussion
Borelog Depth: 97.8 m Drill Date: 11-Jan-2013

Attachments: Site plan
M36/8063 log
M36/8581 log
11 April, 2011 – Geotech Consulting – PC8 (Holmes Block), PC9 (Skellerup Block)
Geotechnical assessment by Ian McCahon
