Birch's Village Plan Change

Geotechnical Assessment Report

Birch's Village Limited

7 July 2022

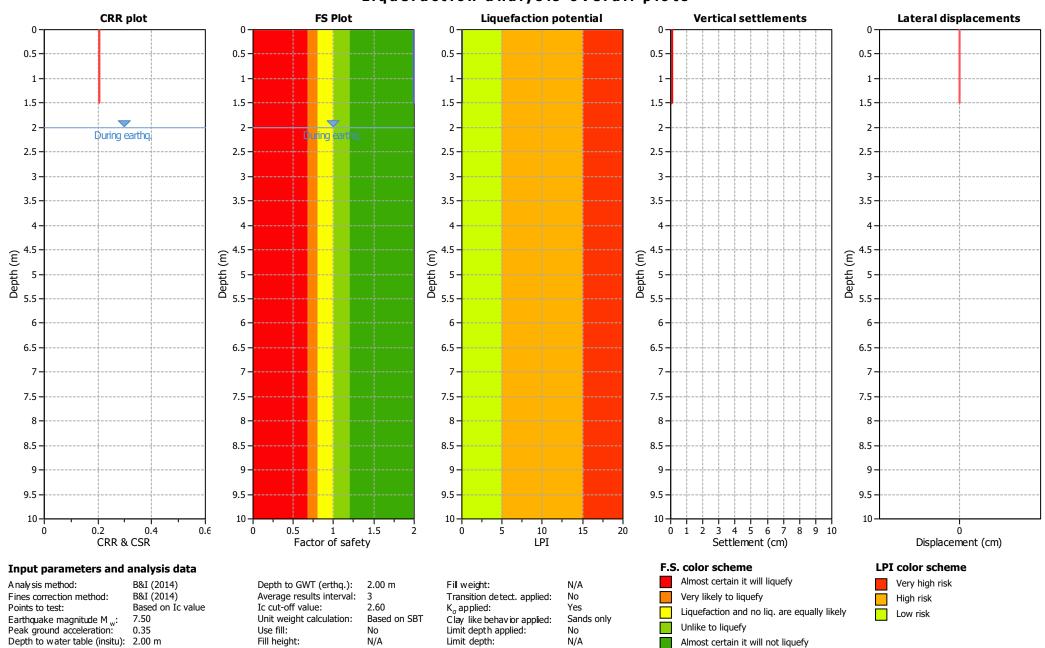
Depth to water table (insitu): 2.00 m

Liquefaction analysis overall plots **CRR** plot **FS Plot** Liquefaction potential **Vertical settlements** Lateral displacements 0.5 -0.5 0.5 0.5 0.5 1 1 -1.5 1.5 -1.5 -1.5 1.5 2 -2 2 · During earthq. 2.5 2.5 2.5 -2.5 2.5 3 · 3 – 3 -3. 3.5 3.5 3.5 3.5 Depth (m) Depth (m) 5.5 Depth (m) 5-5 Depth (m) 5.5 Depth (m) 5.5 6 6. 6-6.5 6.5 6.5 -6.5 6.5 7-7.5 7.5 -7.5 7.5 8 -8 8.5 8.5 -8.5 9 -9.5 9.5 9.5 9.5 9.5 10 10 10-0.2 0.4 0.6 0.5 1.5 10 15 20 0 1 2 3 4 5 6 7 8 9 10 CRR & CSR LPI Factor of safety Settlement (cm) Displacement (cm) F.S. color scheme LPI color scheme Input parameters and analysis data Almost certain it will liquefy Very high risk A naly sis method: B&I (2014) Depth to GWT (erthq.): 2.00 m Fill weight: N/A Fines correction method: B&I (2014) Average results interval: Transition detect. applied: No Very likely to liquefy High risk Based on Ic value Ic cut-off value: 2.60 Points to test: K_{σ} applied: Yes Liquefaction and no liq. are equally likely Low risk Earthquake magnitude M w: Unit weight calculation: Based on SBT 7.50 Clay like behavior applied: Sands only Unlike to liquefy Peak ground acceleration: Use fill: Limit depth applied: No

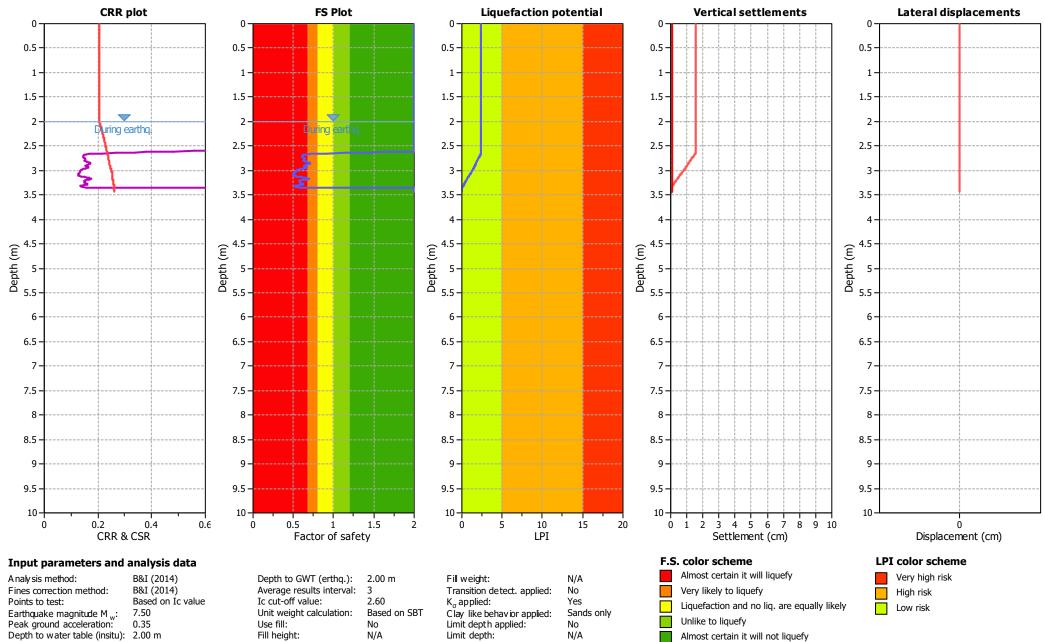
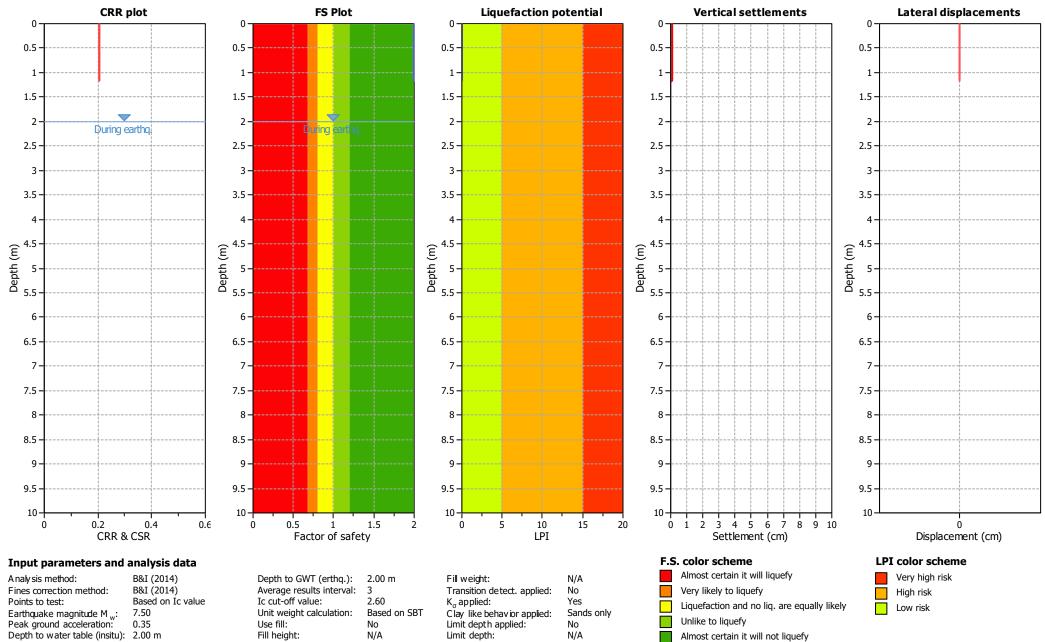
Liquefaction analysis overall plots Liquefaction potential

Peak ground acceleration:

Depth to water table (insitu): 2.00 m

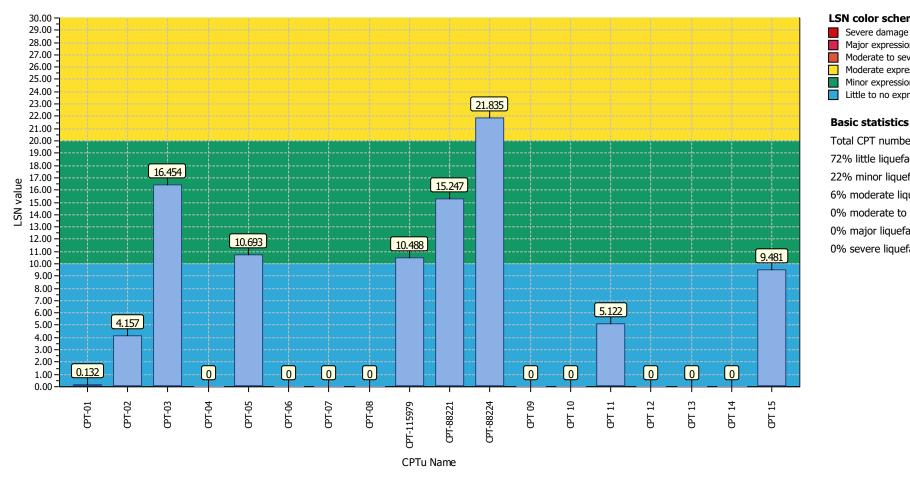
Overall Liquefaction Severity Number report

Major expression of liquefaction

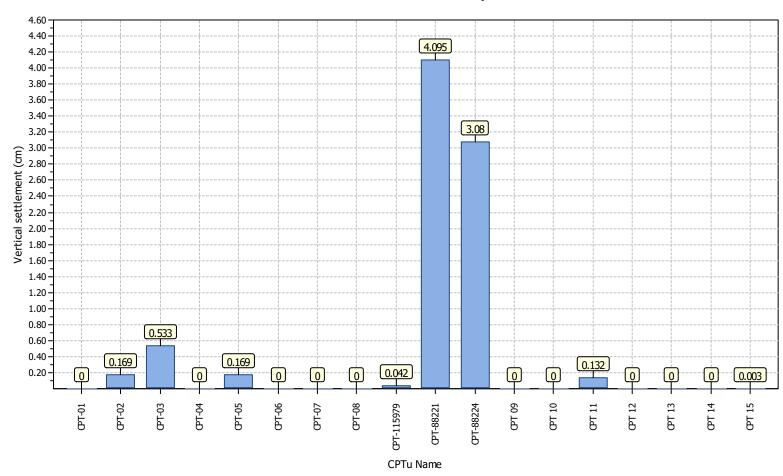
Overall vertical settlements report

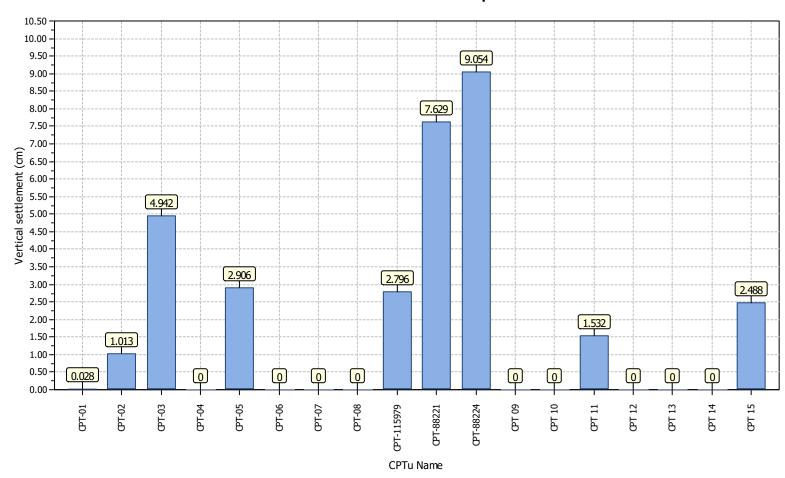
Project title: Birchs Village (ULS case)

Overall vertical settlements report
