In the matter of a hearing on Plan Change 79 to the Operative Selwyn District

Statement of Evidence of Andrew Christopher Jordan

Geotechnical Assessment Report

Birch's Village Limited

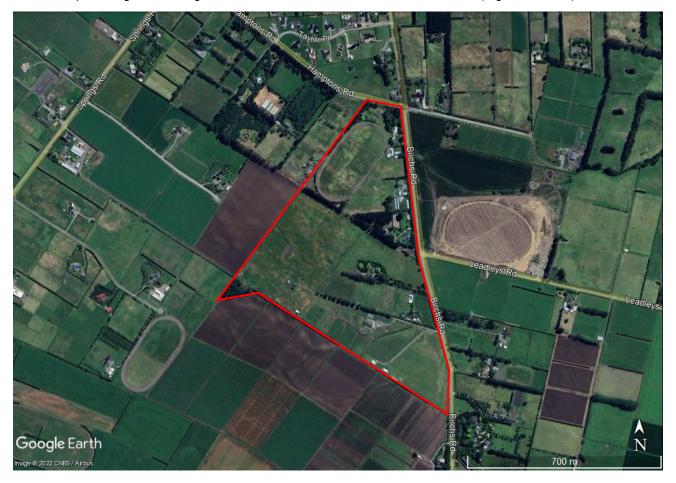
The proposed Plan Change area is comprised of a series of nine land parcels, totalling to approximately 42.3 Ha and is located to the south of Prebbleton township. The site is made up by a number of lifestyle properties which comprise large areas of greenfield land with localised residential houses (Figure 1 below).

Figure 1: Proposed area for plan change (GoogleEarth, 2022).

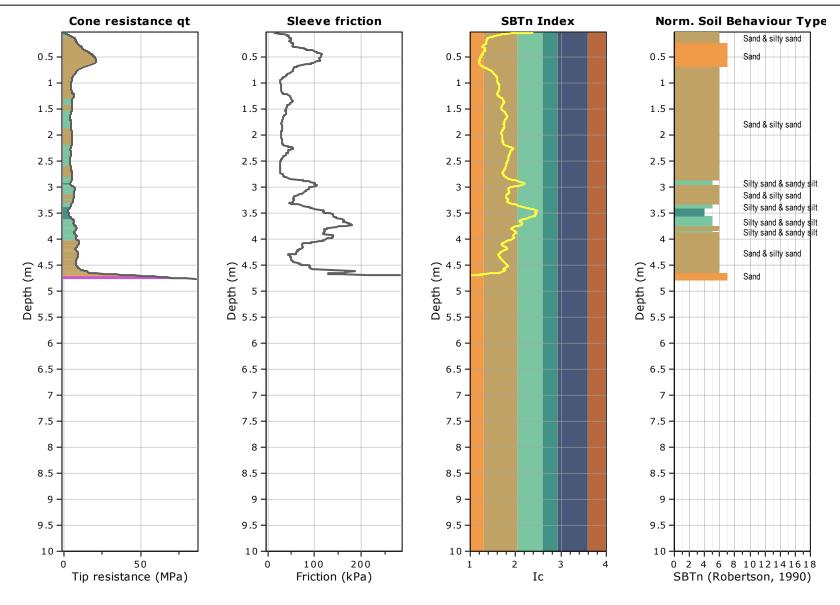
CPT: CPT-03Total depth: 4.76 m

Location: Prebbleton, Christchurch

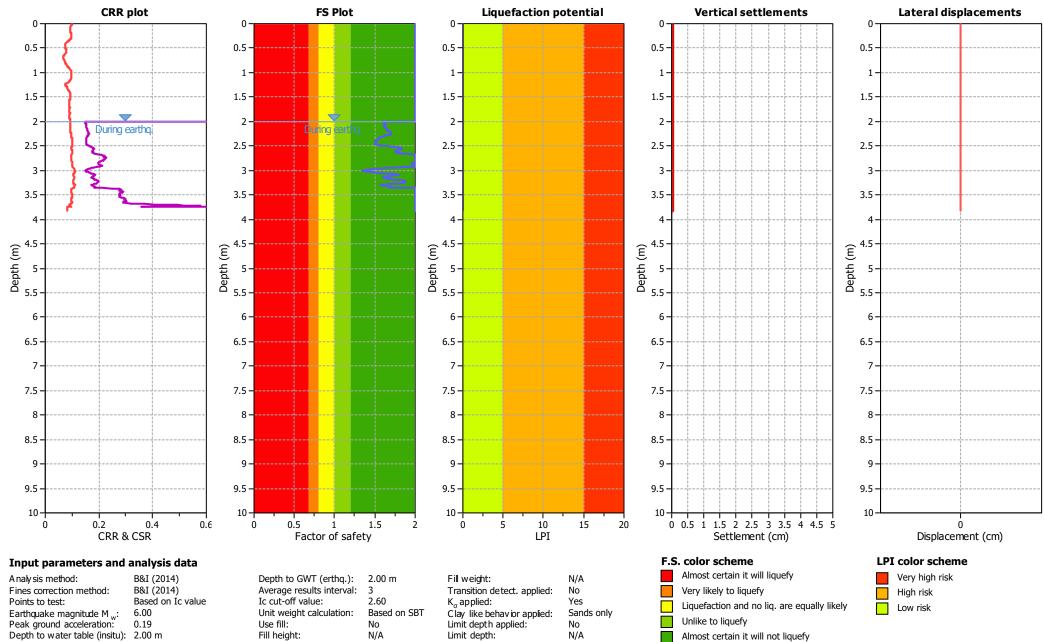
Liquefaction analysis overall plots Liquefaction potential

The CPT analyses show that the site is predominantly TC1-like with small areas that contain TC2-like ground. This is generally in accordance with the ECan technical report referenced in Section 8.3.1 of this report. It appears that liquefaction was not observed in the site area following the most severe 2010 Darfield Earthquake, which indicates that liquefaction at the site is unlikely in strong earthquake shaking.

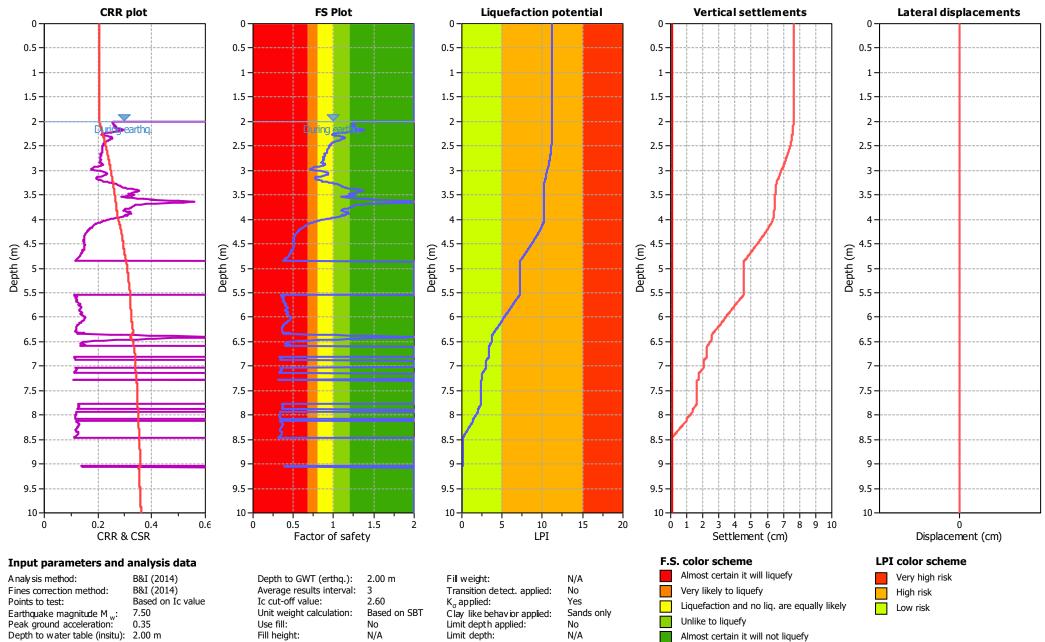
Liquefaction analysis overall plots Liquefaction potential

Liquefaction analysis overall plots **CRR** plot **FS Plot** Liquefaction potential **Vertical settlements Lateral displacements** 0.5 -0.5 0.5 0.5 0.5 1 1 -1.5 1.5 -1.5 -1.5 2-2 2 During earthq. 2.5 2.5 2.5 -2.5 2.5 3 · 3 – 3 – 3. 3.5 3.5 3.5 -3.5 3.5 Depth (m) Depth (m) 5.5 Depth (m) 5-5 Depth (m) 5.5 Depth (m) 5.5 6 6-6-6.5 -6.5 6.5 6.5 6.5 7 -7.5 7.5 7.5 -7.5 8 8 -8 -8 -8.5 8.5 8.5 -8.5 9 9 -9.5 9.5 9.5 9.5 9.5 10 10 10-0.2 0.4 0.6 0.5 1.5 10 15 20 0 1 2 3 4 5 6 7 8 9 10 CRR & CSR LPI Factor of safety Settlement (cm) Displacement (cm) F.S. color scheme LPI color scheme Input parameters and analysis data Almost certain it will liquefy Very high risk A naly sis method: B&I (2014) Depth to GWT (erthq.): 2.00 m Fill weight: N/A Fines correction method: B&I (2014) Average results interval: Transition detect. applied: No Very likely to liquefy High risk Based on Ic value Ic cut-off value: 2.60 Points to test: K_{σ} applied: Yes Liquefaction and no liq. are equally likely Low risk Earthquake magnitude M w: Unit weight calculation: Based on SBT Clay like behavior applied: 7.50 Sands only

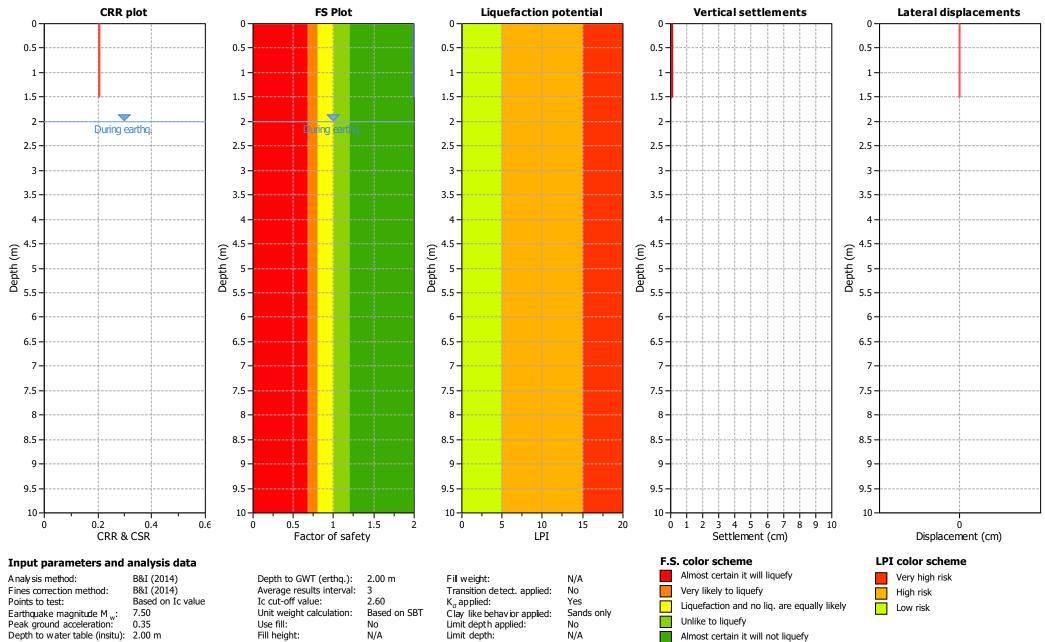
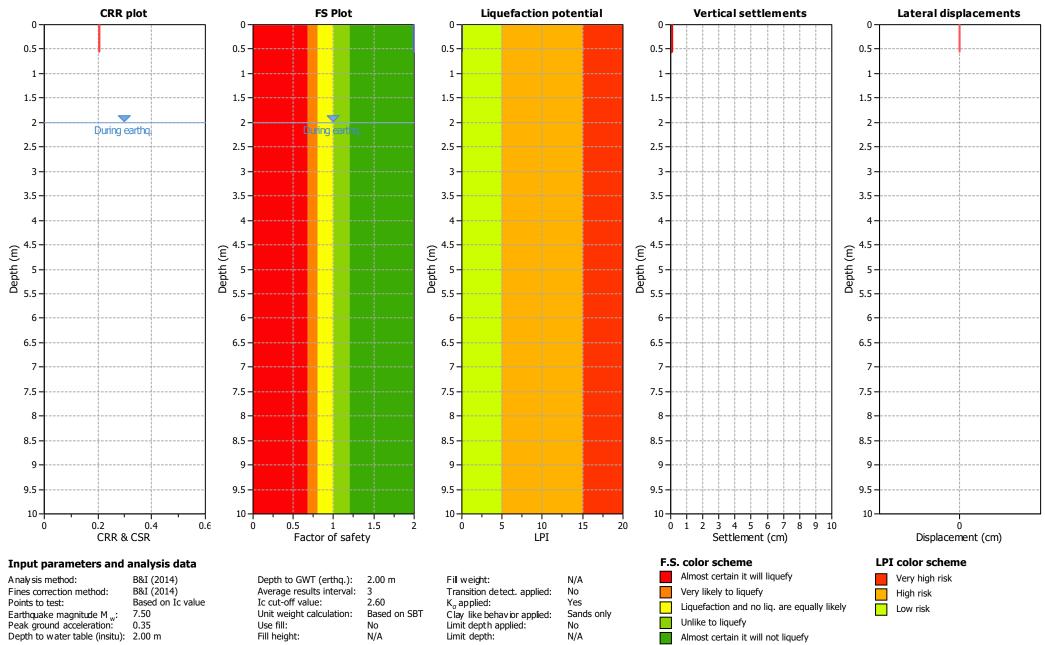
Liquefaction analysis overall plots Liquefaction potential

Depth to water table (insitu): 2.00 m

Liquefaction analysis overall plots **CRR** plot **FS Plot** Liquefaction potential **Vertical settlements** Lateral displacements 0.5 -0.5 0.5 0.5 0.5 1 1 -1.5 1.5 -1.5 -1.5 -1.5 2 -2 2 -During earthq. 2.5 2.5 2.5 -2.5 2.5 3 · 3 – 3 – 3 -3.5 3.5 3.5 3.5 Depth (m) Depth (m) 5.5 Depth (m) 5-5 Depth (m) 5.5 Depth (m) 5.5 6 6. 6-6.5 6.5 6.5 -6.5 6.5 7-7.5 7.5 -7.5 7.5 8 -8 8.5 8.5 -8.5 9 -9.5 9.5 9.5 9.5 9.5 10 10 10-0.2 0.4 0.6 0.5 1.5 10 15 20 0 1 2 3 4 5 6 7 8 9 10 CRR & CSR LPI Factor of safety Settlement (cm) Displacement (cm) F.S. color scheme LPI color scheme Input parameters and analysis data Almost certain it will liquefy Very high risk A naly sis method: B&I (2014) Depth to GWT (erthq.): 2.00 m Fill weight: N/A Fines correction method: B&I (2014) Average results interval: Transition detect. applied: No Very likely to liquefy High risk Based on Ic value Ic cut-off value: 2.60 Points to test: K_{σ} applied: Yes Liquefaction and no liq. are equally likely Low risk Earthquake magnitude M w: Unit weight calculation: Based on SBT 7.50 Clay like behavior applied: Sands only

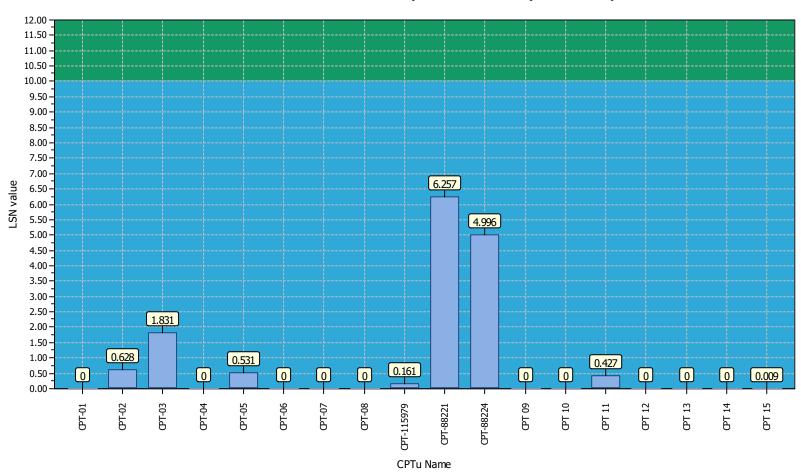
Overall Liquefaction Severity Number report

LSN color scheme

Severe damage
Major expression of liquefaction
Moderate to severe exp. of liquefaction
Moderate expression of liquefaction
Minor expression of liquefaction
Little to no expression of liquefaction

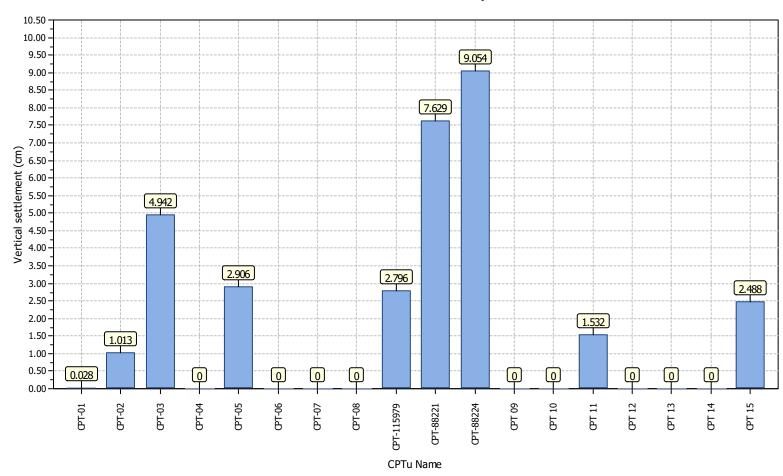
Overall vertical settlements report

Project title: Birchs Village (ULS case)
