Birch's Village Limited
Birch's Village Plan Change

Geotechnical Assessment Report

9 March 2021

Birch's Village Plan Change

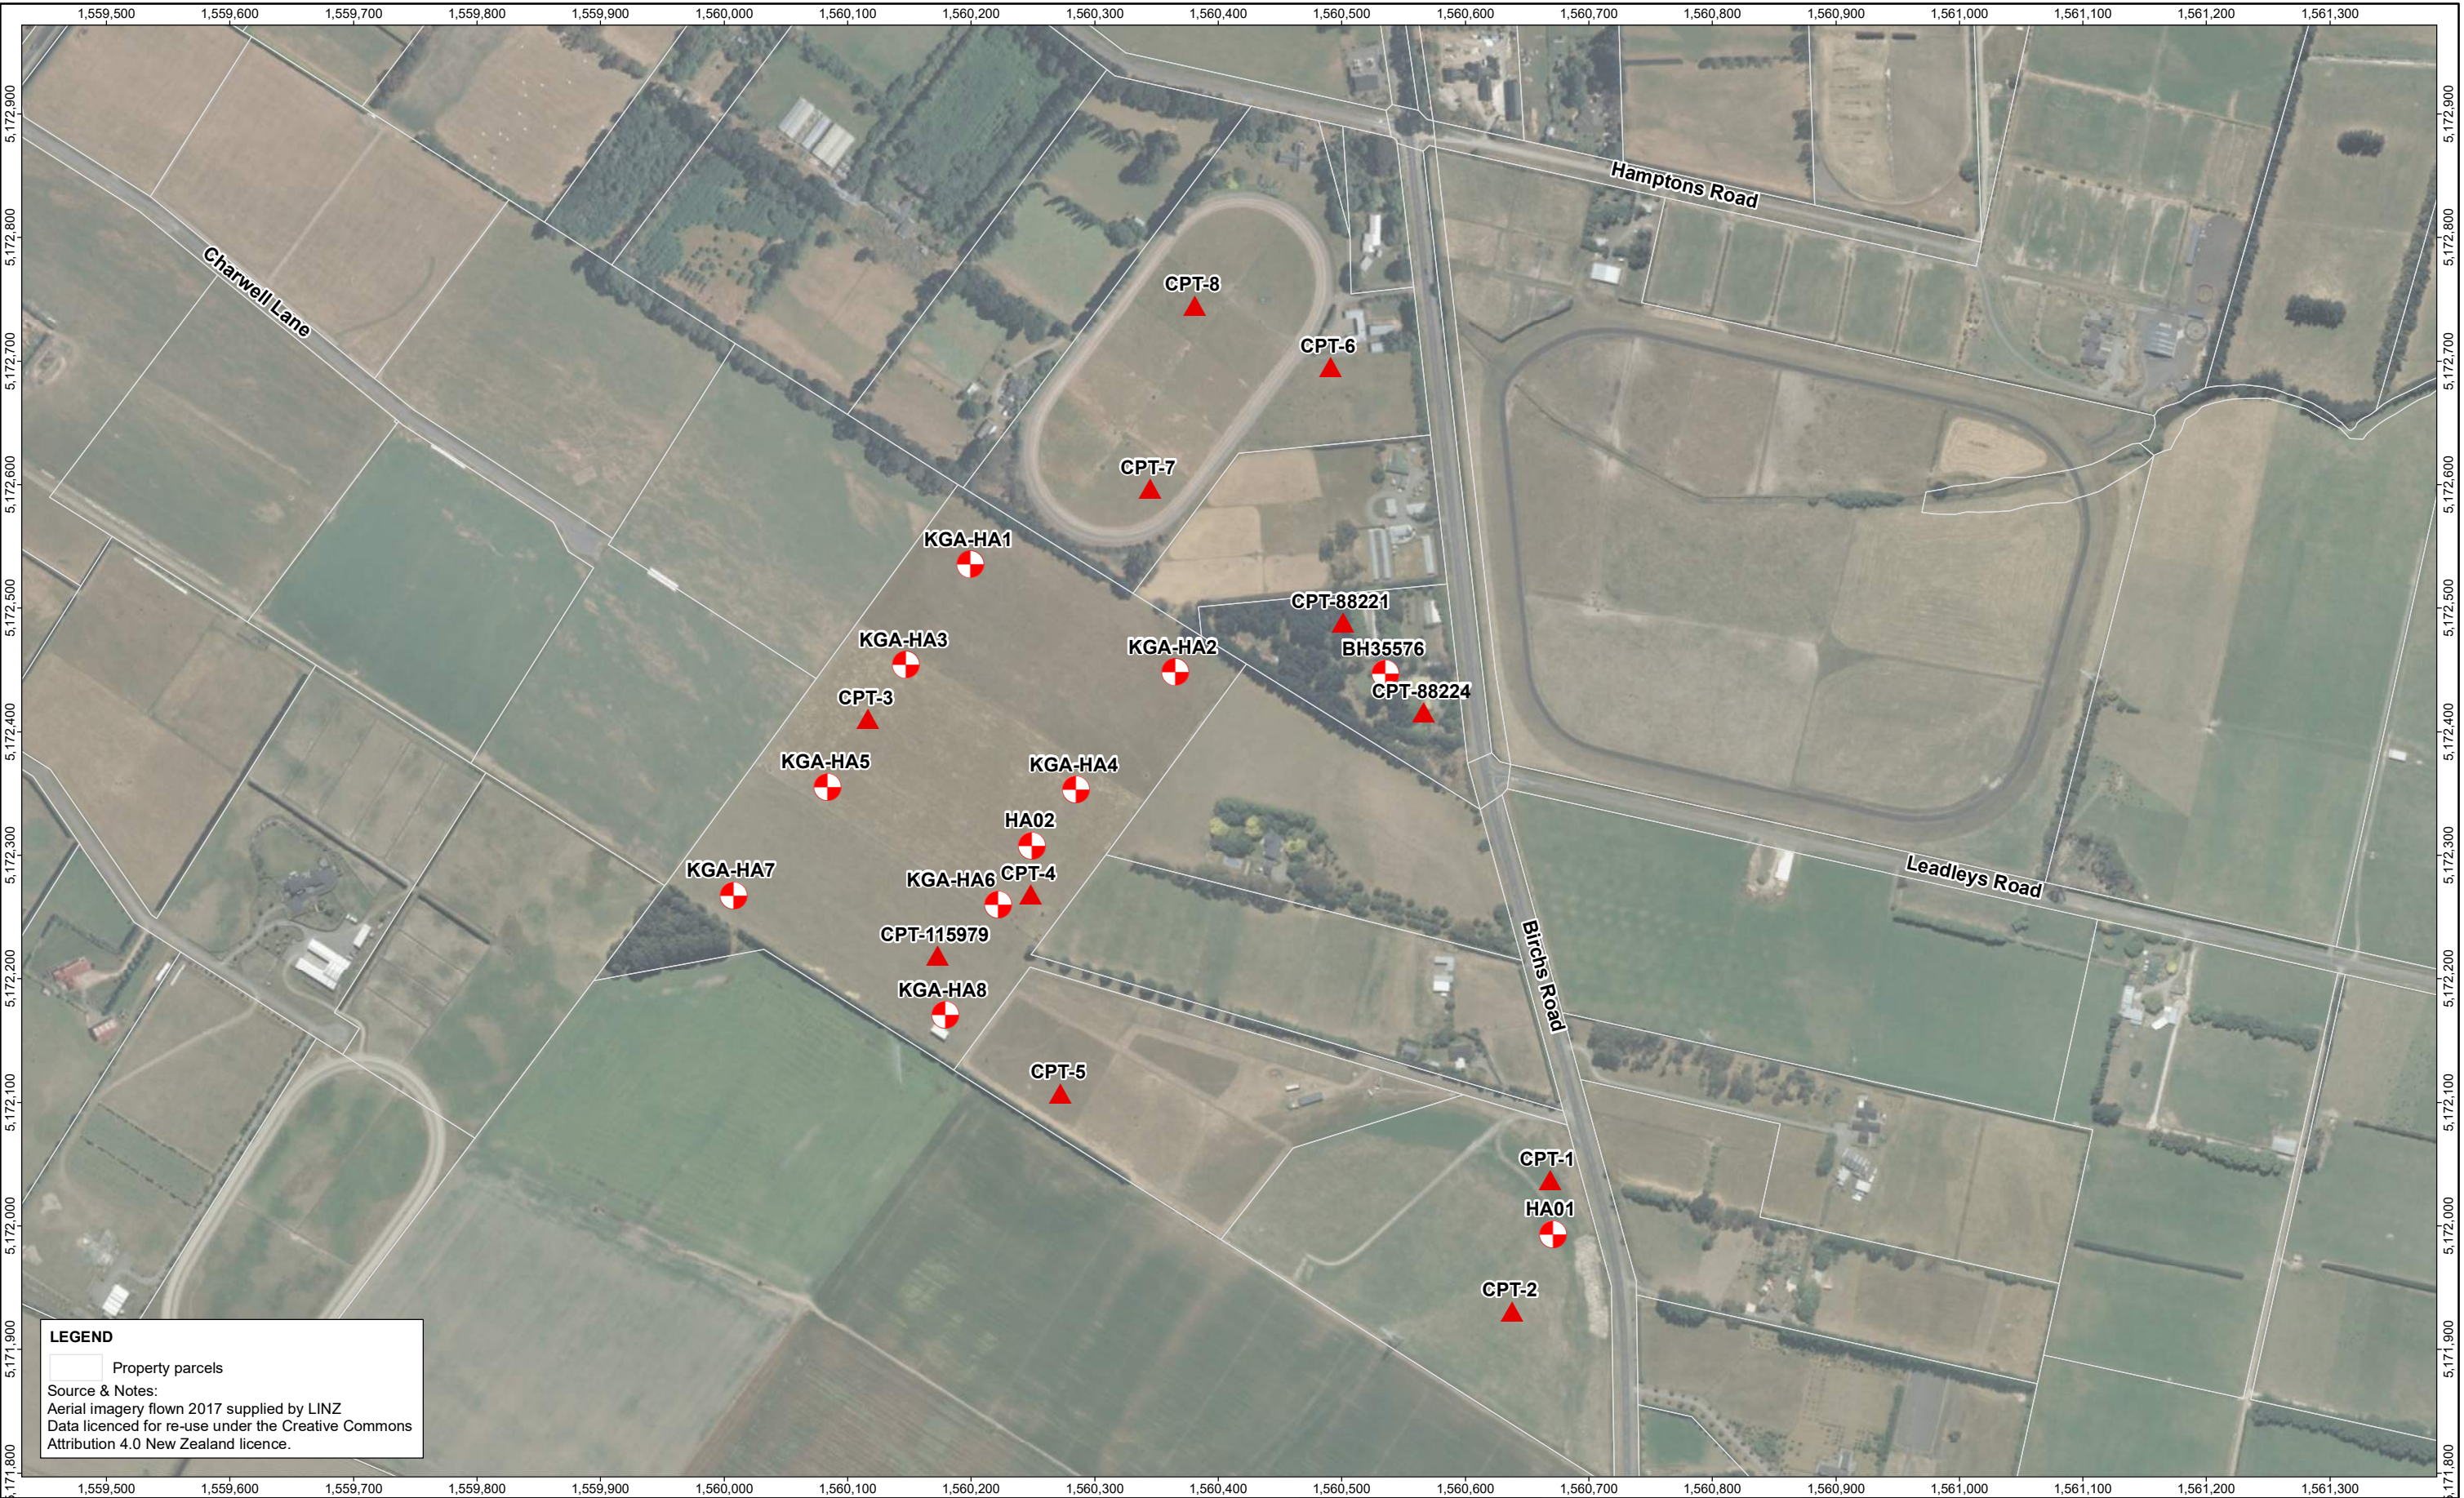
Appendix A - Site plan and factual data

LEGEND
Property parcels
Source & Notes:
Aerial imagery flown 2017 supplied by LINZ
Data licenced for re-use under the Creative Commons
Attribution 4.0 New Zealand licence.

The liquefaction triggering analysis was carried out for the CPTs shown on the site plan (Appendix A) using the Boulanger and Idriss (2014) method³ and proprietary liquefaction assessment software⁴, in accordance with the updates to the MBIE Guidance¹ (Issue 7 October 2014).

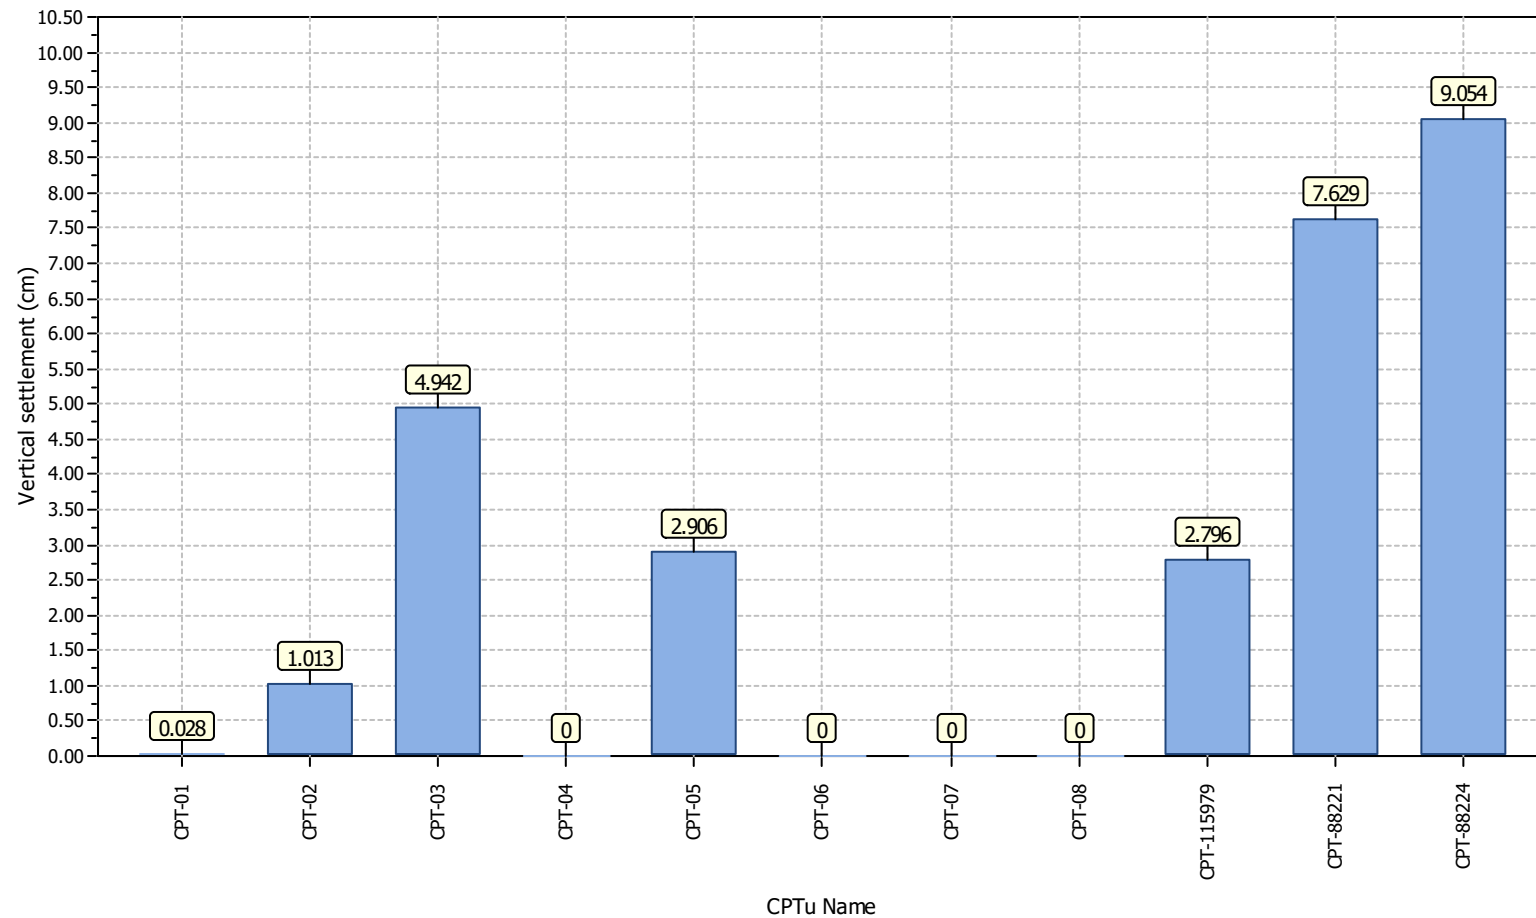
Overall vertical settlements report
