# Birch's Village Limited Birch's Village Plan Change

Geotechnical Assessment Report

9 March 2021

## Birch's Village Plan Change

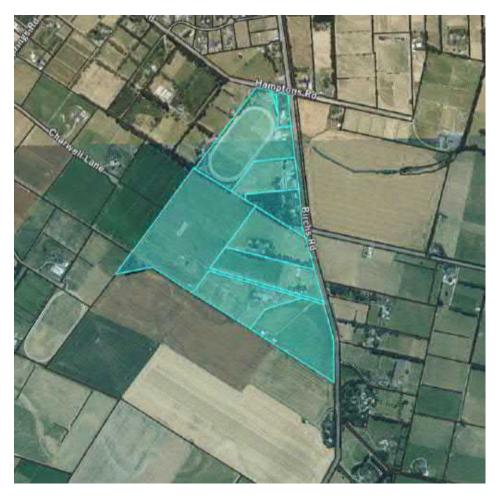
Figure 1: Site plan

The proposed Plan Change area comprises a series of 9 land parcels totalling 42.3 Ha located to the south of Prebbleton The site is made up by a number of lifestyle properties which comprise large areas of greenfield land with localised residential houses (see the Site Plan, Figure 1 below).

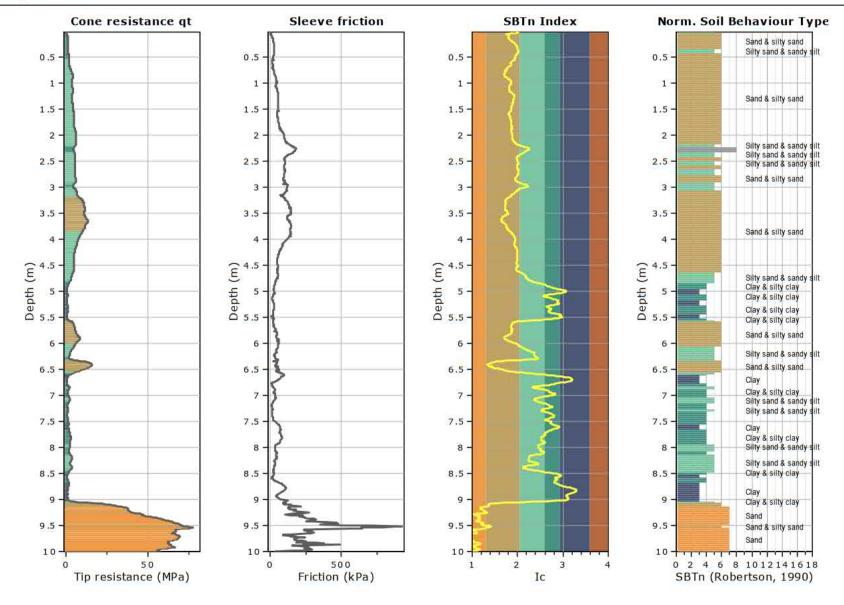
CPT: CPT-88221
Total depth: 12.27 m

Location: Prebbleton, Christchurch

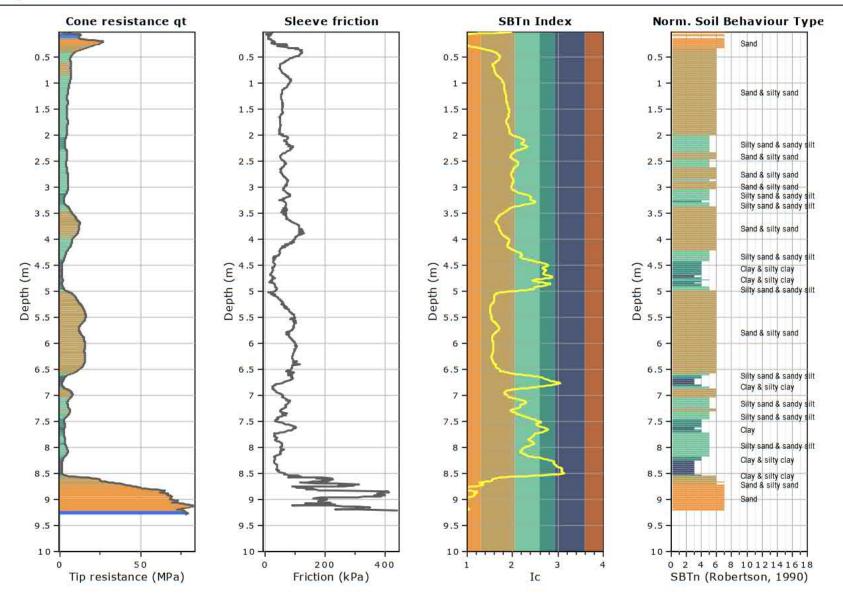
CPT: CPT-88224 Total depth: 9.28 m

Location: Prebbleton, Christchurch

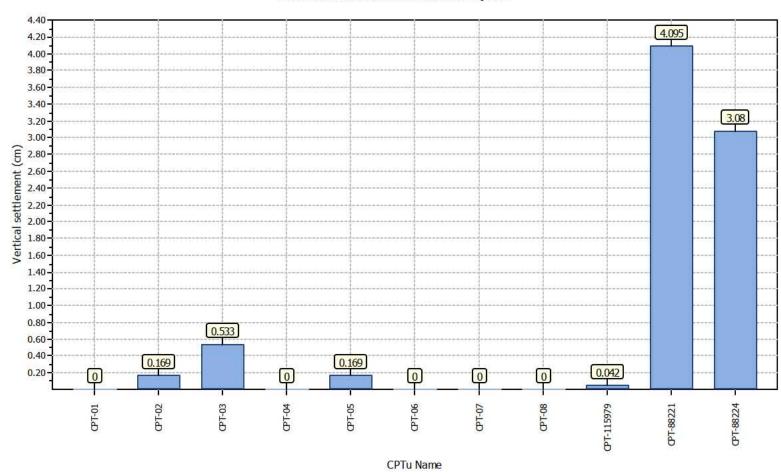
## **Overall vertical settlements report**

Project title: Birches Village - SLS assessment

The estimated free-field settlement values and the correlated residential foundation Technical Category, as defined by Table 3 1 of the MBIE Guidance, are given in Table 4

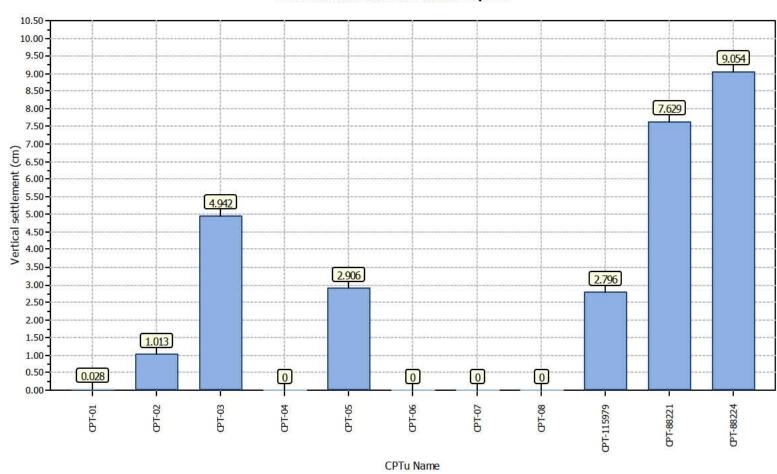
## **Overall vertical settlements report**

Project title: Birches Village - ULS assessment
