Leeston Industrial - Land Constraints Assessment

Selwyn District Council

Flooding, Groundwater and Geotechnical Summary

IZ124100-0005-NP-RPT-0001 | 2

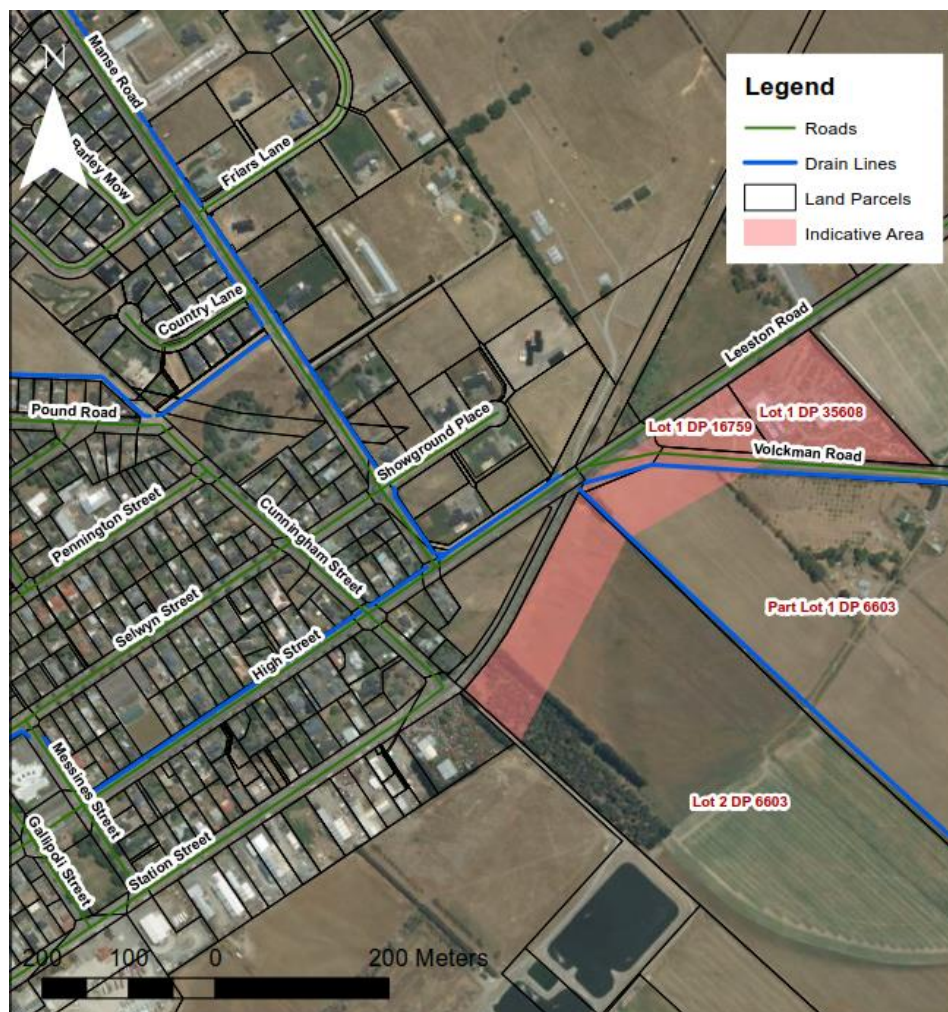
Figure 1.1: Map shows land to the east of Leeston, with the indicative site boundary in red proposed for rezoning to Business 2 (Industrial)

Selwyn District Council (SDC) is considering extending the Business 2 (Industrial) Zone in the east of Leeston Township. The Indicative Site area (SDC reference LEE3) is shown in red in **Figure 1.1**. This report summarises an assessment of the land constraints that apply to the identified site. The constraints considered in this summary report are flooding, shallow groundwater and geotechnical. The full information for flooding and shallow groundwater is provided as Appendix A¹, and for geotechnical as Appendix B².

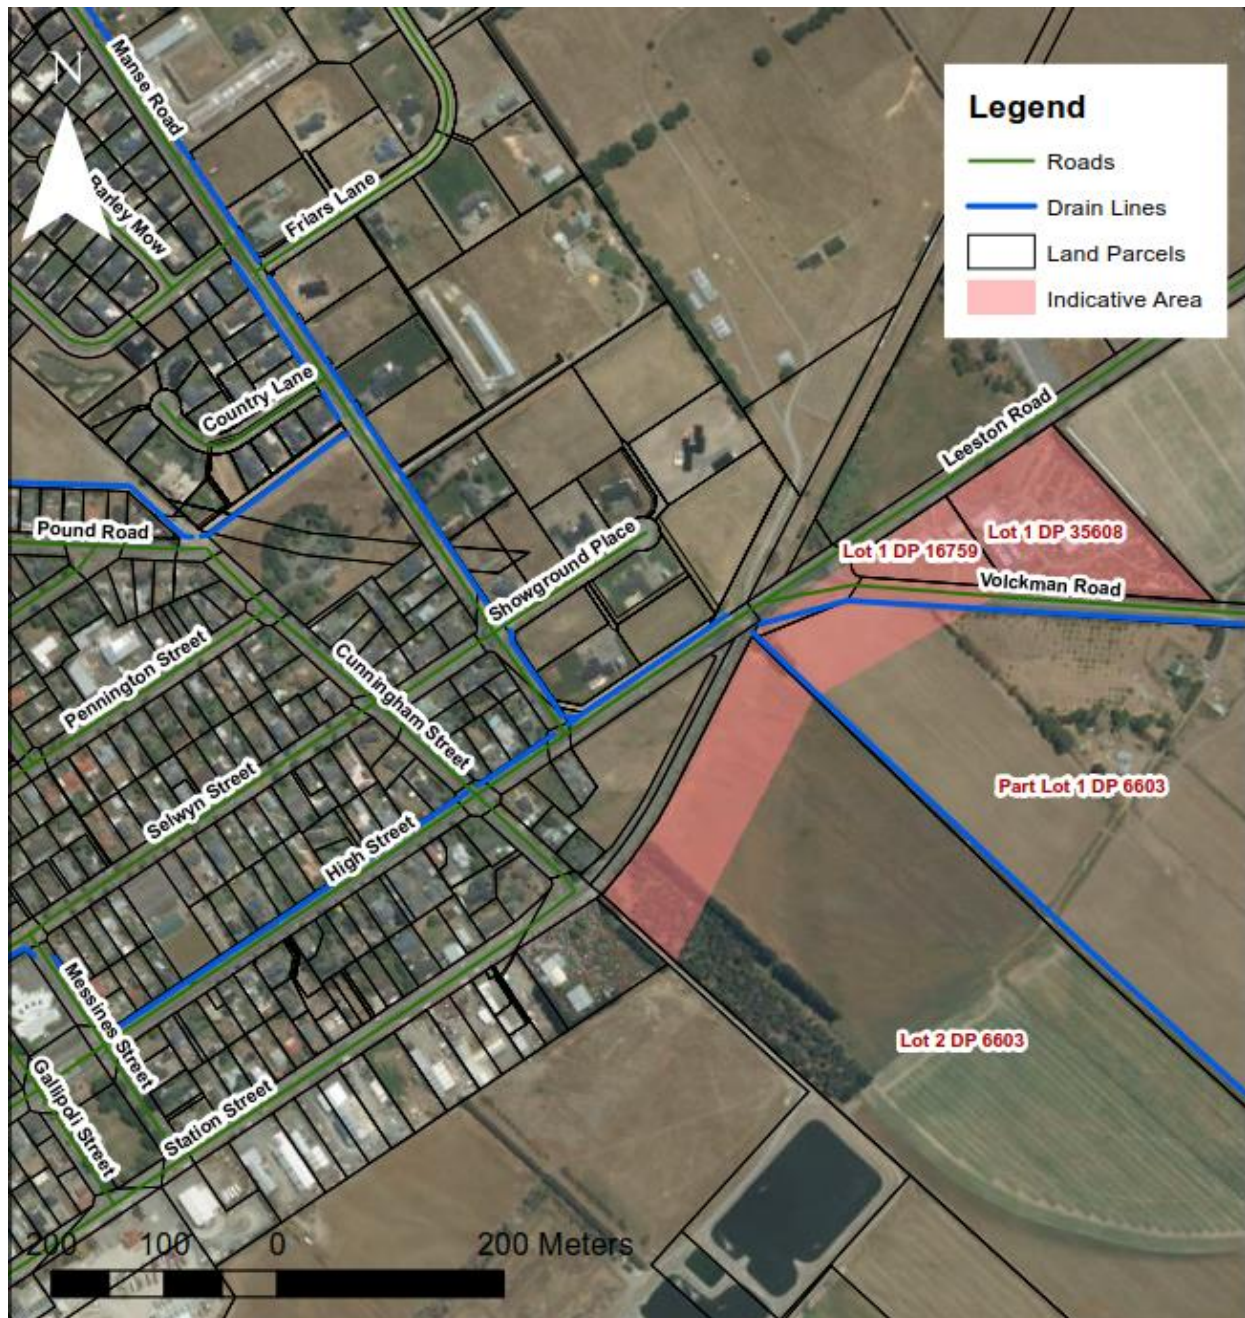
Figure 1.1: Map shows land to the south east of Leeston, with the indicative site boundary in red proposed for rezoning to Business 2 (Industrial)

Selwyn District Council (SDC) is considering extending the Business 2 (Industrial) Zone in the south-east of Leeston Township. The Indicative Site area (SDC reference LEE3) is shown in red in Figure 1.1. This report covers an assessment of the land constraints that apply to the identified site. The constraints considered in this report are flooding and shallow groundwater, with geotechnical risks considered in the accompanying report¹.

The Indicative Site (SDC reference LEE3) occupies four different land parcels as labelled in Figure 1.1. This report will refer to the site area encompassed within Lots 1 DP 35608 and DP 16759 to the north of Volckman Road as the northern portion of the site. The site area encompassed within Part Lot 1 DP 6603 and Lot 2 DP 6603 to the south of Volckman Road will be referred to as the southern portion of the site.

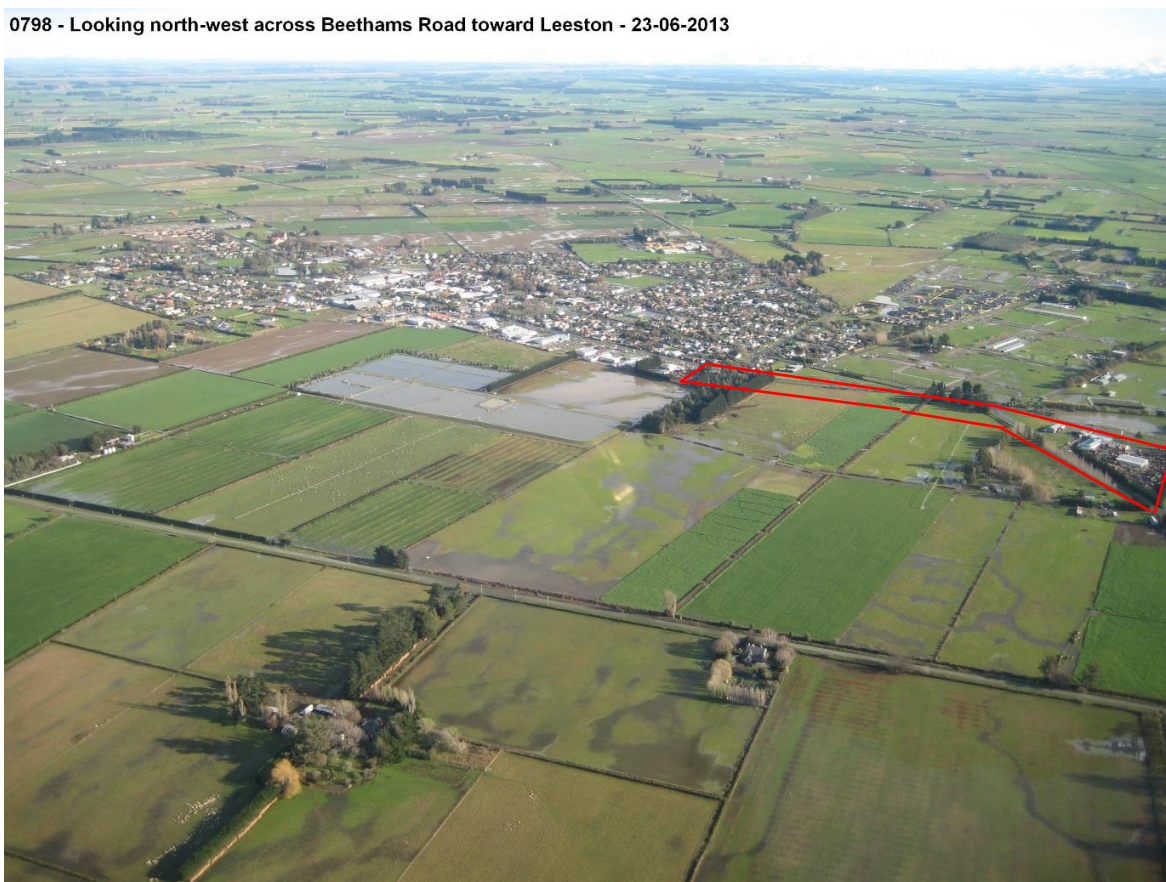
0798 - Looking north-west across Beethams Road toward Leeston - 23-06-2013

Figure 2.1: June 2013 flooding aerial photograph with the Indicative Area outlined in red.

Figure 2.1 shows an aerial photograph taken following the June 2013 flooding. The Indicative Site area is outlined in red. It should be noted that this photograph was likely taken after the peak of the flooding had occurred, so does not represent the maximum extent of flooding. Nonetheless, it does indicate that only minimal surface flooding occurred within the Indicative Site, whereas significant pooling of water was observed directly adjacent to the southern portion of the site (near the waste water treatment works), as well as across Leeston Road from the northern portion of the site.

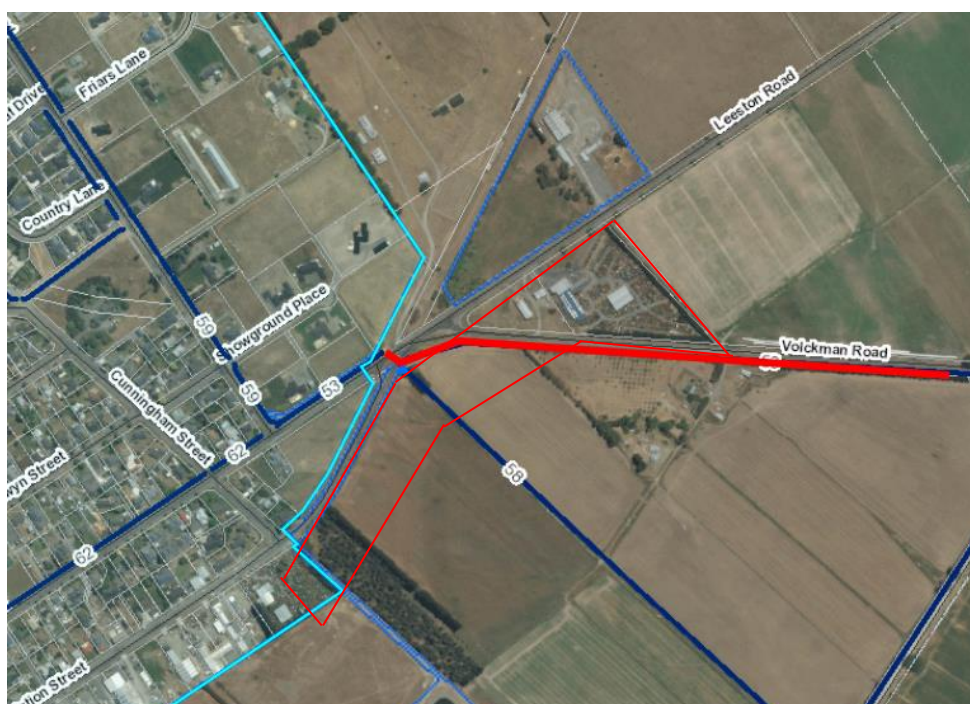
Figure 3.8: Proposed route of Stage 3 of the Leeston Stormwater Bypass, shown in red

The Leeston Stormwater Bypass design has been split into two stages; Stage 3 and Stage 4. Stage 4 starts west of the Township at Leeston Creek and finishes at the intersection between Leeston and Volckman Road. We understand that (at the time of writing) construction has not begun as there are some access issues to be resolved. Stage 3 will continue downstream from the Leeston and Volckman Road intersection, and will finish downstream of the Indicative Site. Figure 3.8 shows in red the proposed path of Stage 3.

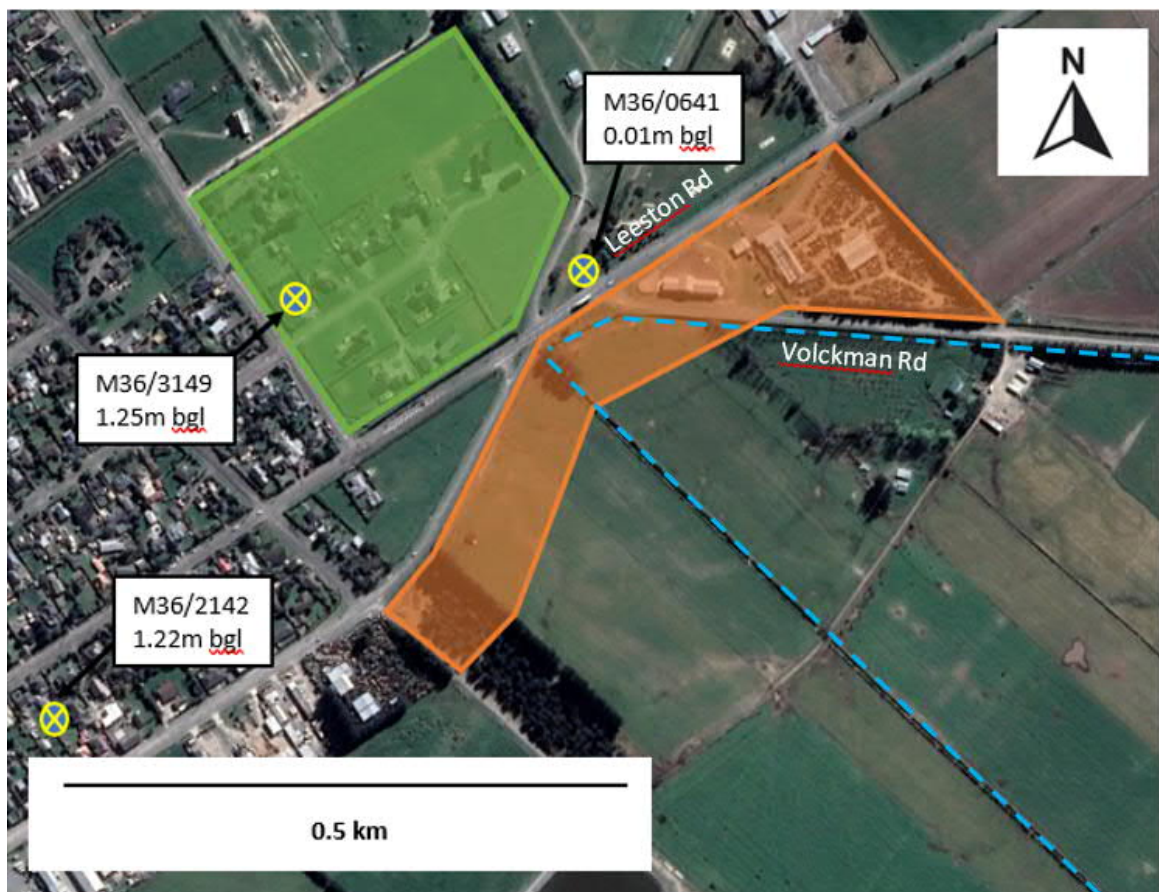
Figure 3. 2 – Groundwater reading locations and highest groundwater level recorded at each well, marked by blue and yellow markers. The site location is marked in orange, the area covered by the Geoscience GI is marked in green. Drainage trenches are marked with the dashed blue line.

Groundwater data is available from various wells near the site via the ECan well database². There are also groundwater readings recorded in the trial pits carried out in the ground investigation carried out in the site to the North of Leeston Road by Geoscience, as provided by SDC, the exploratory locations in this ground investigation are shown in Appendix A Borehole **Logs**. The locations of these sites are shown in **Figure 3. 2** below.

Well M36/3149, which lies to the west of the site, shows a ground water level of 1.25m bgl. This coincides with the levels recorded as part of the Geoscience GI which recorded levels between 0.5 and 1.2m bgl. Another well (M36/2142) to the West of the site gives a similar reading of 1.22m bgl. Well M36/0641, which is on the Northern edge of Leeston Road, adjacent to the centre of the site, records readings between 1953 and 1989. The readings range from 0.01 - 1.65m bgl, the highest reading was recorded in August 1979.

A previous ground investigation has been carried out to the North of Leeston Road for SDC, the logs from this investigation have been provided by the client. Other than this, no publicly available ground investigation data is available for the area. The ground investigation available consists of six trial pits to depths of 1.2-2.3m bgl, all of which had Scala Penetrometer tests carried out in them. All the trial pits also encountered ground water at levels between 0.5 and 1.2m bgl. The logs provided for this GI are presented in **Appendix A** and a summary of the findings is presented in **Table 5. 1** below, the area covered by the GI is shown in **Figure 3. 2**.

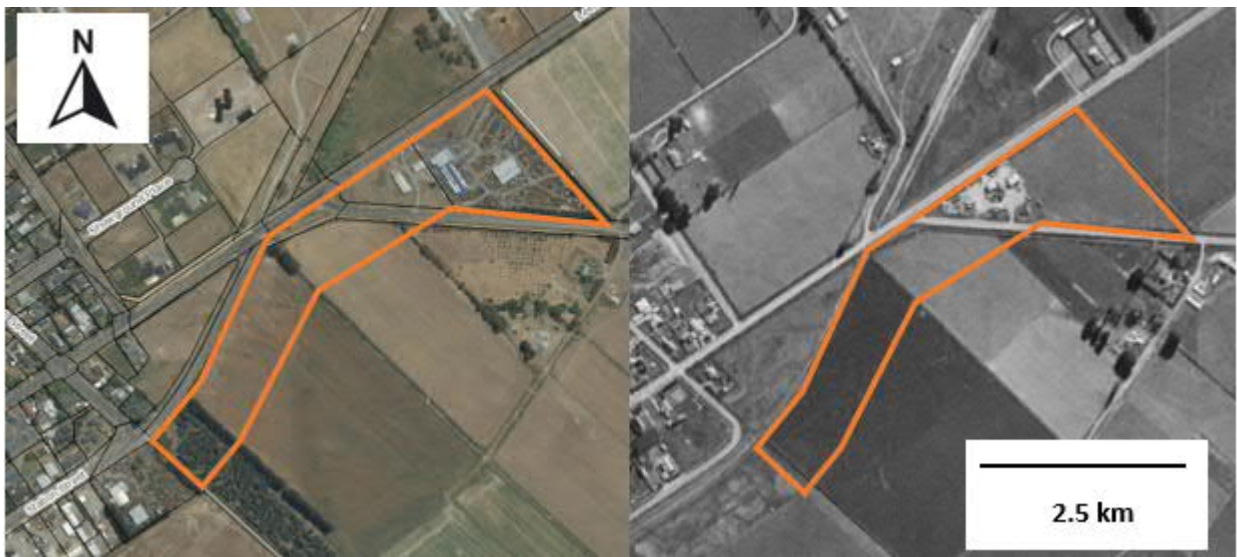
Figure 3. 3 - Comparison between 2018 (left) and 1965-69 (right) – The site is outlined in orange in each image (ECan, LINZ & Statistics NZ, n.d.), (Google Earth, 2018).

The historical photographs from 1940-44 show that the site was farm land at that stage, the surrounding roads are all present at this date. The 1965-69 images show a development in the corner where Volckman Road meets Leeston Road, this appears to be some small buildings and entrances from both roads, as shown in **Figure 3. 3** below.

By 1975-79, the previous development has been removed, and a larger development consisting of two large rectangular buildings and a smaller square one, is present. These buildings are present currently, although small extensions have been added. By 1980-84, a large square building is added to the site, to the East of the buildings in place in the 75-79 photographs, this building is also in place currently. The section of the site that runs to the south of Station Road shows no development in the aerial photographs available. This appears to be worked farm land, as it is currently.

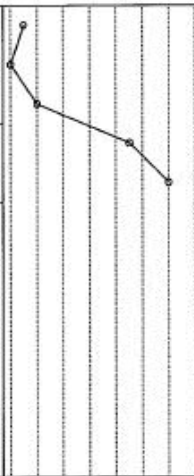
0.2		ML	SILT with trace clay; brown with orange mottles. Low plasticity.

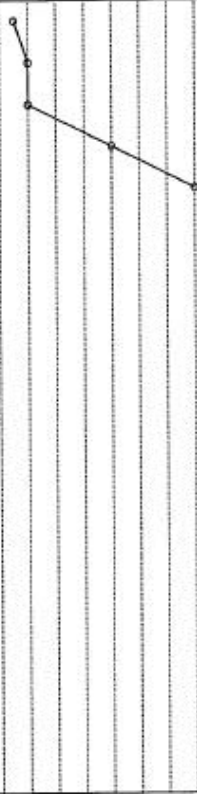
ML	SILT with trace clay; brown with orange mottles. Low plasticity.

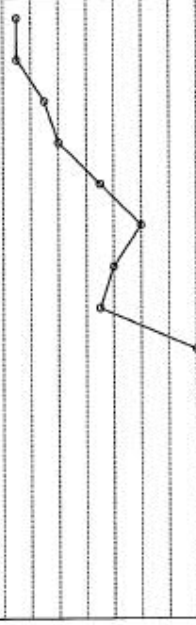
0.5			Sandy fine to coarse GRAVEL and trace cobbles; grey rounded. Well graded. Sand is fine to medium.
