# Leeston Residential Deferred Zones

Selwyn District Council

Geotechnical Desk Study

IZ124100-0005-CG-RPT-0002 | C

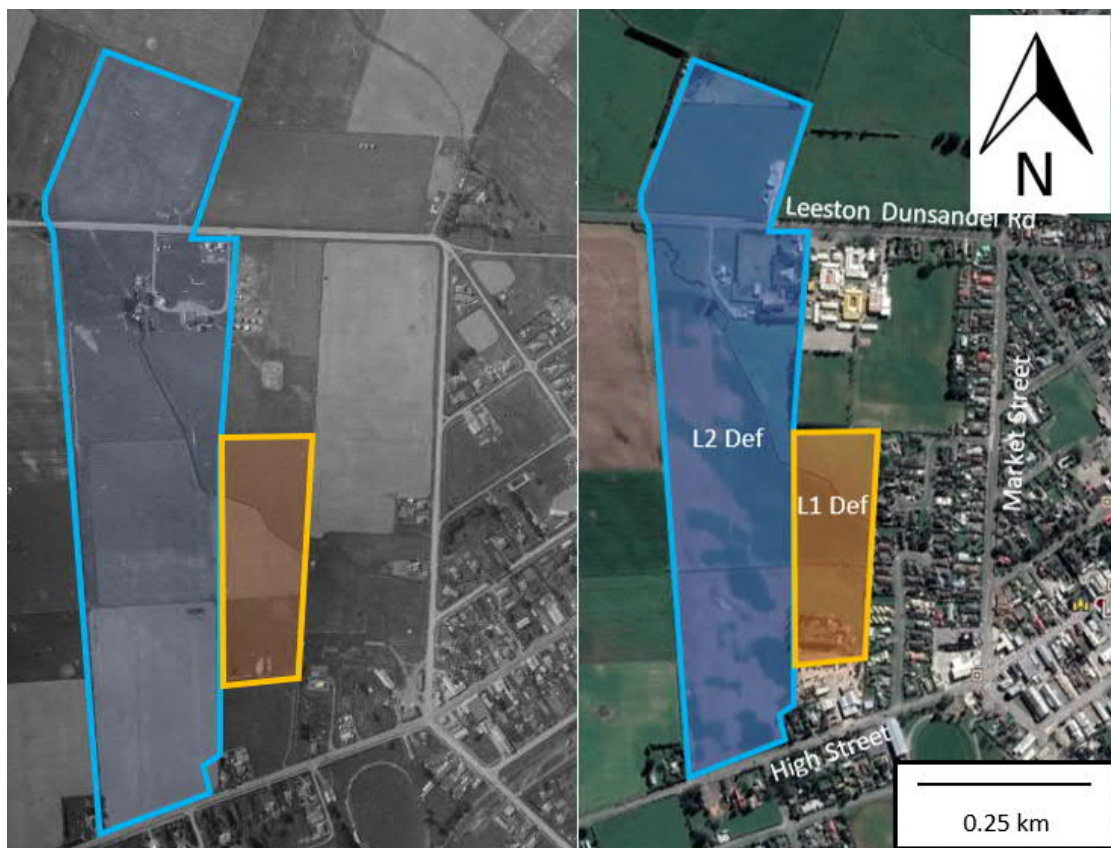
Figure 3. 1 - Comparison between 1940-44 (left) and 2018 (right) – The site is outlined in orange and blue in each image (ECan, LINZ & Statistics NZ, n.d.)<sup>2</sup>, (Google Earth, 2018).

The historical aerial photographs from 1940-44 show the sites are predominantly farmland. The area of present-day development to the south of Leeston Dunsandel Road has some development at the time of these photographs. The southernmost building currently present is in place, as well as two smaller buildings adjacent to Leeston Dunsandel Road, as shown in Figure 3.1.

Development in the area to the north of Leeston Dunsandel Road first appear in the 1975-79 aerial photographs. A building is constructed at this time, which does not appear to be either of the existing buildings. This remains until the 2010-15 images, which show the buildings that are currently in place. The area to the south of the Leeston Dunsandel Road also appears to undergo most of its current development in recent years, with two of the three buildings currently present only appearing from 2010-15 onwards.
