Geotechnical Assessment

Geotechnical Report for Proposed Plan Change

1, 2 & 10 /487 Weedons Road

Miyamoto Ref: **200357-08-RP-001[0]**

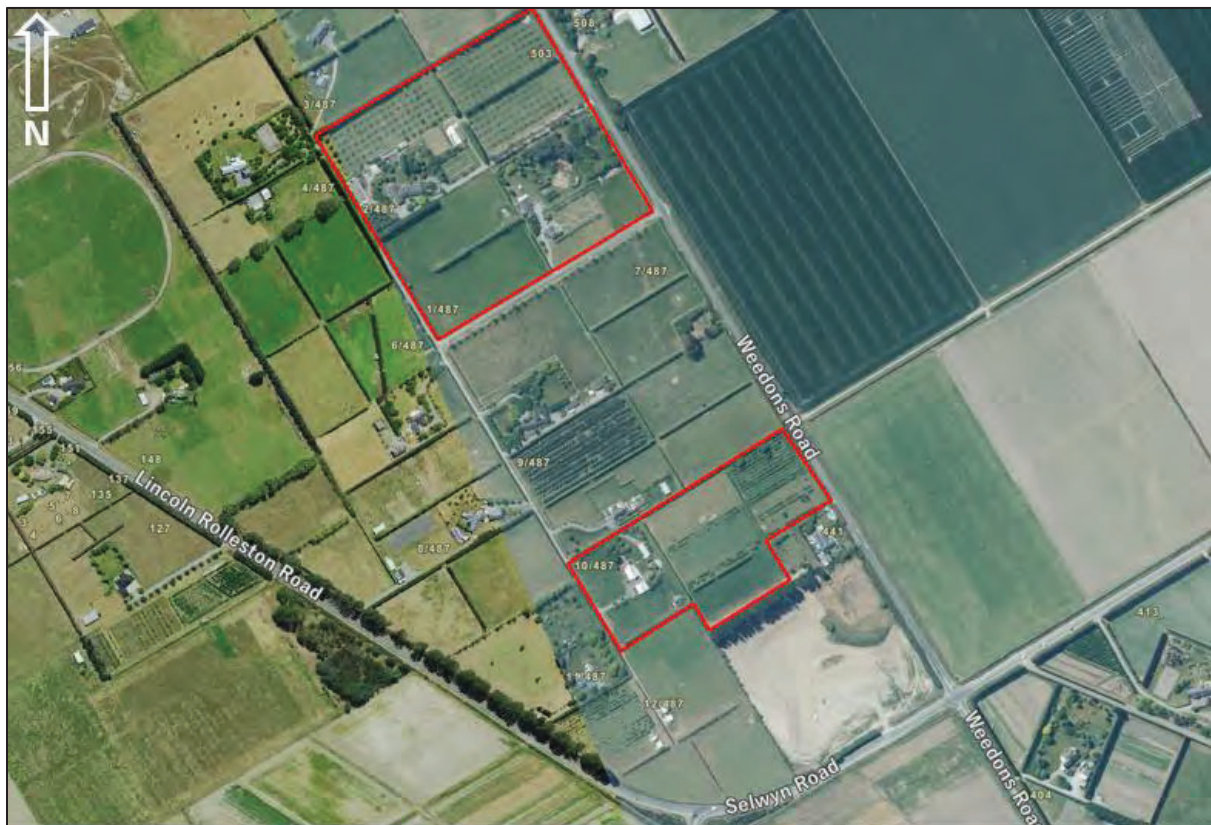
Figure 1: Site Location / Layout Plan

The site located in a rural setting in Rolleston, Canterbury (Selwyn District), encompassing Lot 2, Lot 3, and Lot 6 DP 47839 (1, 2 and 10 487 Weedons), refer to Figure 1 below. The land covers an area of approximately ~13 ha and comprises of two separate roughly rectangular parcels of land.

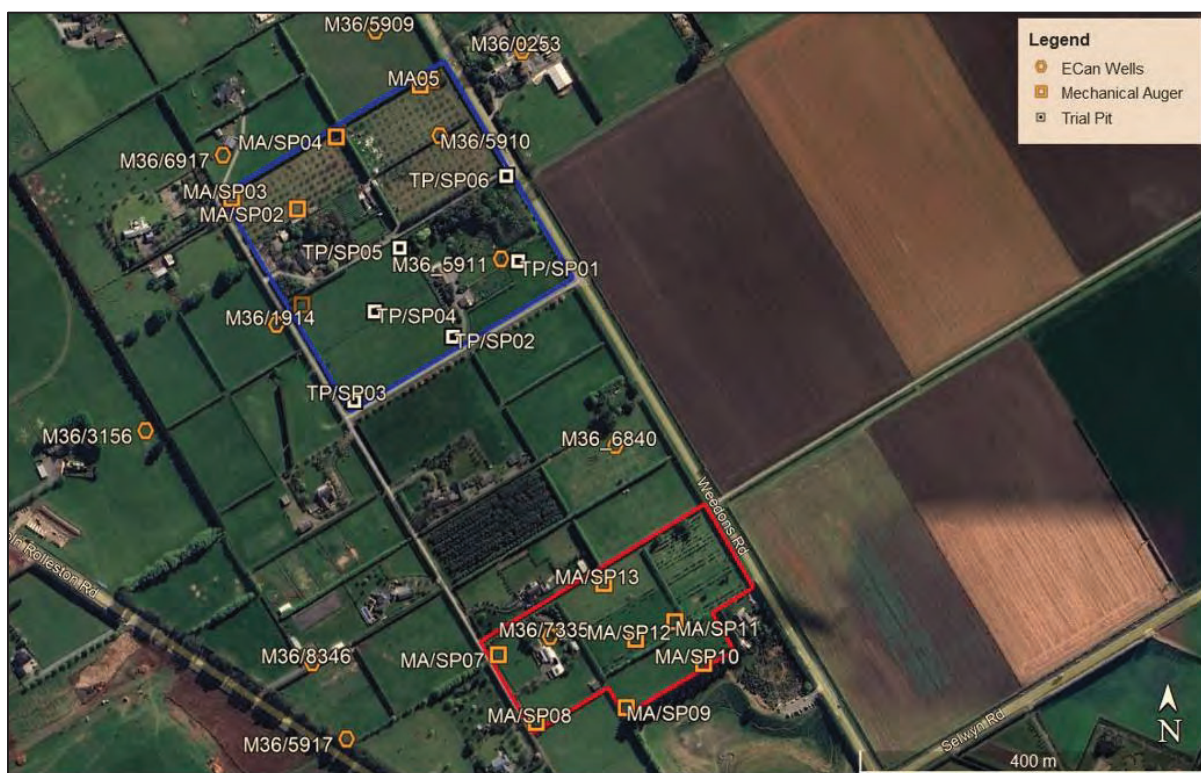
Figure 2: Ground Investigation Location Plan

The test locations are shown in Figure 2, the general details of the ground investigations are summarised in Table 1, and the engineering and well bore logs are presented in Appendix A.

Standing groundwater was not encountered during our site-specific investigation. Groundwater was encountered in nearby ECan well bores (refer Figure 2) at depths ranging 12 to 13 mbgl.

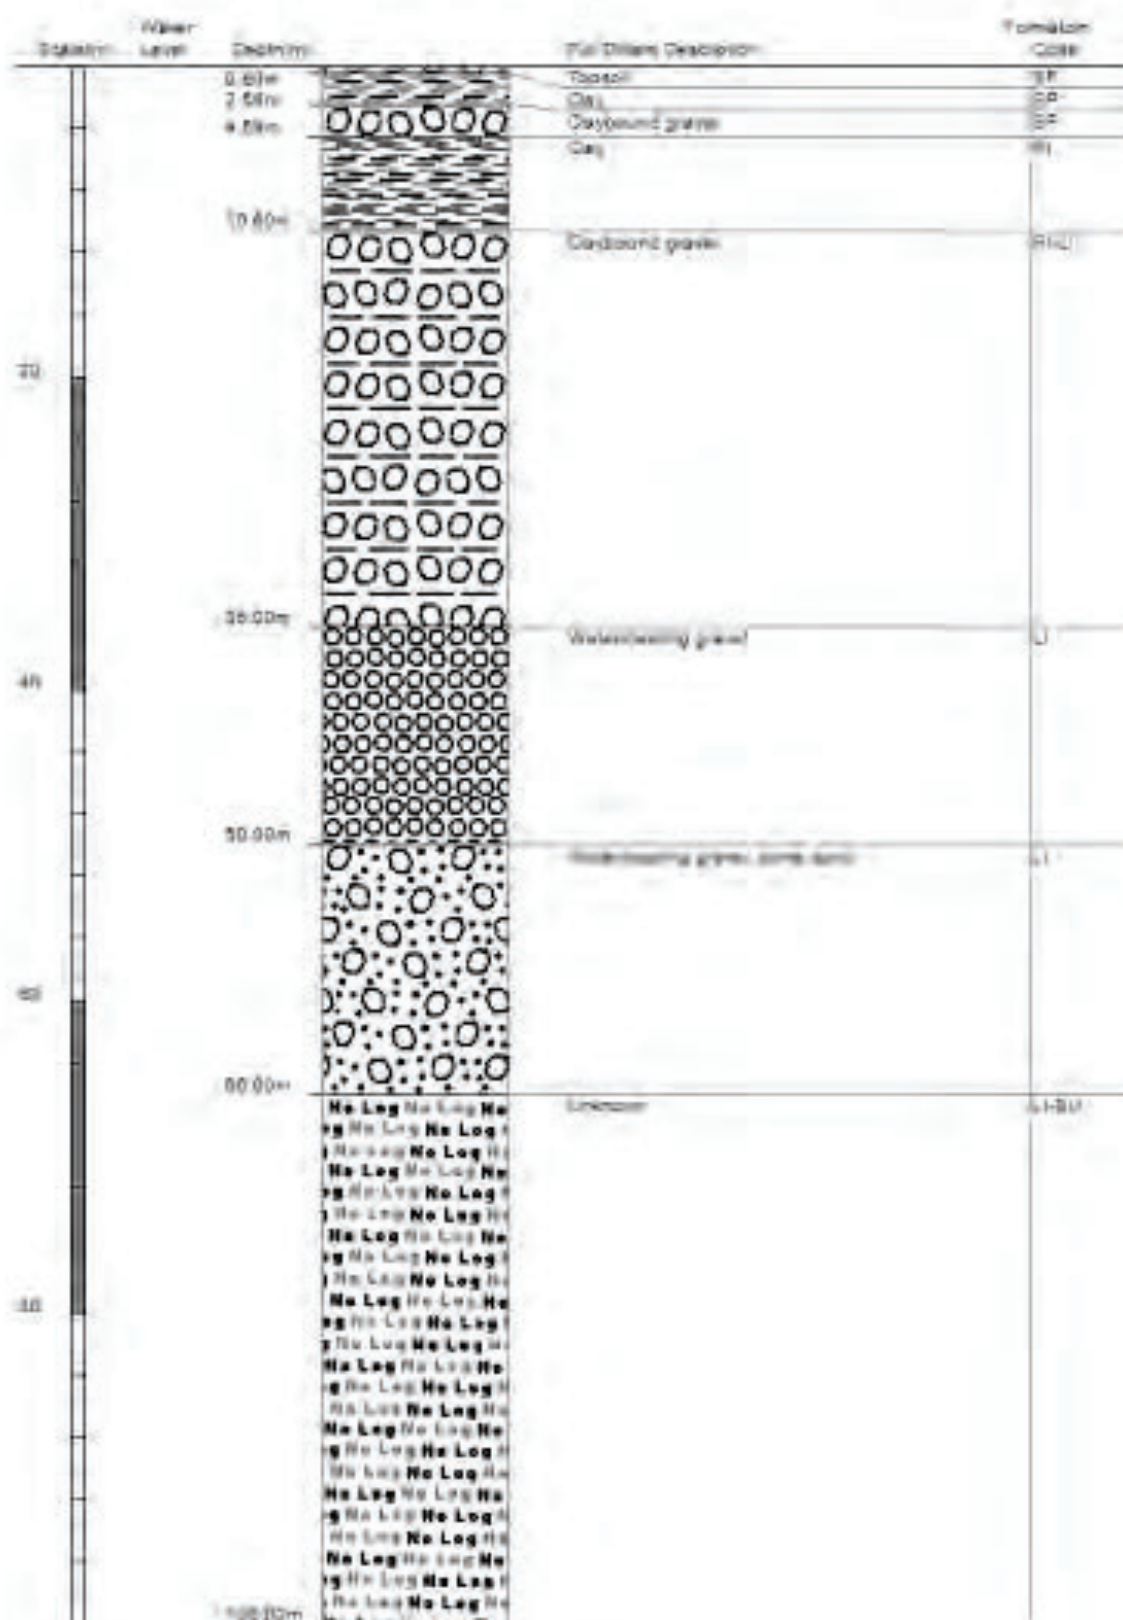
Borelog for well M36/1914

Grid Reference (NZTM): 1663309 mE 8171594 mN
 Location Accuracy: 2 - 15m
 Ground Level Altitude: 37.0 m +MSD Accuracy: < 0.5 m
 Driller: A M Bisset & Co
 Drill Method: Cable Tool
 Borelog Depth: 105.0 m Drill Date: 26-Mar-1984

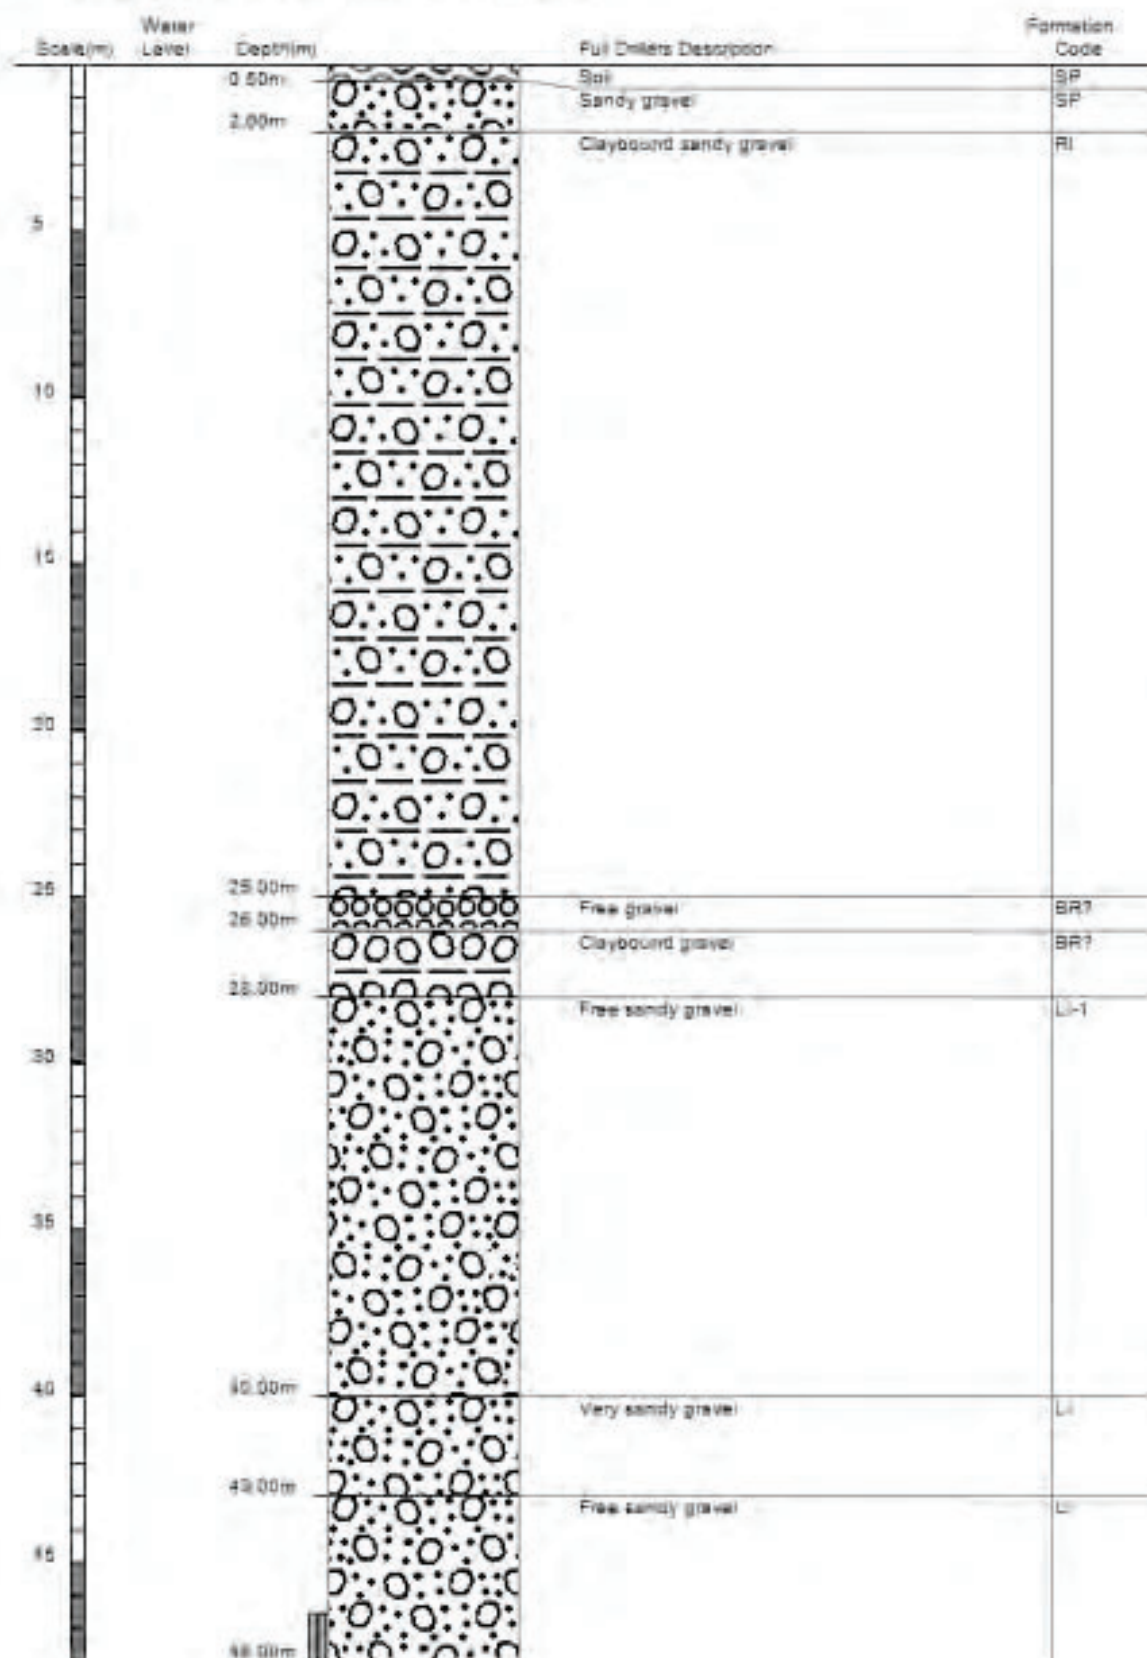
Borelog for well M36/5909

Grid Reference (NZTM): 1553366 mE, 5171950 mN
 Location Accuracy: 50 - 300m
 Ground Level Altitude: 38.6 m +MSD Accuracy: < 2.5 m
 Driller: Smiths Welldrilling
 Drill Method: Rotary Rig
 Borelog Depth: 48.0 m Drill Date: 04-Apr-2000

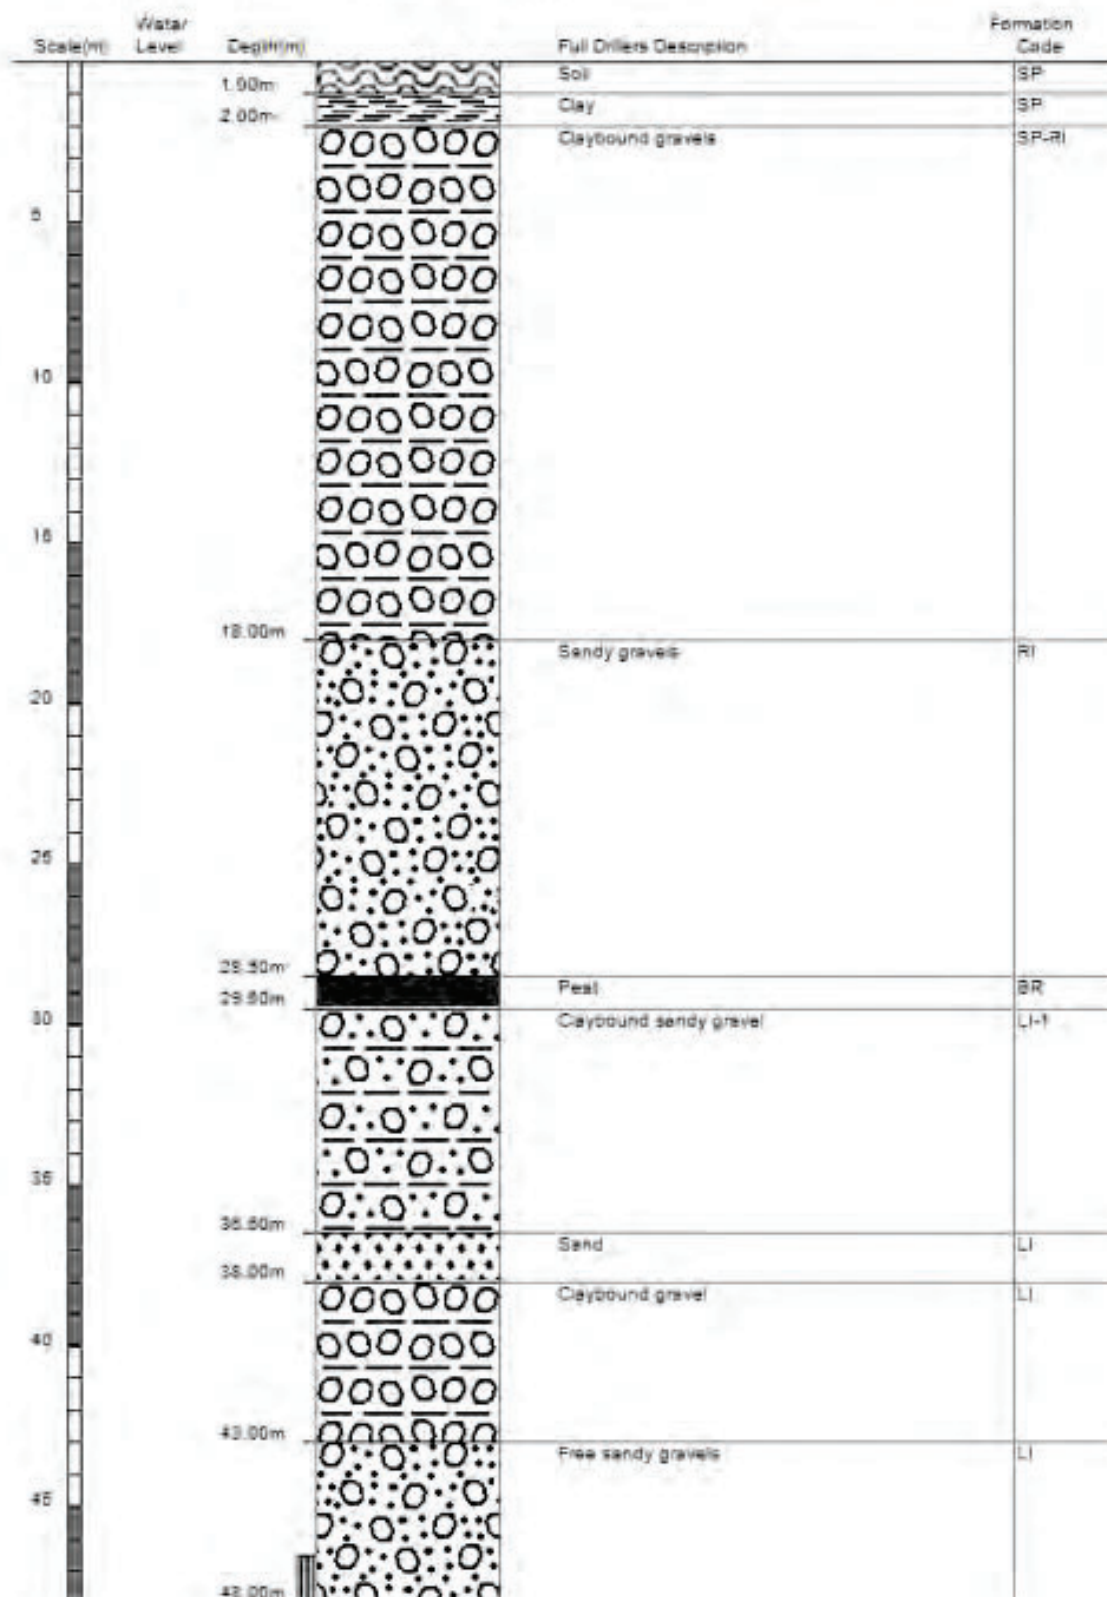
Borelog for well M36/6840

Grid Reference (NZTM): 1553670 mE, 5171476 mN
 Location Accuracy: 2 - 15m
 Ground Level Altitude: 36.4 m +MSD Accuracy: < 0.5 m
 Driller: Smiths Well Drilling
 Drill Method: Rotary Rig
 Borelog Depth: 48.0 m Drill Date: 20-Jul-2000

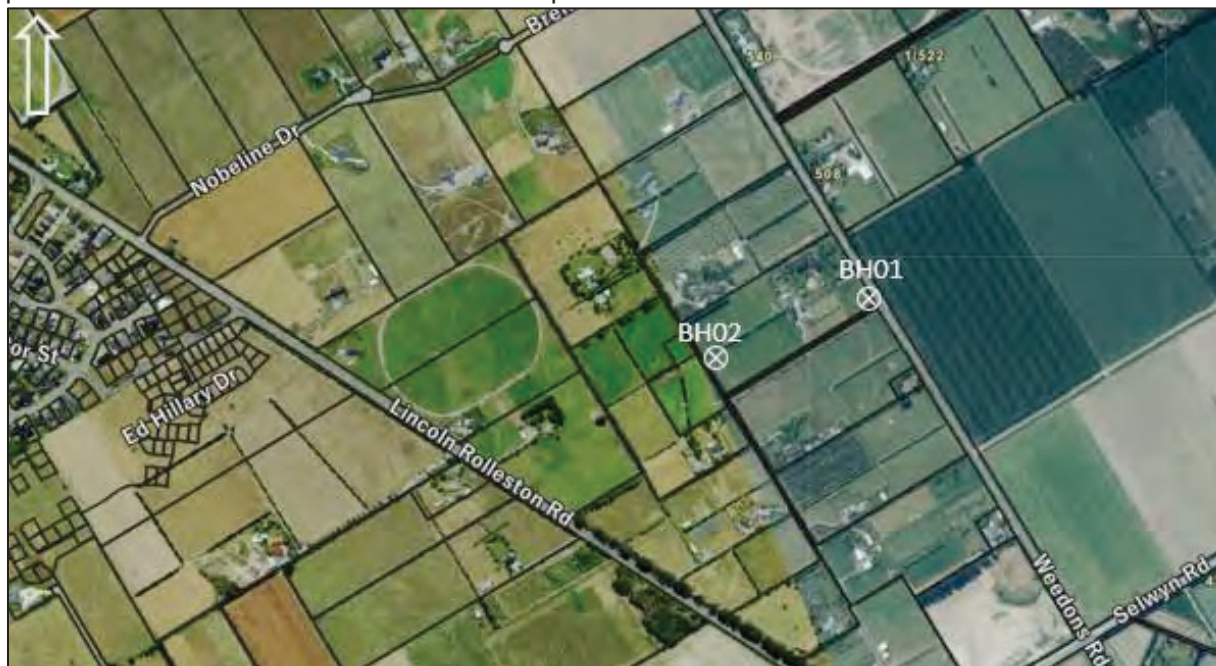
Figure 1: Test locations

The location of testing is shown below in figure 1. Two boreholes and associated soakage testing was completed at the eastern and western end of 1/487 Weedons Road, Rolleston, within grassed paddocks to the east of the Rolleston township.

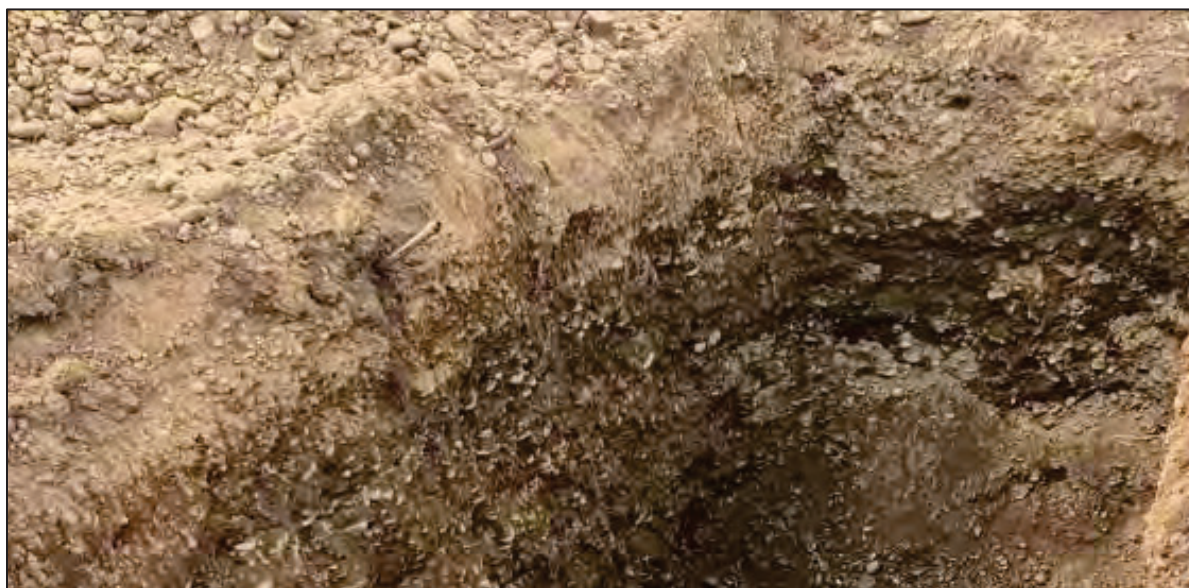
The sandy gravel deposits beneath surficial sand and silt soils are typically free draining at some depth below the ground surface. The surficial deposits of silt overlying the gravel (which are often Loess / aeolian derived and likely hydrophobic) can infill the free draining sandy gravel voids over time, typically to between 0.3 and 1.0 m below the top of the gravel deposits. See figure 2 below for typical appearance of the sandy gravel deposits in Rolleston.

Figure 2: An excavation in a neighbouring subdivision showing typical sandy gravel deposits.

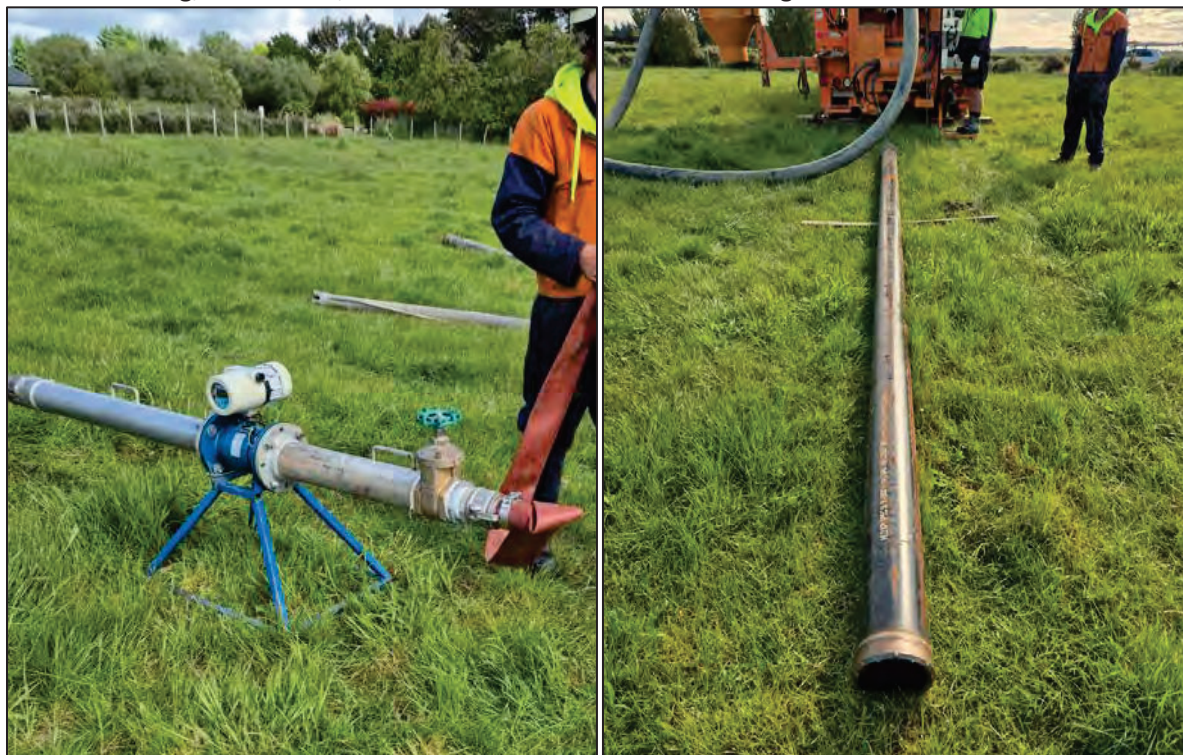
Borehole casing, flow meter, and well screen is shown below in figures 3 and 4.

Figure 3: The flow meter used during testing set inline between water cart and top of steel casing (left). The 6 meter long, 154 mm ID, 184 mm OD steel casing prior to advancing into ground to 4.5m bgl for soakage testing.

Water was delivered to the borehole via a pump and water cart with 10,000 litre capacity. Water flow rates were measured using a Euromag electromagnetic flow meter connected in parallel between the water cart and borehole. An electronic dip meter was used to measure the water level within casing when performing soakage testing.

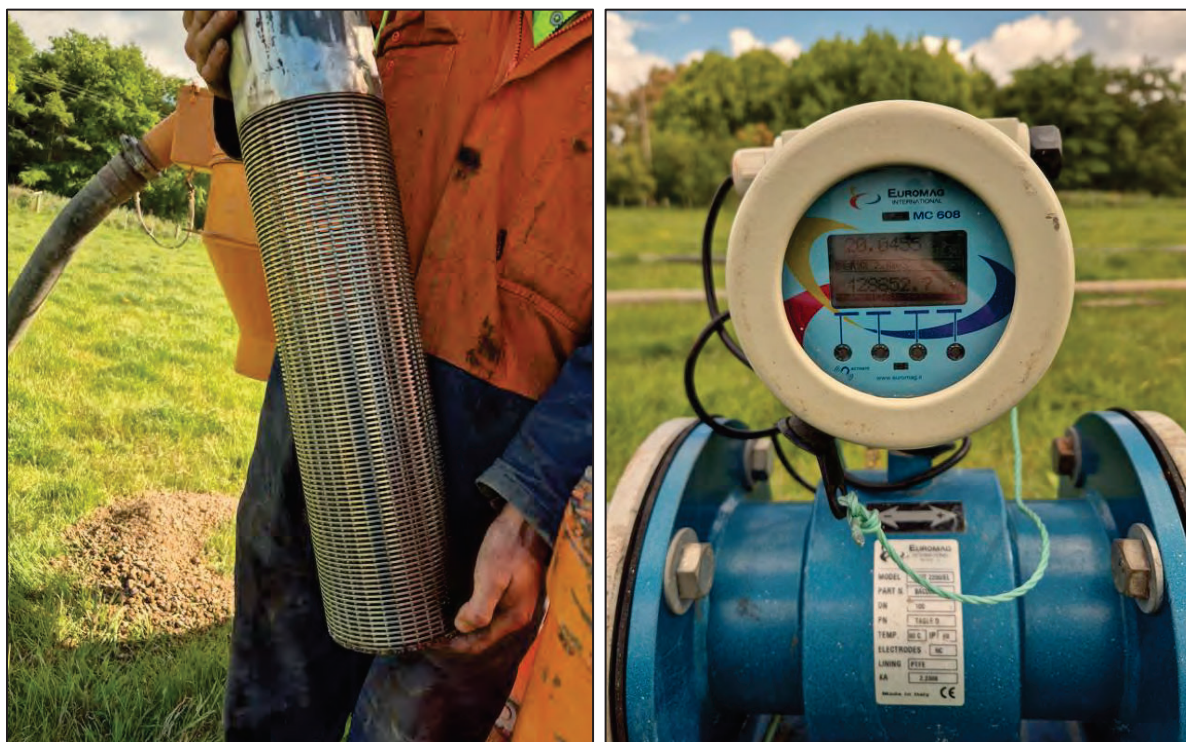
Figure 4: The 0.5 m long 3.5 mm gauge well screen inserted at the base of casing (left). Euromag flow meter with flow reported in litres per second and volume in cubic meters (m³) providing values to the nearest to 0.1 m³ increment.

Steel cased boreholes were advanced to 4.5 m bgl within the sandy gravel deposits at 1/487 Weedons Road for both BH01 and BH02, with a well screen (see figure 4) inserted at the base of the casing. The depth of the boreholes approximates the depth of future soak pit design.
