### **Geotechnical Assessment**

# Geotechnical Report for Proposed Plan Change

1, 2 & 10 /487 Weedons Road

Miyamoto Ref: **200357-08-RP-001[0]**

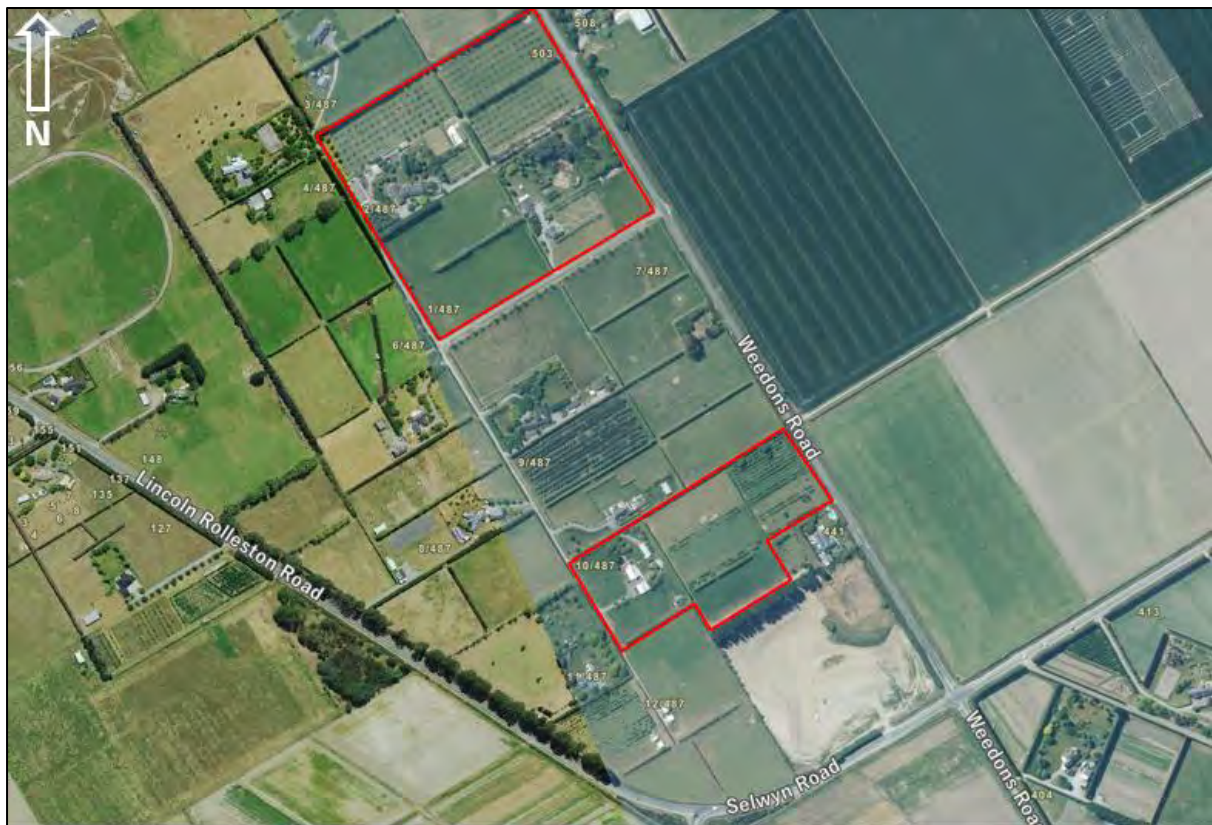
Figure 1: Site Location / Layout Plan

The site located in a rural setting in Rolleston, Canterbury (Selwyn District), encompassing Lot 2, Lot 3, and Lot 6 DP 47839 (1, 2 and 10 487 Weedons), refer to Figure 1 below. The land covers an area of approximately ~13 ha and comprises of two separate roughly rectangular parcels of land.

The site is predominantly flat with a global elevation difference of ~1.5 m (increasing towards the north-west). The land is predominantly used as mixed-farmland:

- The northern paddocks of 1/ 487 Weedons Road are occupied by a walnut orchard.
- The central paddocks of 1 & 2/ 487 Weedons Road are occupied by residential and auxiliary structures, and, producing and ornamental shrubs and trees.
- Residential structures occupy the northwestern paddocks of 10/ 487 Weedons Road.
- The southwestern paddocks of 2/ 487 Weedons Road are grass-covered.
- The central paddocks of 10/ 487 Weedons Road are grass-covered.
- A former quarry is located to the southeast of 10/ 487 Weedons Road.

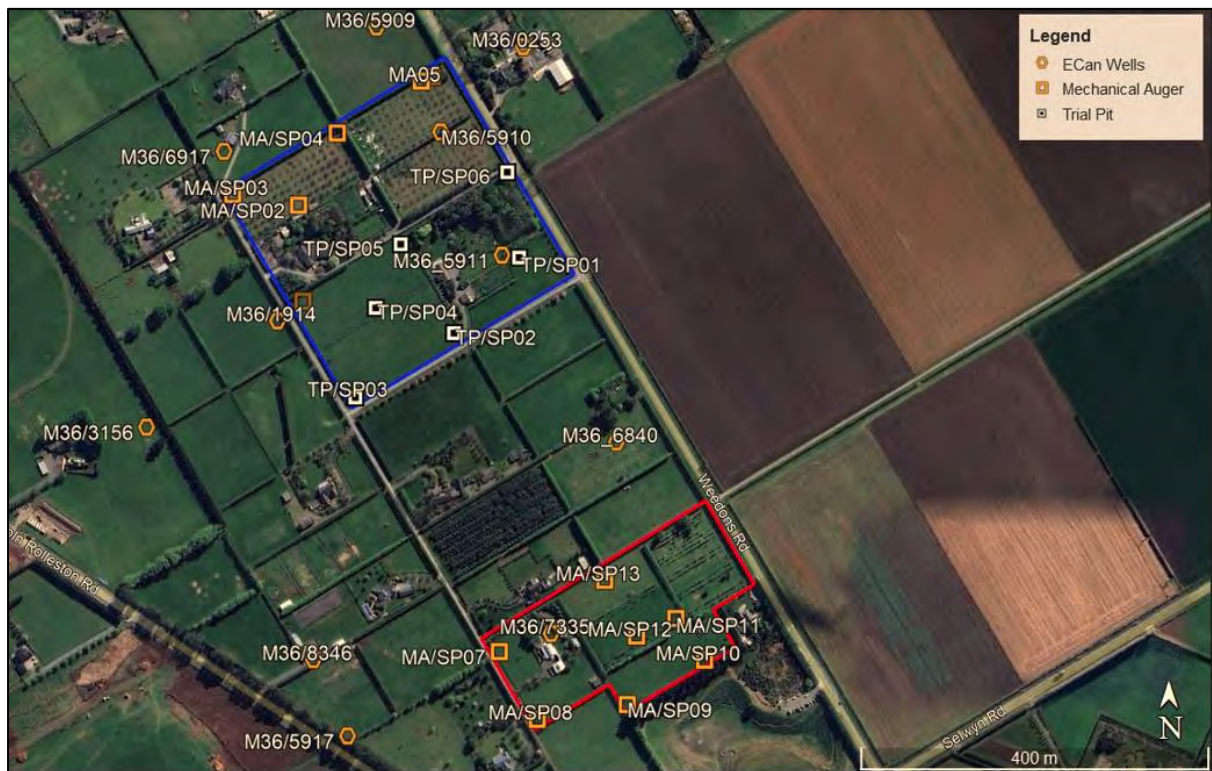
Figure 2: Ground Investigation Location Plan

The test locations are shown in Figure 2, the general details of the ground investigations are summarised in Table 1, and the engineering and well bore logs are presented in Appendix A.

Standing groundwater was not encountered during our site-specific investigation. Groundwater was encountered in nearby ECan well bores (refer Figure 2) at depths ranging 12 to 13 mbgl.

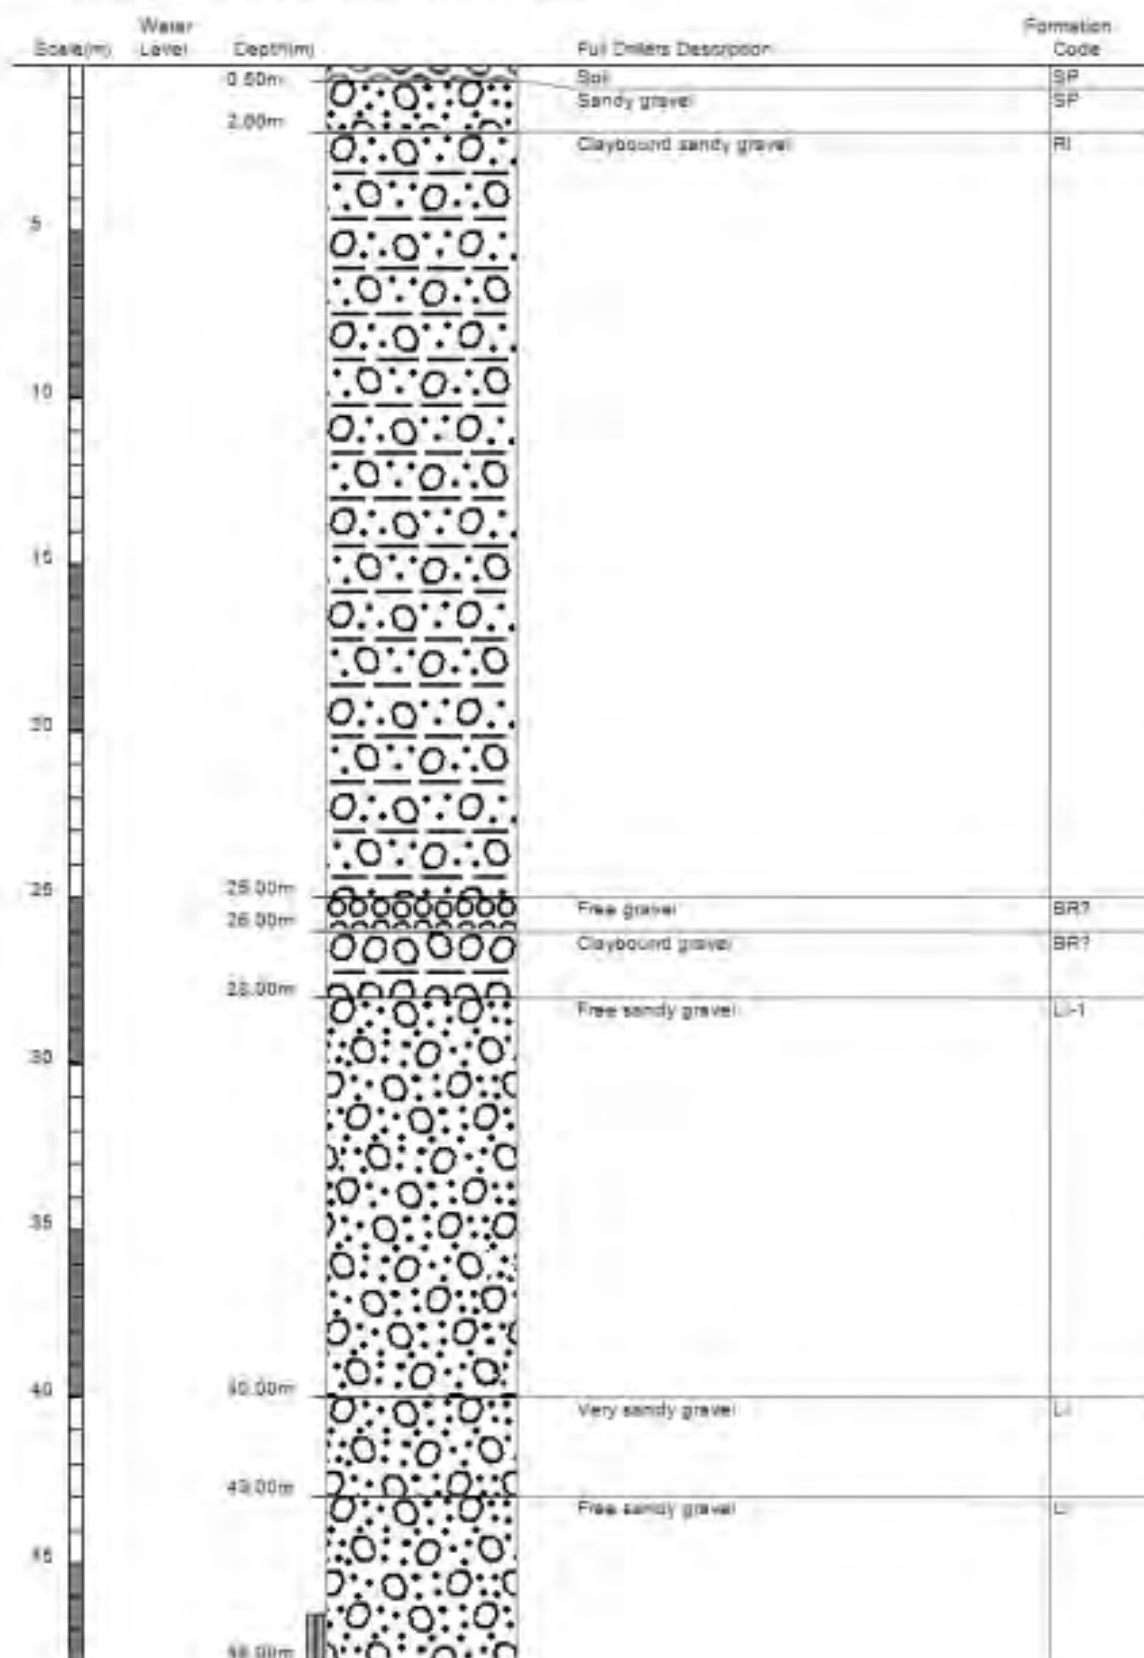
# Borelog for well M36/5909

Grid Reference (NZTM): 1553366 mE, 5171950 mN  
 Location Accuracy: 50 - 300m  
 Ground Level Altitude: 38.6 m +MSD Accuracy: < 2.5 m  
 Driller: Smiths Welldrilling  
 Drill Method: Rotary Rig  
 Borelog Depth: 48.0 m Drill Date: 04-Apr-2000

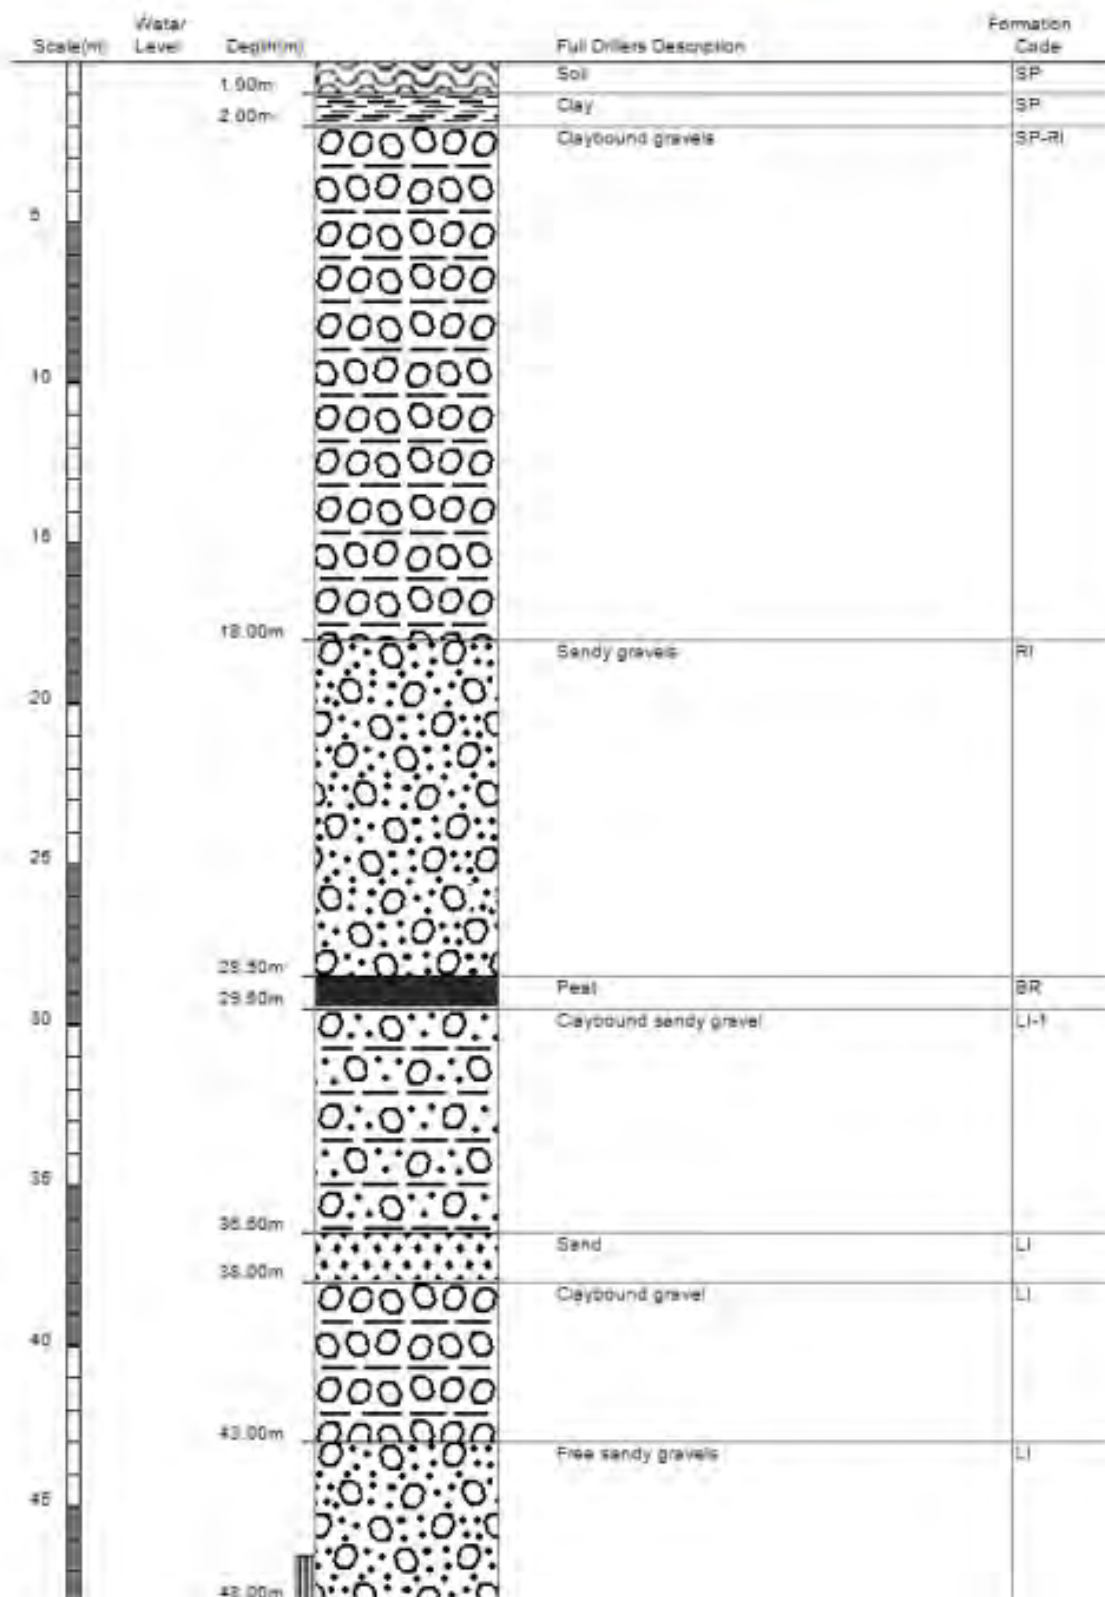
# Borelog for well M36/6840

Grid Reference (NZTM): 1553670 mE, 5171476 mN  
 Location Accuracy: 2 - 15m  
 Ground Level Altitude: 36.4 m +MSD Accuracy: < 0.5 m  
 Driller: Smiths Well Drilling  
 Drill Method: Rotary Rig  
 Borelog Depth: 48.0 m Drill Date: 20-Jul-2000

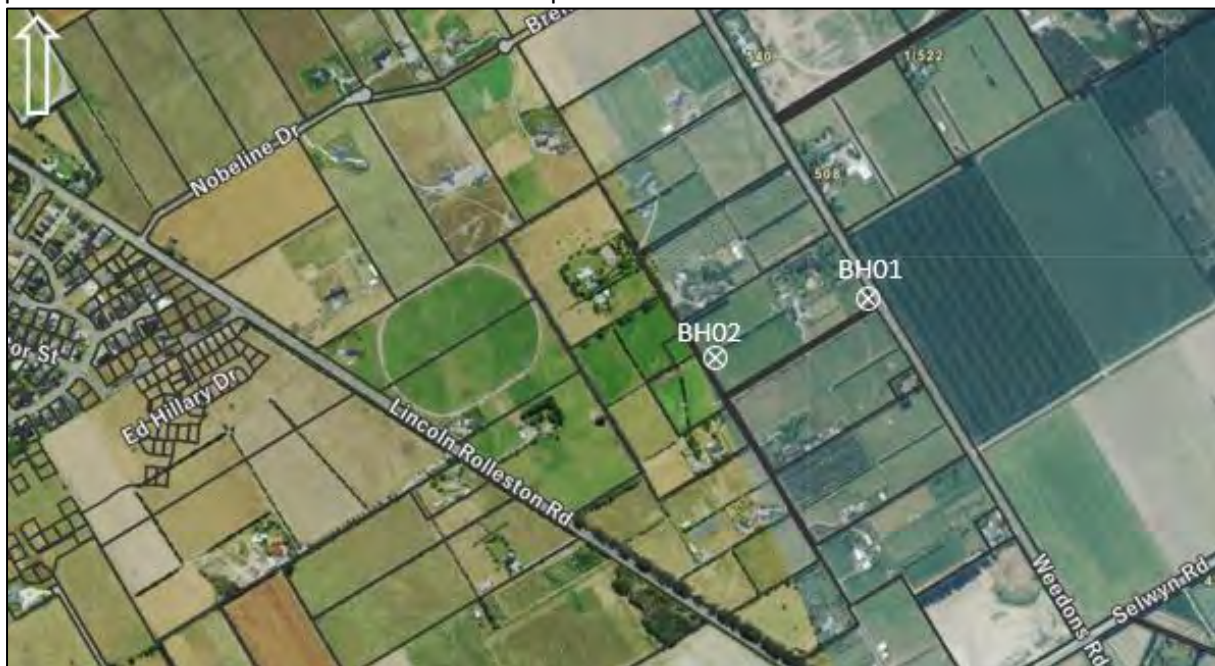
Figure 1: Test locations

The location of testing is shown below in figure 1. Two boreholes and associated soakage testing was completed at the eastern and western end of 1/487 Weedons Road, Rolleston, within grassed paddocks to the east of the Rolleston township.

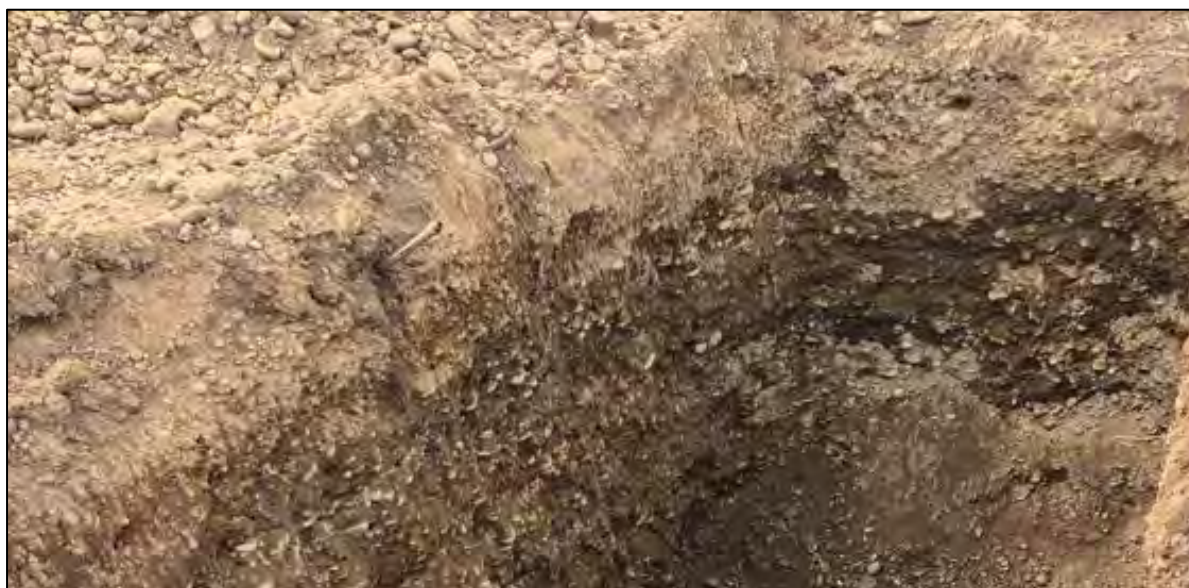
**Figure 2: An excavation in a neighbouring subdivision showing typical sandy gravel deposits.**

The sandy gravel deposits beneath surficial sand and silt soils are typically free draining at some depth below the ground surface. The surficial deposits of silt overlying the gravel (which are often Loess / aeolian derived and likely hydrophobic) can infill the free draining sandy gravel voids over time, typically to between 0.3 and 1.0 m below the top of the gravel deposits. See figure 2 below for typical appearance of the sandy gravel deposits in Rolleston.

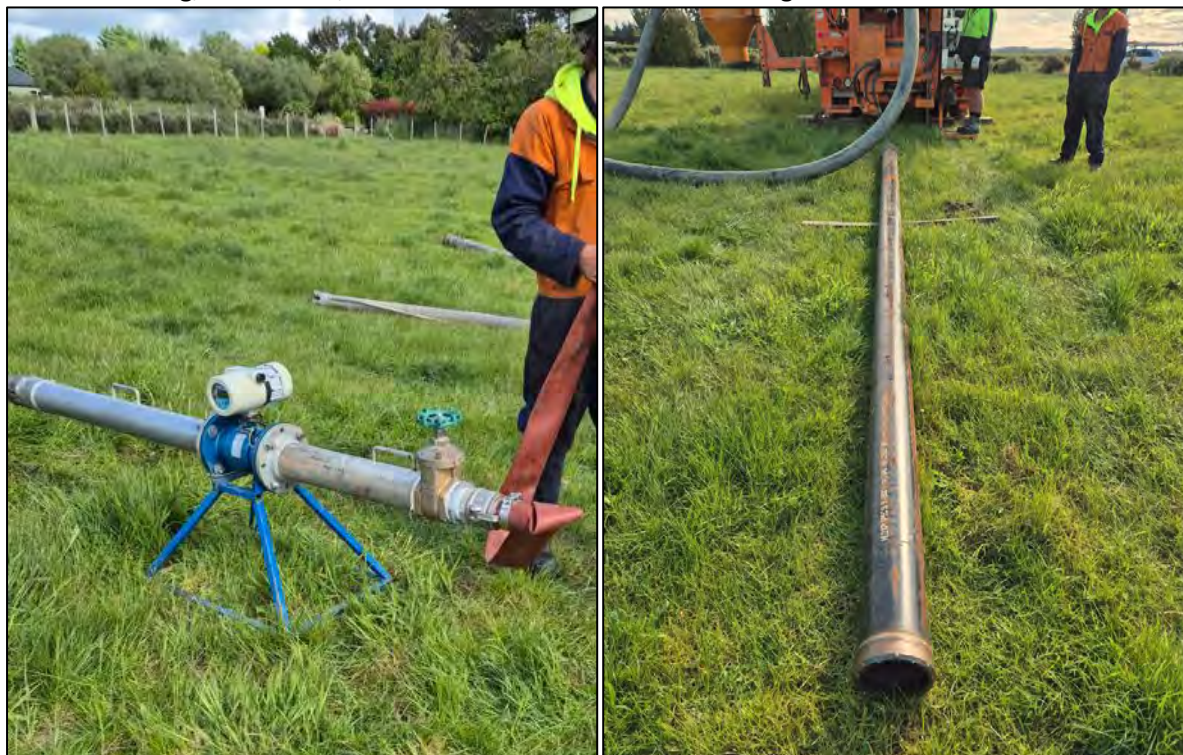
**Figure 3: The flow meter used during testing set inline between water cart and top of steel casing (left). The 6 meter long, 154 mm ID, 184 mm OD steel casing prior to advancing into ground to 4.5m bgl for soakage testing.**

Water was delivered to the borehole via a pump and water cart with 10,000 litre capacity. Water flow rates were measured using a Euromag electromagnetic flow meter connected in parallel between the water cart and borehole. An electronic dip meter was used to measure the water level within casing when performing soakage testing.

Borehole casing, flow meter, and well screen is shown below in figures 3 and 4.

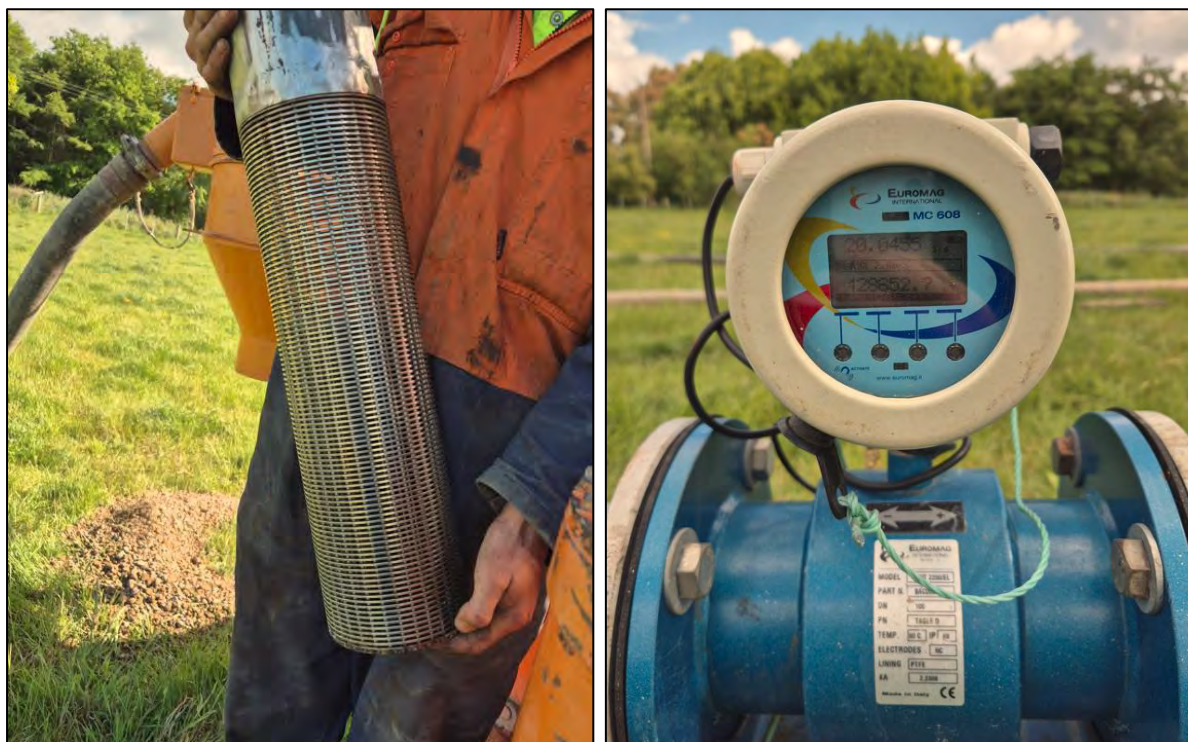
**Figure 4: The 0.5 m long 3.5 mm gauge well screen inserted at the base of casing (left). Euromag flow meter with flow reported in litres per second and volume in cubic meters (m<sup>3</sup>) providing values to the nearest to 0.1 m<sup>3</sup> increment.**

Steel cased boreholes were advanced to 4.5 m bgl within the sandy gravel deposits at 1/487 Weedons Road for both BH01 and BH02, with a well screen (see figure 4) inserted at the base of the casing. The depth of the boreholes approximates the depth of future soak pit design.

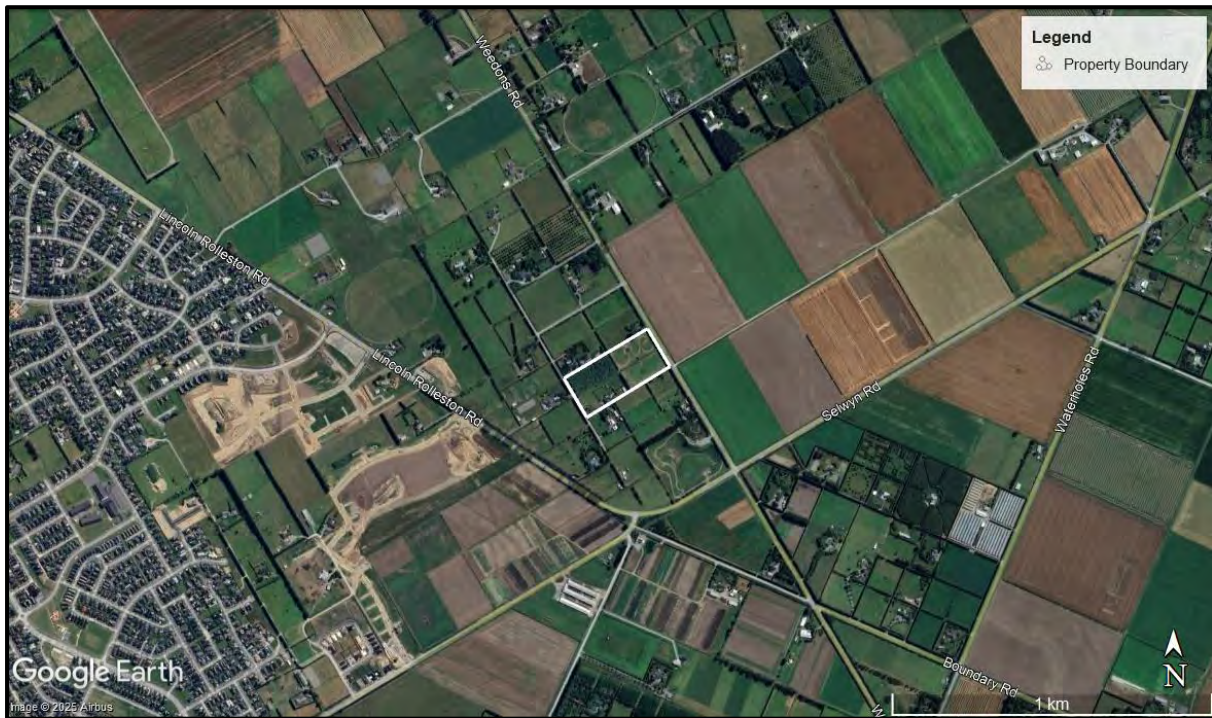
**Figure 1: Site Location Plan**

The site, legally described as LOT 5 DP 47839, is located in Rolleston and is approximately 4.3 hectares (ha) in area. The topography of the site is relatively flat with a difference in elevation of ~1.0 m and slight shallow undulations / channel features. The property is bound by Weedons Road to the northeast and by rural properties on all other boundaries. A site location plan is provided as Figure 1.

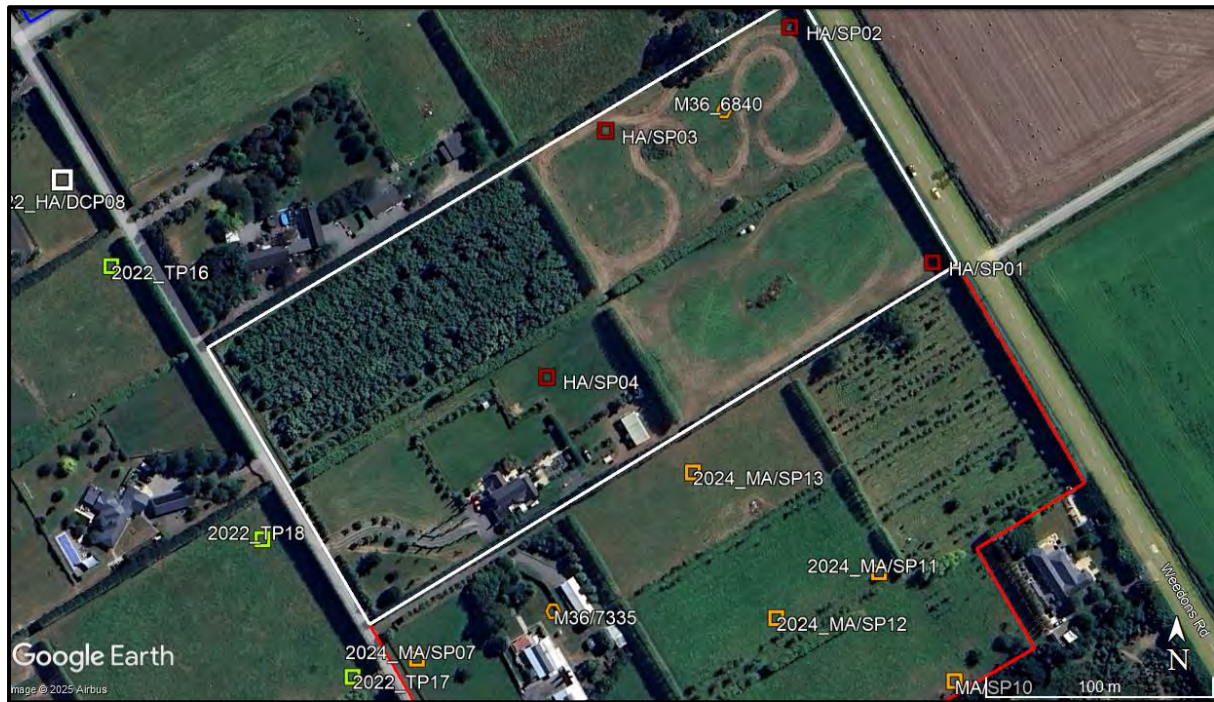
**Figure 2: Exploratory Hole Location Plan**

- 4 No. Hand-augered boreholes (HA).
- 4 No. Dynamic Cone Penetrometer (DCP) tests.

The exploratory hole locations are shown in Figure 2, summarised in Table 1, and the engineering logs / plots are included as Appendix B.

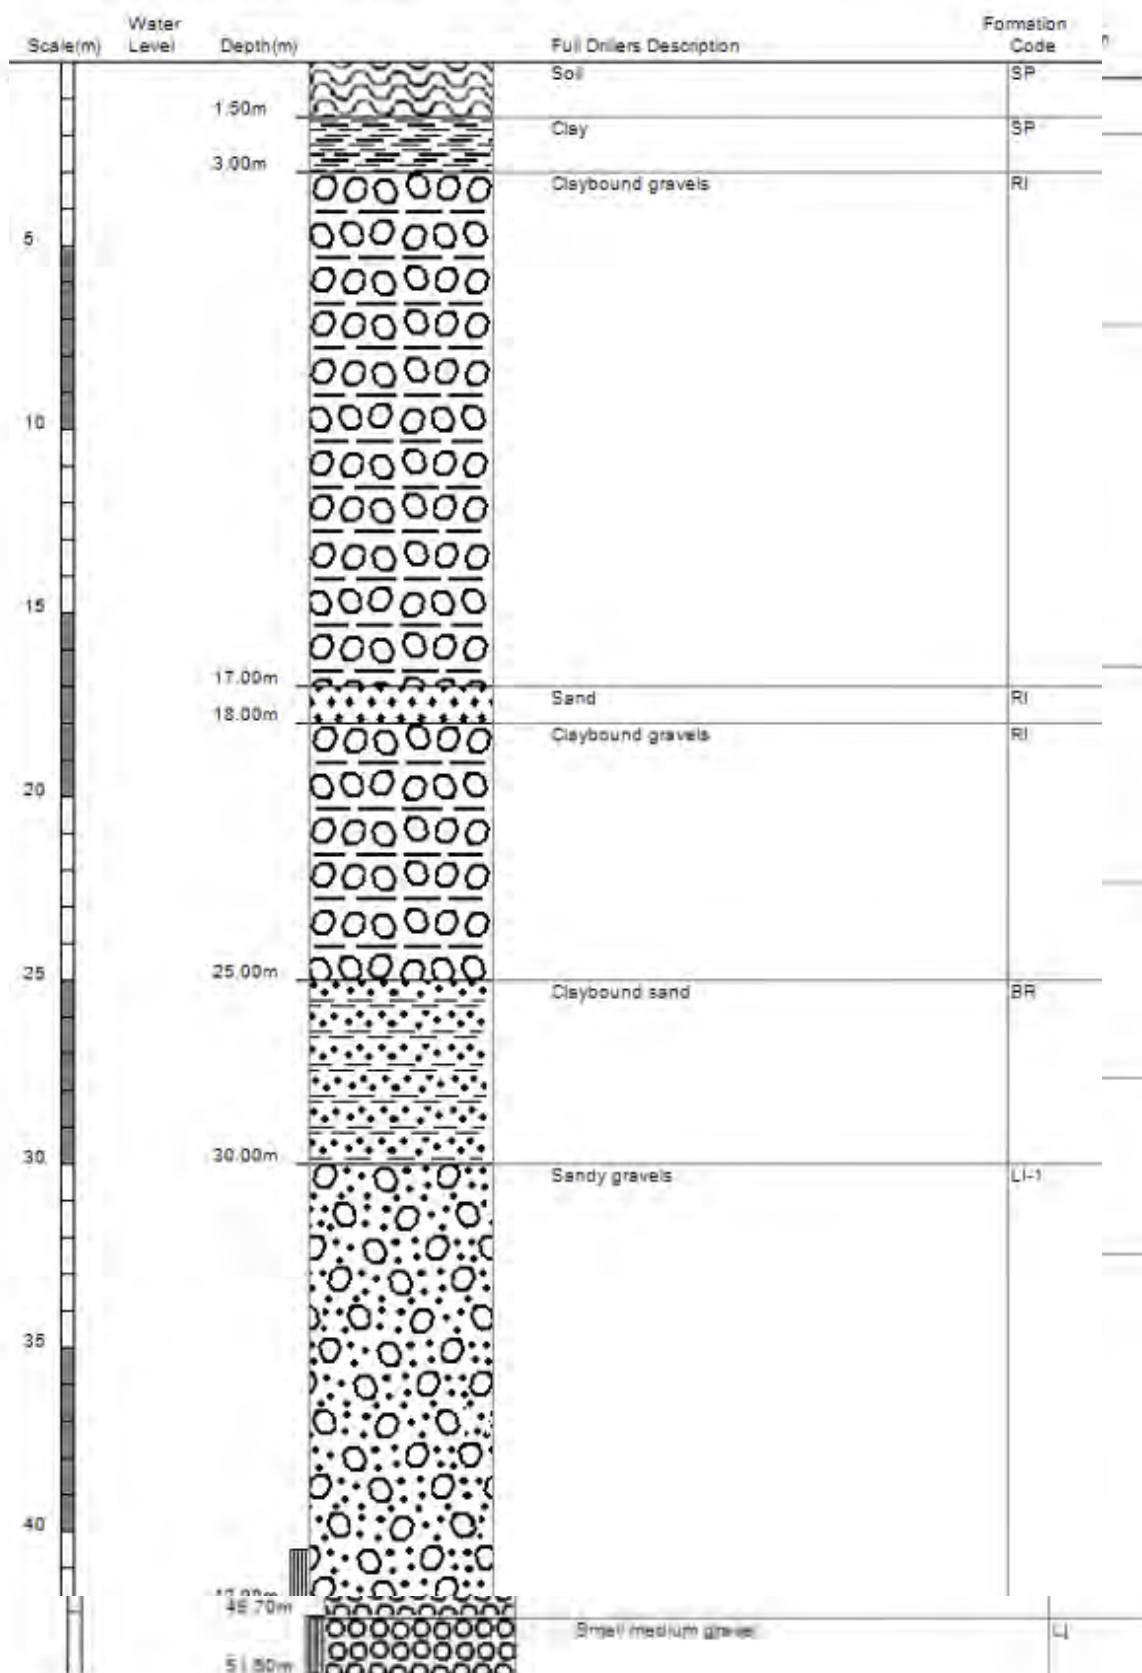
# Borelog for well M36/7335

Grid Reference (NZTM): 1553586 mE, 5171271 mN  
 Location Accuracy: 50 - 300m  
 Ground Level Altitude: 35.9 m +MSD Accuracy: < 2.5 m  
 Driller: Smiths Welldrilling  
 Drill Method: Rotary Rig  
 Borelog Depth: 42.0 m Drill Date: 13-Dec-2002
