# Geotechnical Desktop Assessment

**Rolleston PAK'n SAVE, 157 Levi Road – Geotechnical Desktop Assessment Letter**  
**Our Ref: 229723**

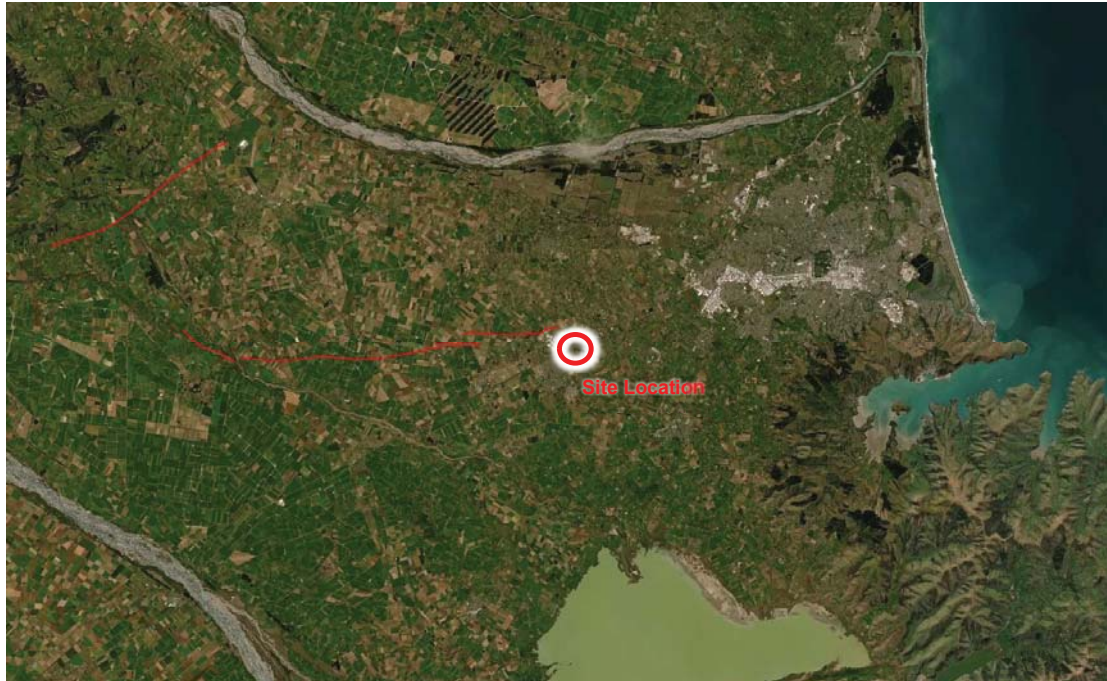
Figure 1 GNS Active Fault Database

A review of the Geological and Nuclear Sciences Active Fault Database (GNS, 2021) indicates two recorded active faults within the vicinity of the site. These faults are summarised in Table 2 below and their locations are shown in Figure 1. From this assessment it can be seen there are known recorded faults within the direct vicinity of the site.
