# Appendix 6: Flood Hazard Assessment

**LOT 1, 2, 3, & 4 DP 82846, LOT 1 DP 9138, LOT 2 DP 319397, LOT 2 DP 365379, PART RS 5482 & 5483, SECTION 7 LEESTON SETT – HIGH STREET, LEESTON**

### **Flood Risk**

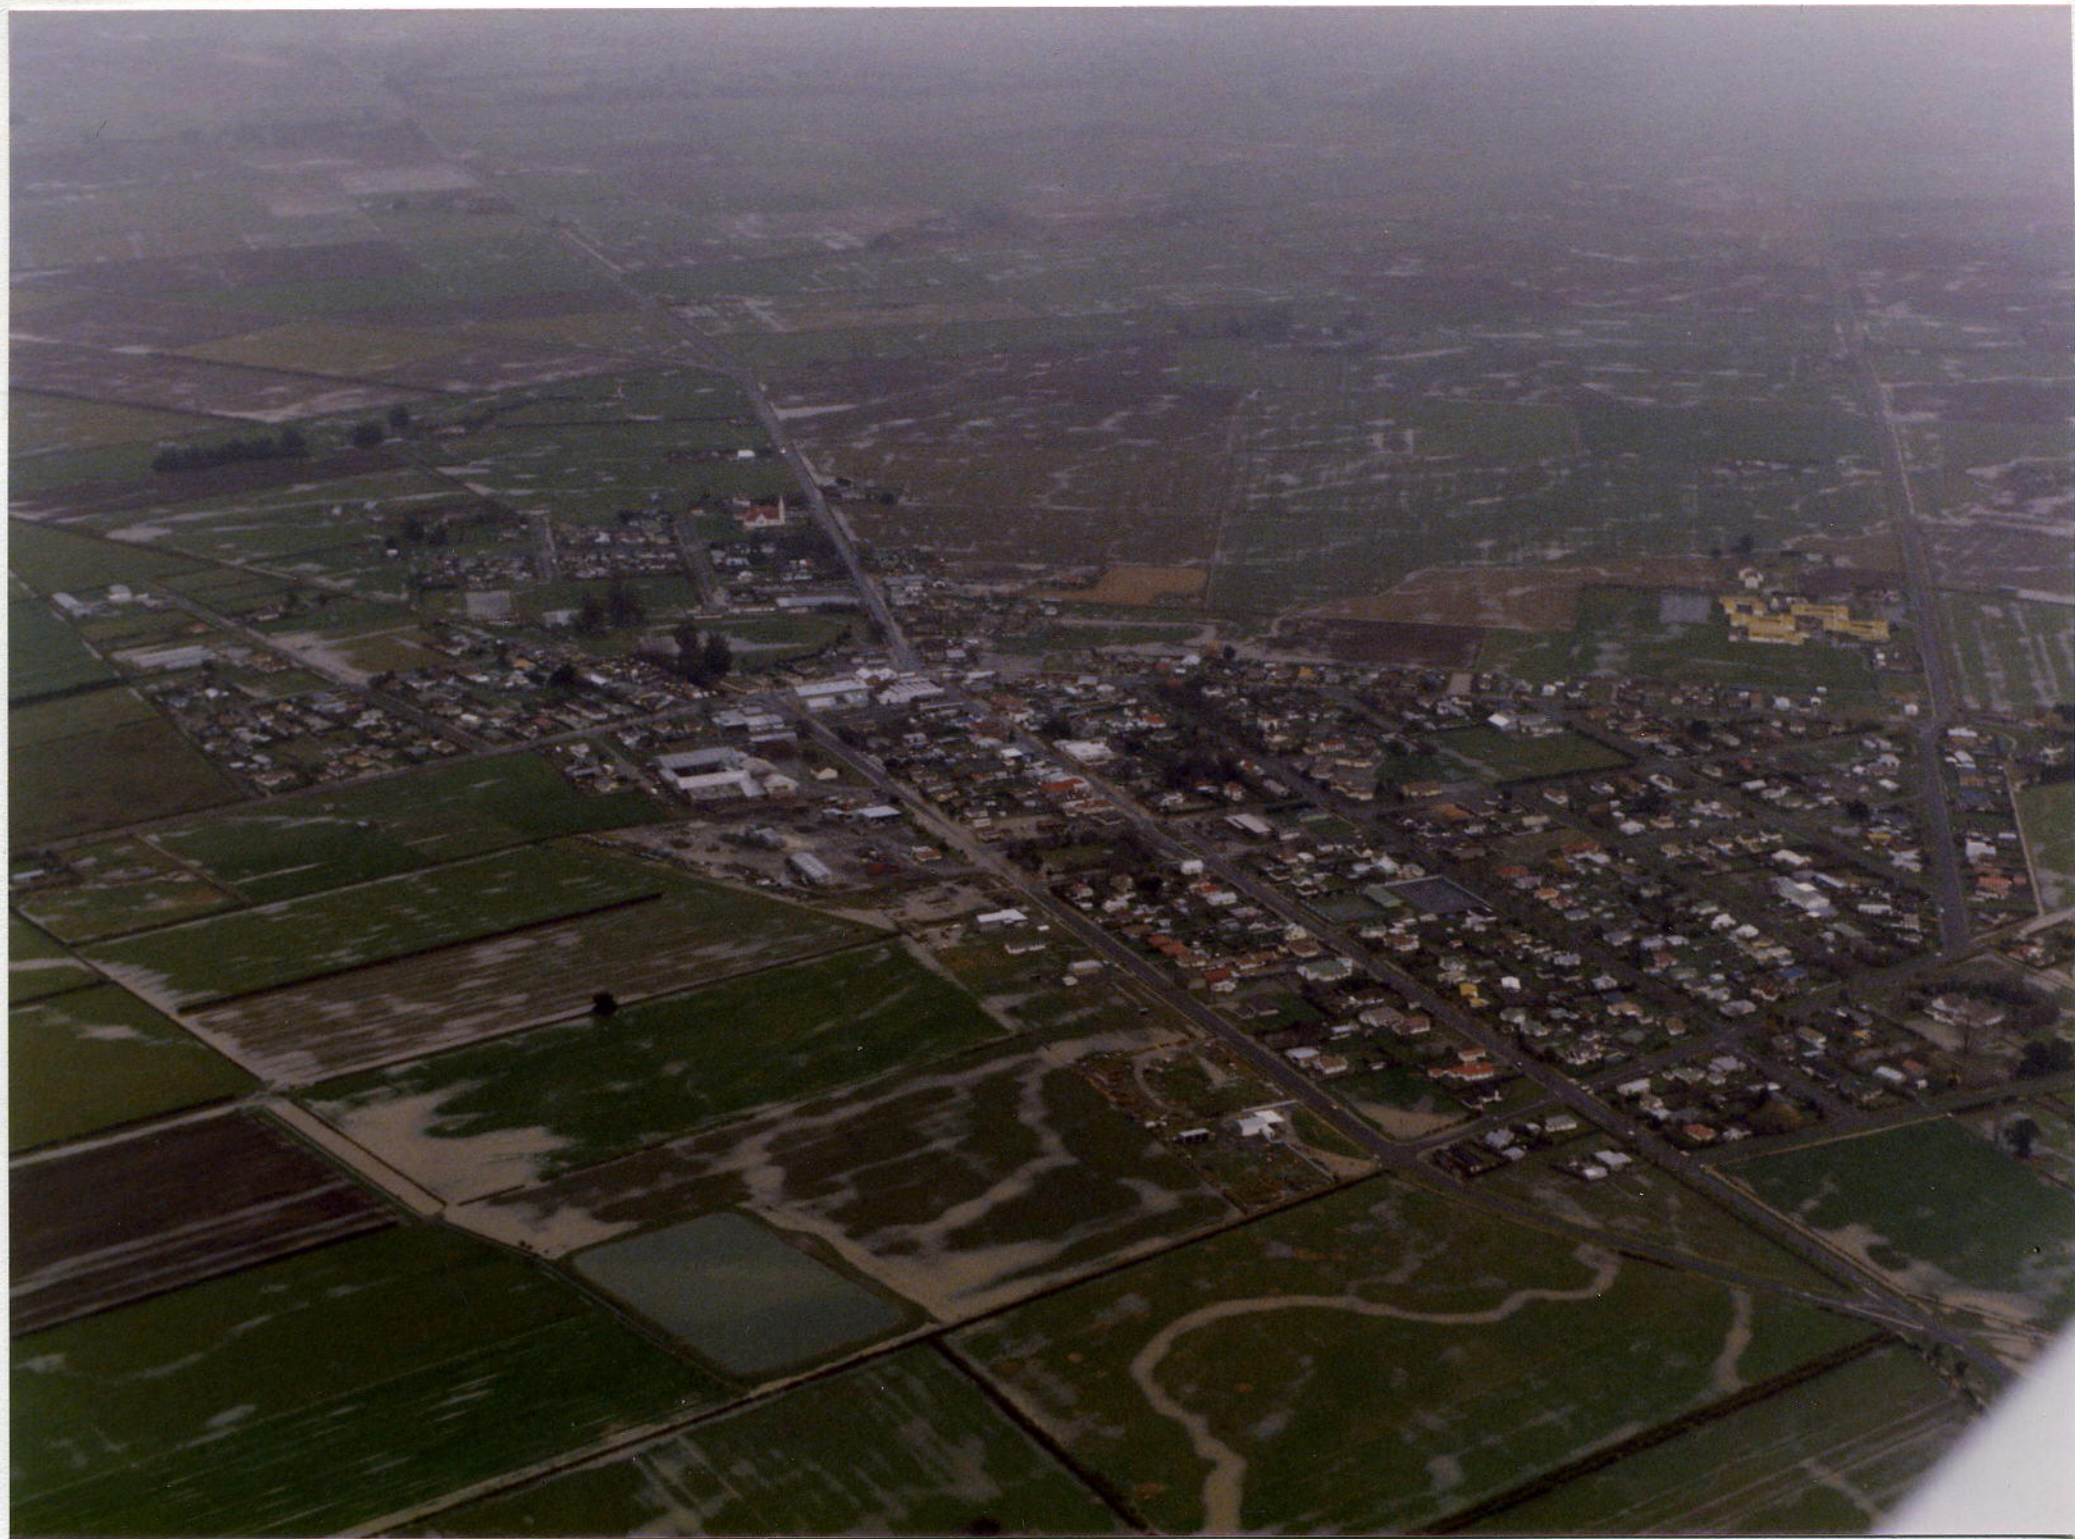
621. Leeston. (West)

Photograph No. **621** was taken on 24/08/1986 following a rainfall event where 72.7 mm was recorded at Greenpark, 81.3 mm at Lincoln, 96.8 mm at Burnham and 105.1 mm at Dunsandel in the 72 hours to 9 am on 23/08/1986. The return period of the rainfall at Greenpark and Lincoln is estimated at 2 - 5 years, with the slightly heavier rainfall at Burnham and Dunsandel having an estimated return period of 5 - 10 years. Antecedent conditions at the time were relatively wet due to rainfall earlier in the month.

The photographs show rainfall runoff flowing across the property and ponding behind barriers to flow and in natural depressions. Note that in both cases the photographs were taken 24 hours or more after the bulk of the rain had fallen, and therefore will not show flooding at its peak. In larger flood events it is likely that more extensive areas than those shown as flooded in the photographs will be affected.

24/08/1986

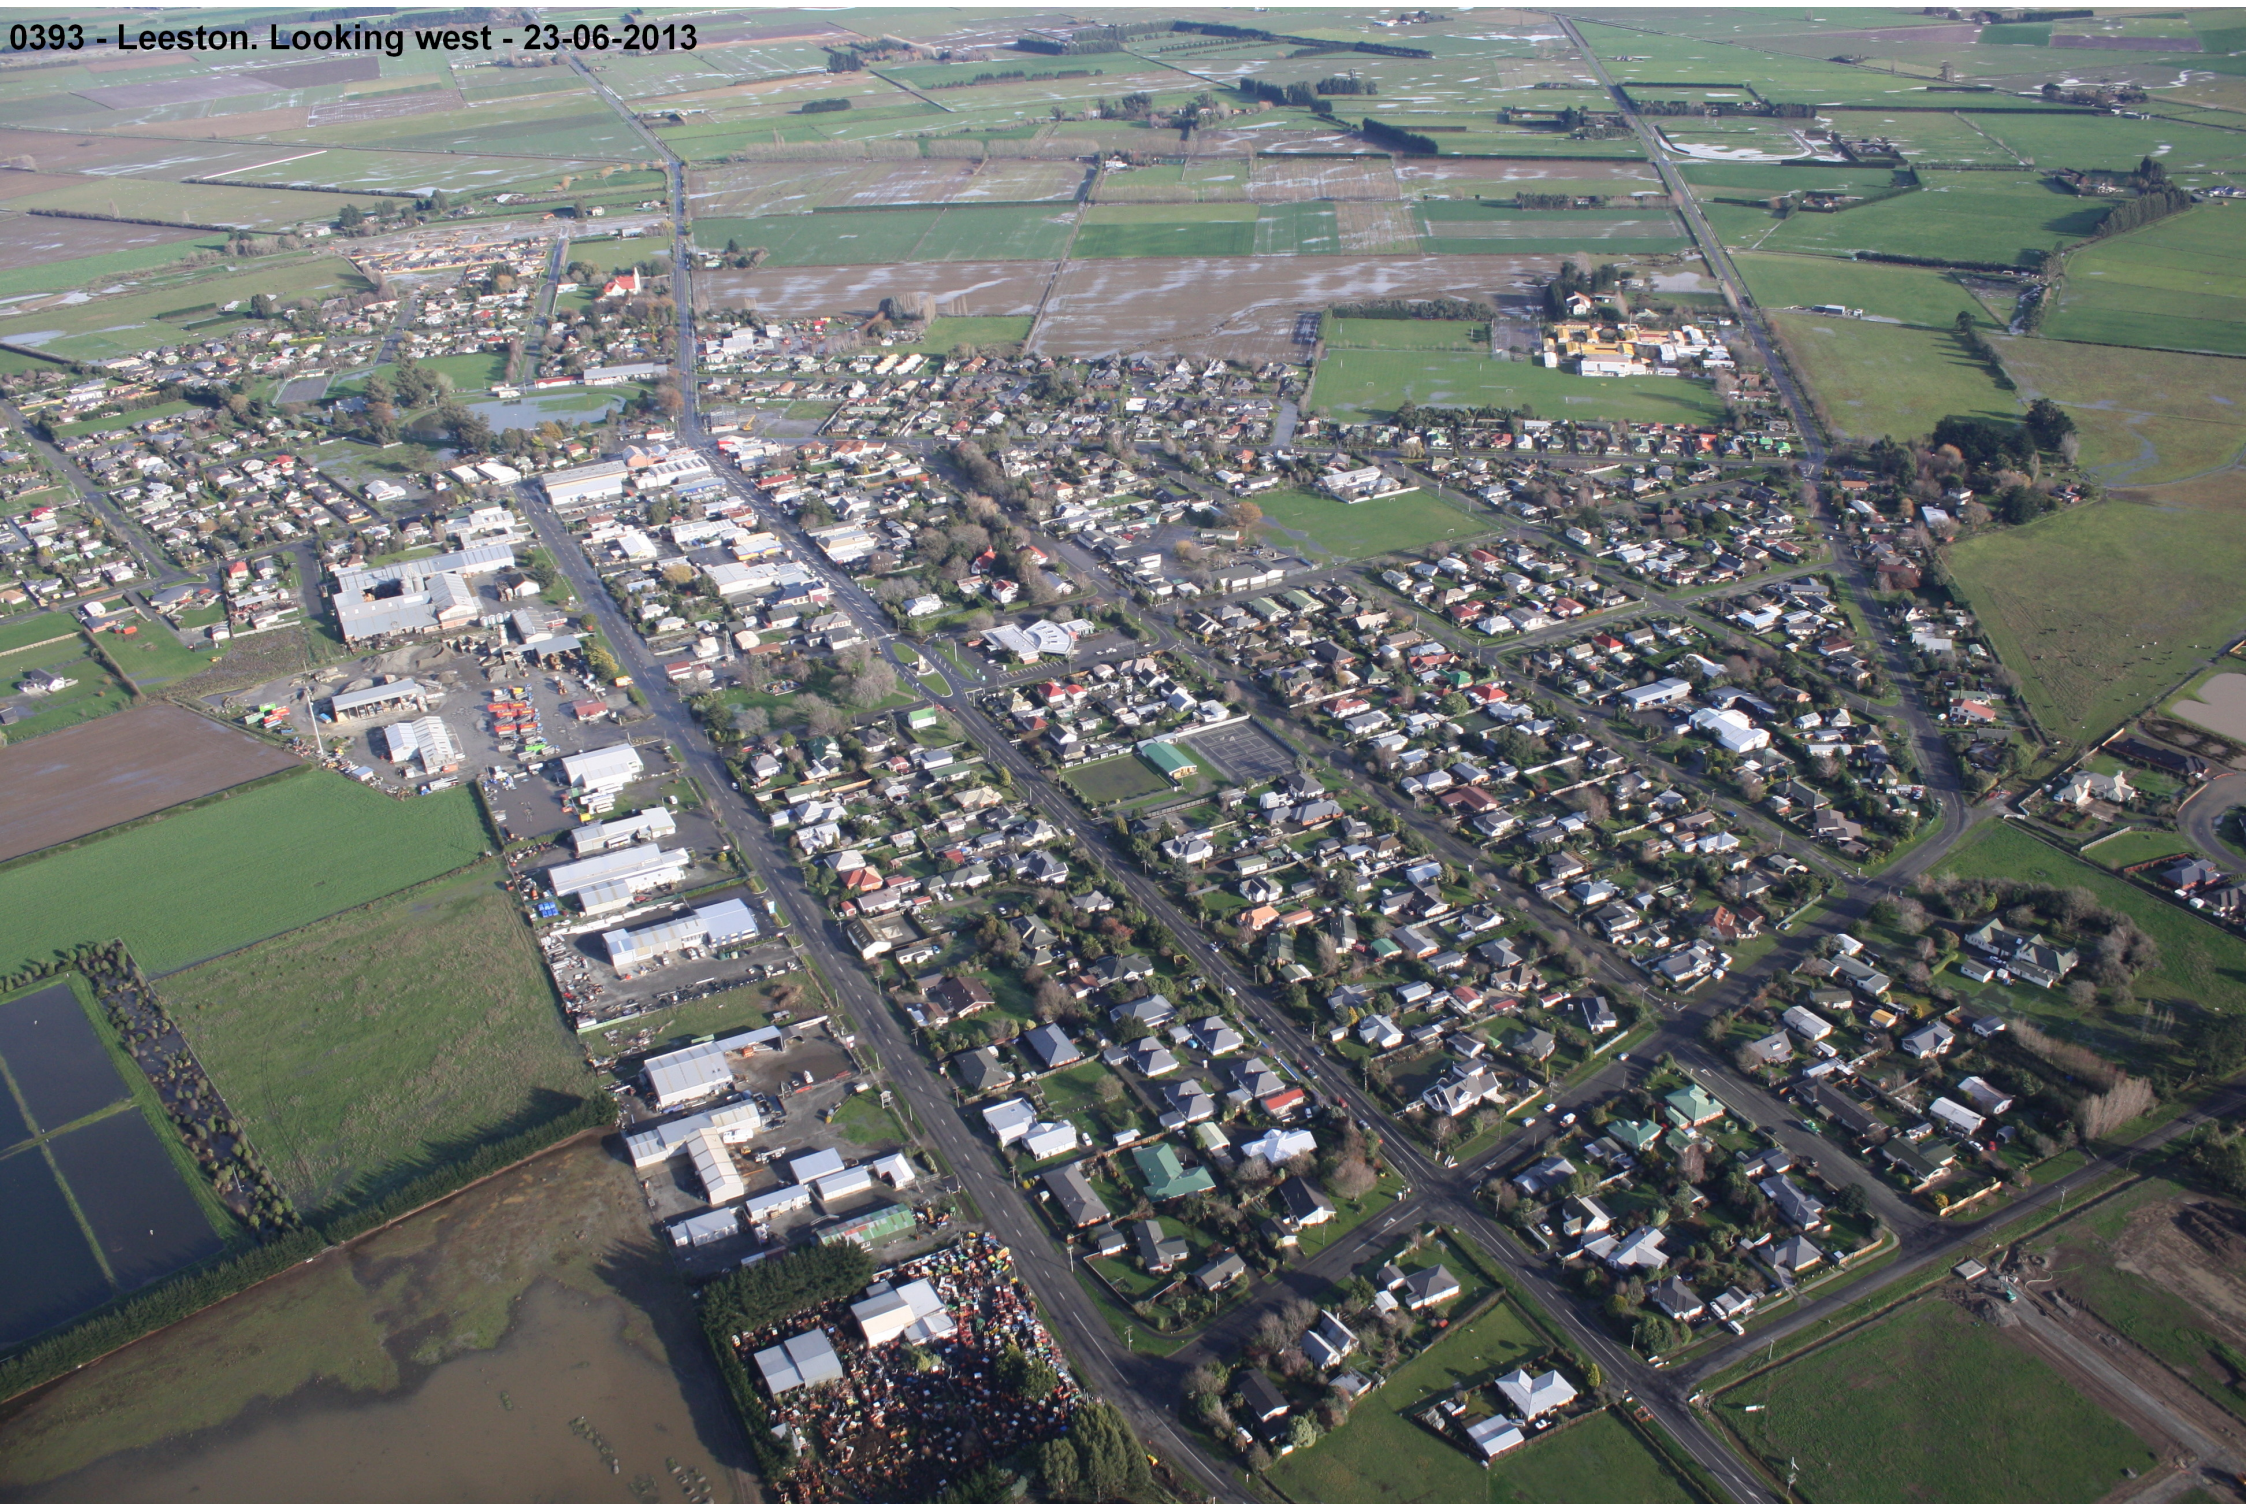
Photographs No. **0393, 0408, 0421, 0788, and 0802** were taken on 23/06/2013 following a rainfall event where 117.6 mm was recorded at Leeston in the 72 hours to 9 am on 22 June 2013. This rainfall had a return period of approximately 10 years, however this was following a rainfall of more than 60 mm earlier in the week.

0393 - Leeston. Looking west - 23-06-2013

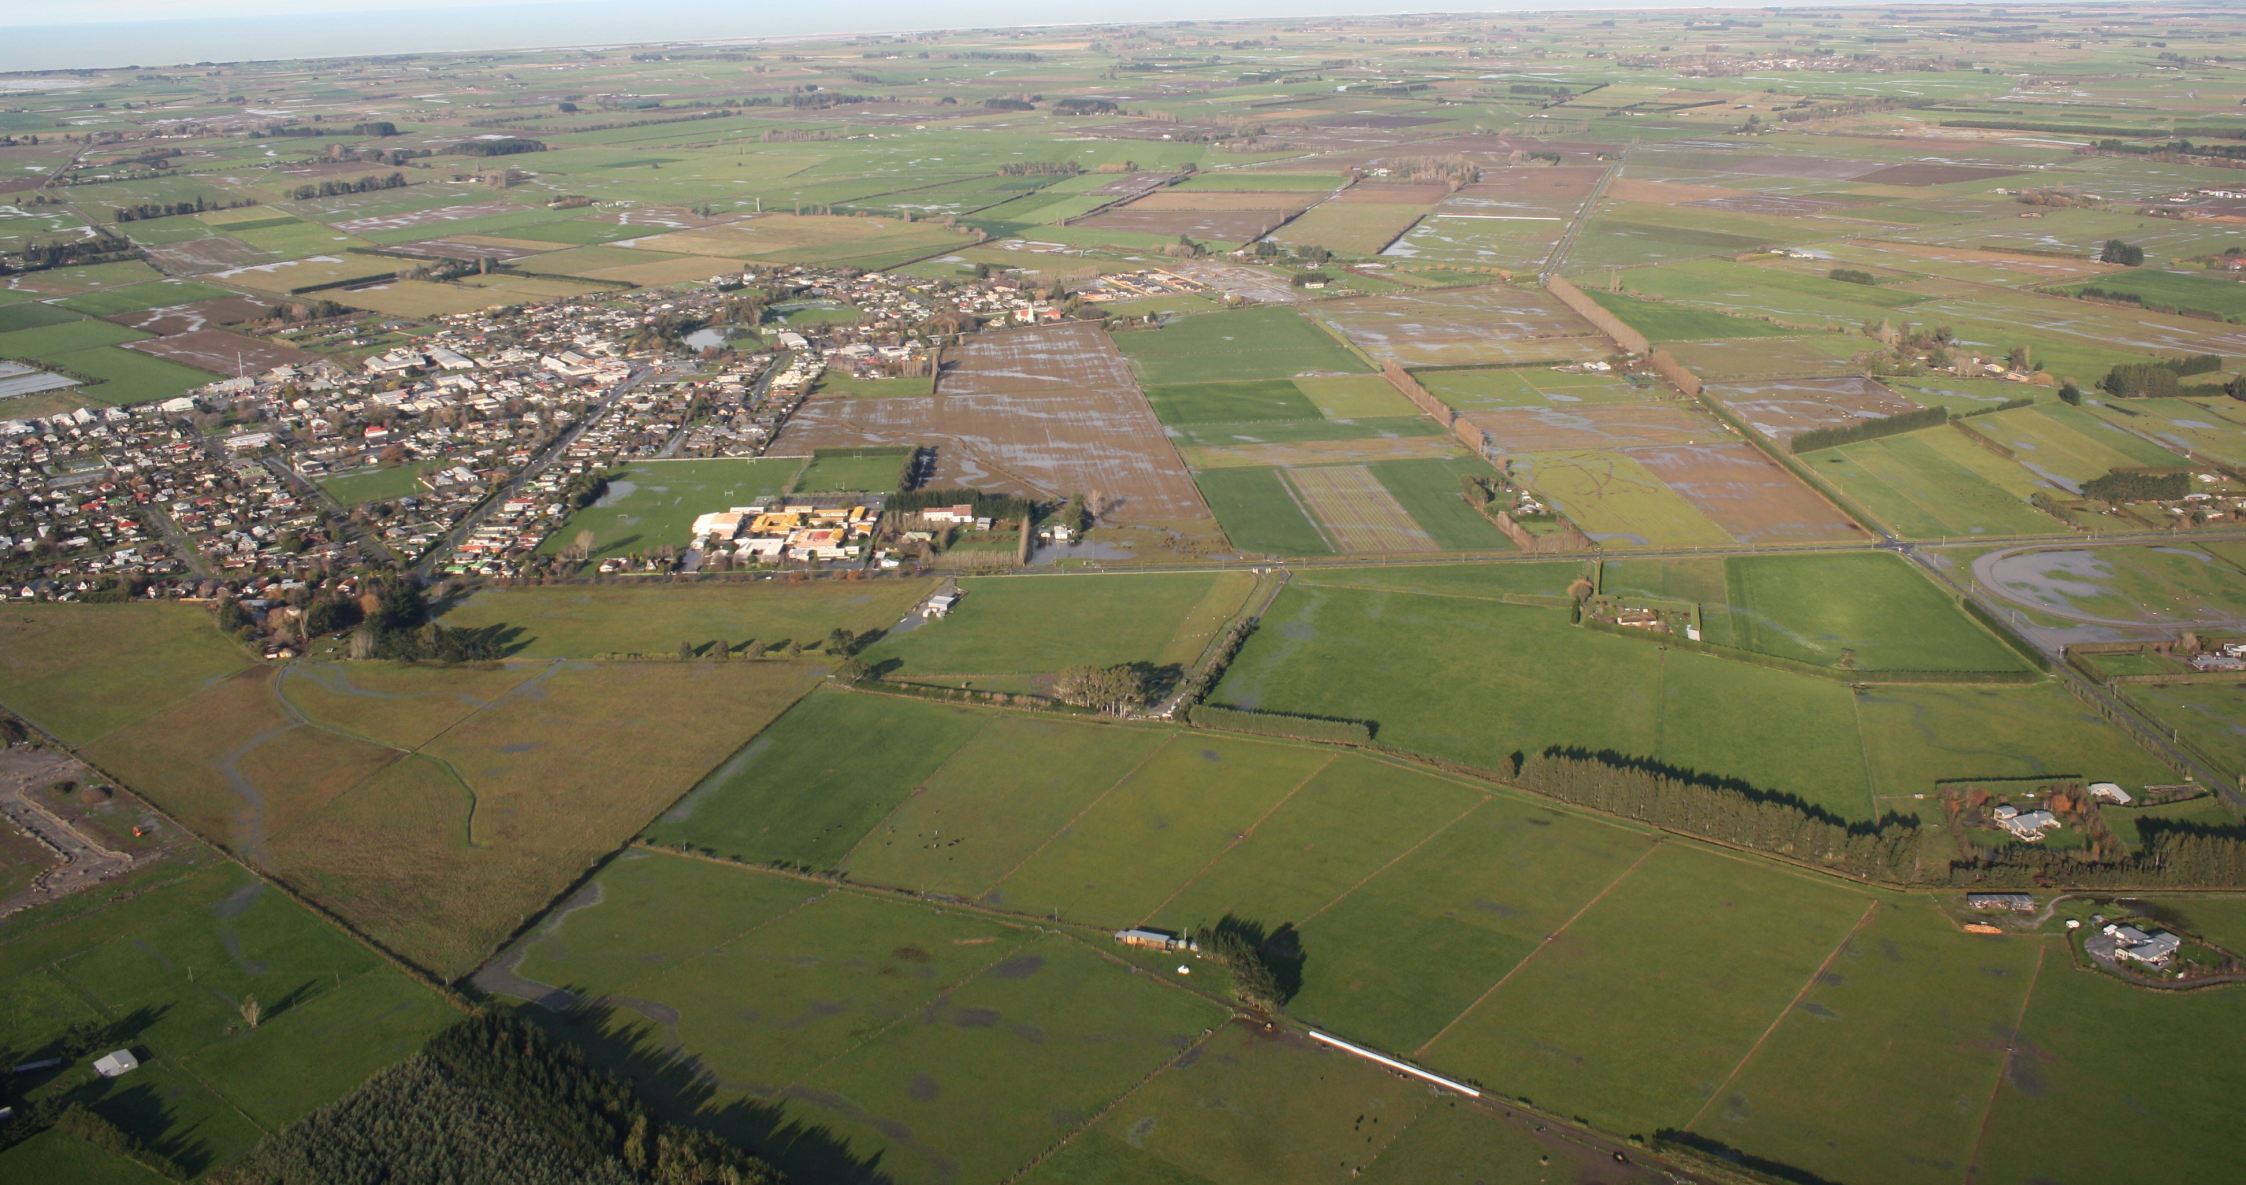
0408 - Leeston. Looking south toward Leeston Dunsandel Road - 23-06-2013

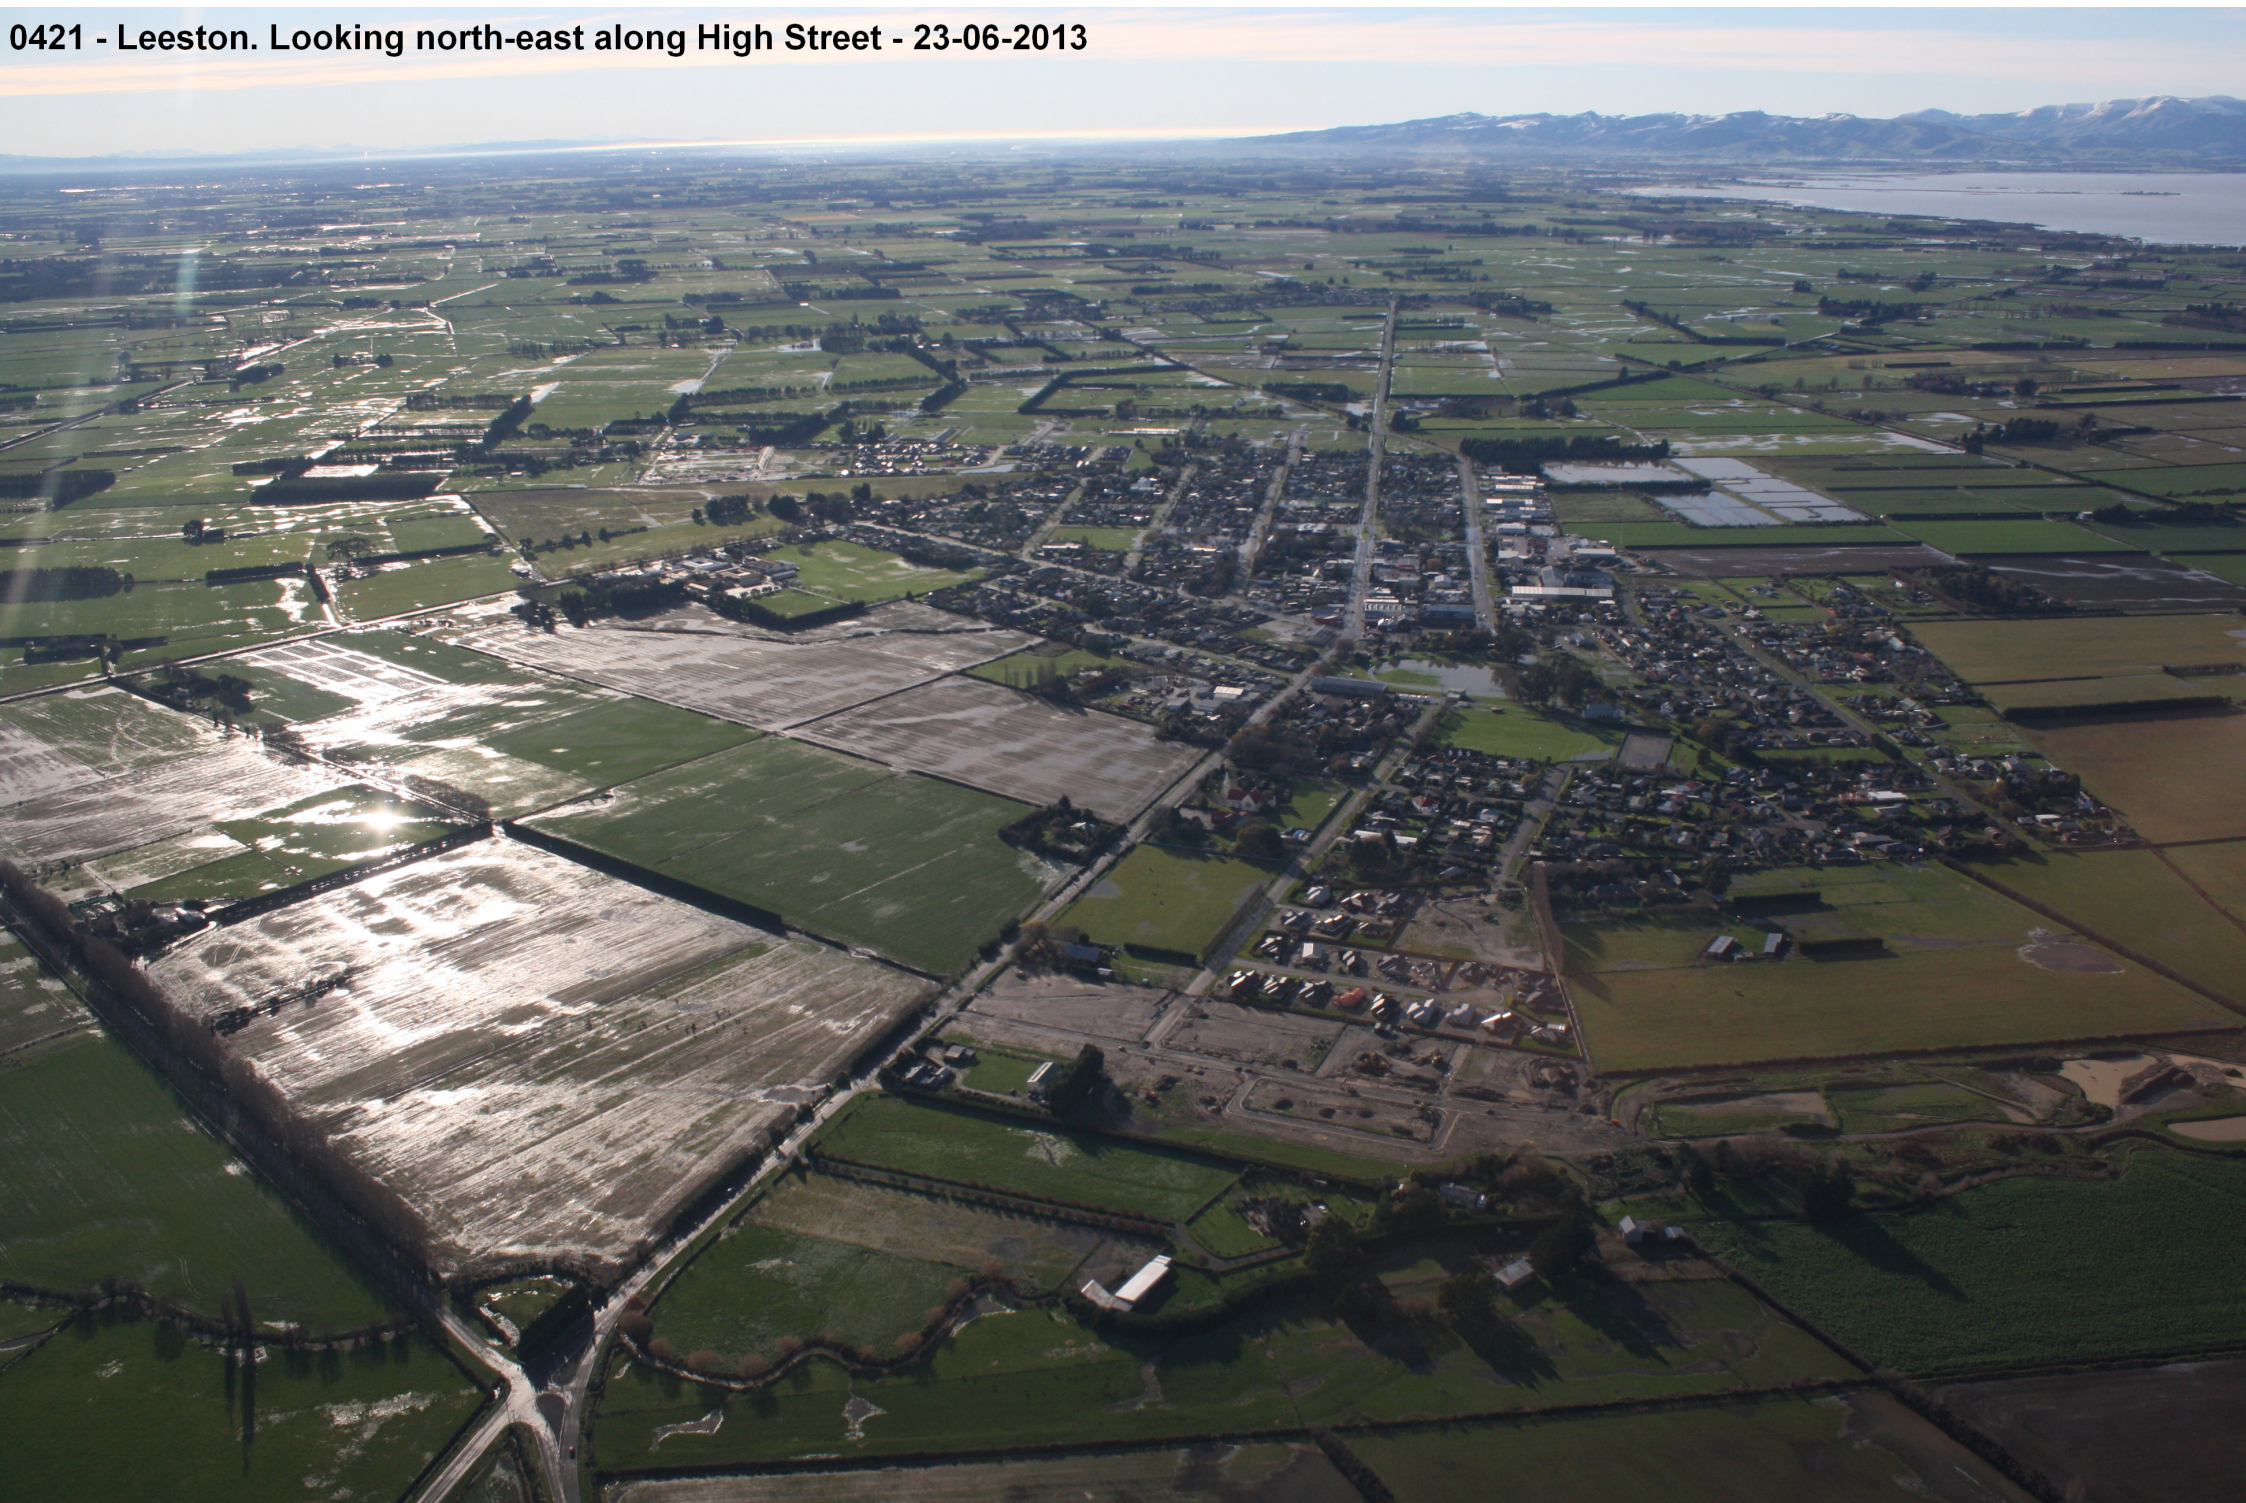
0421 - Leeston. Looking north-east along High Street - 23-06-2013

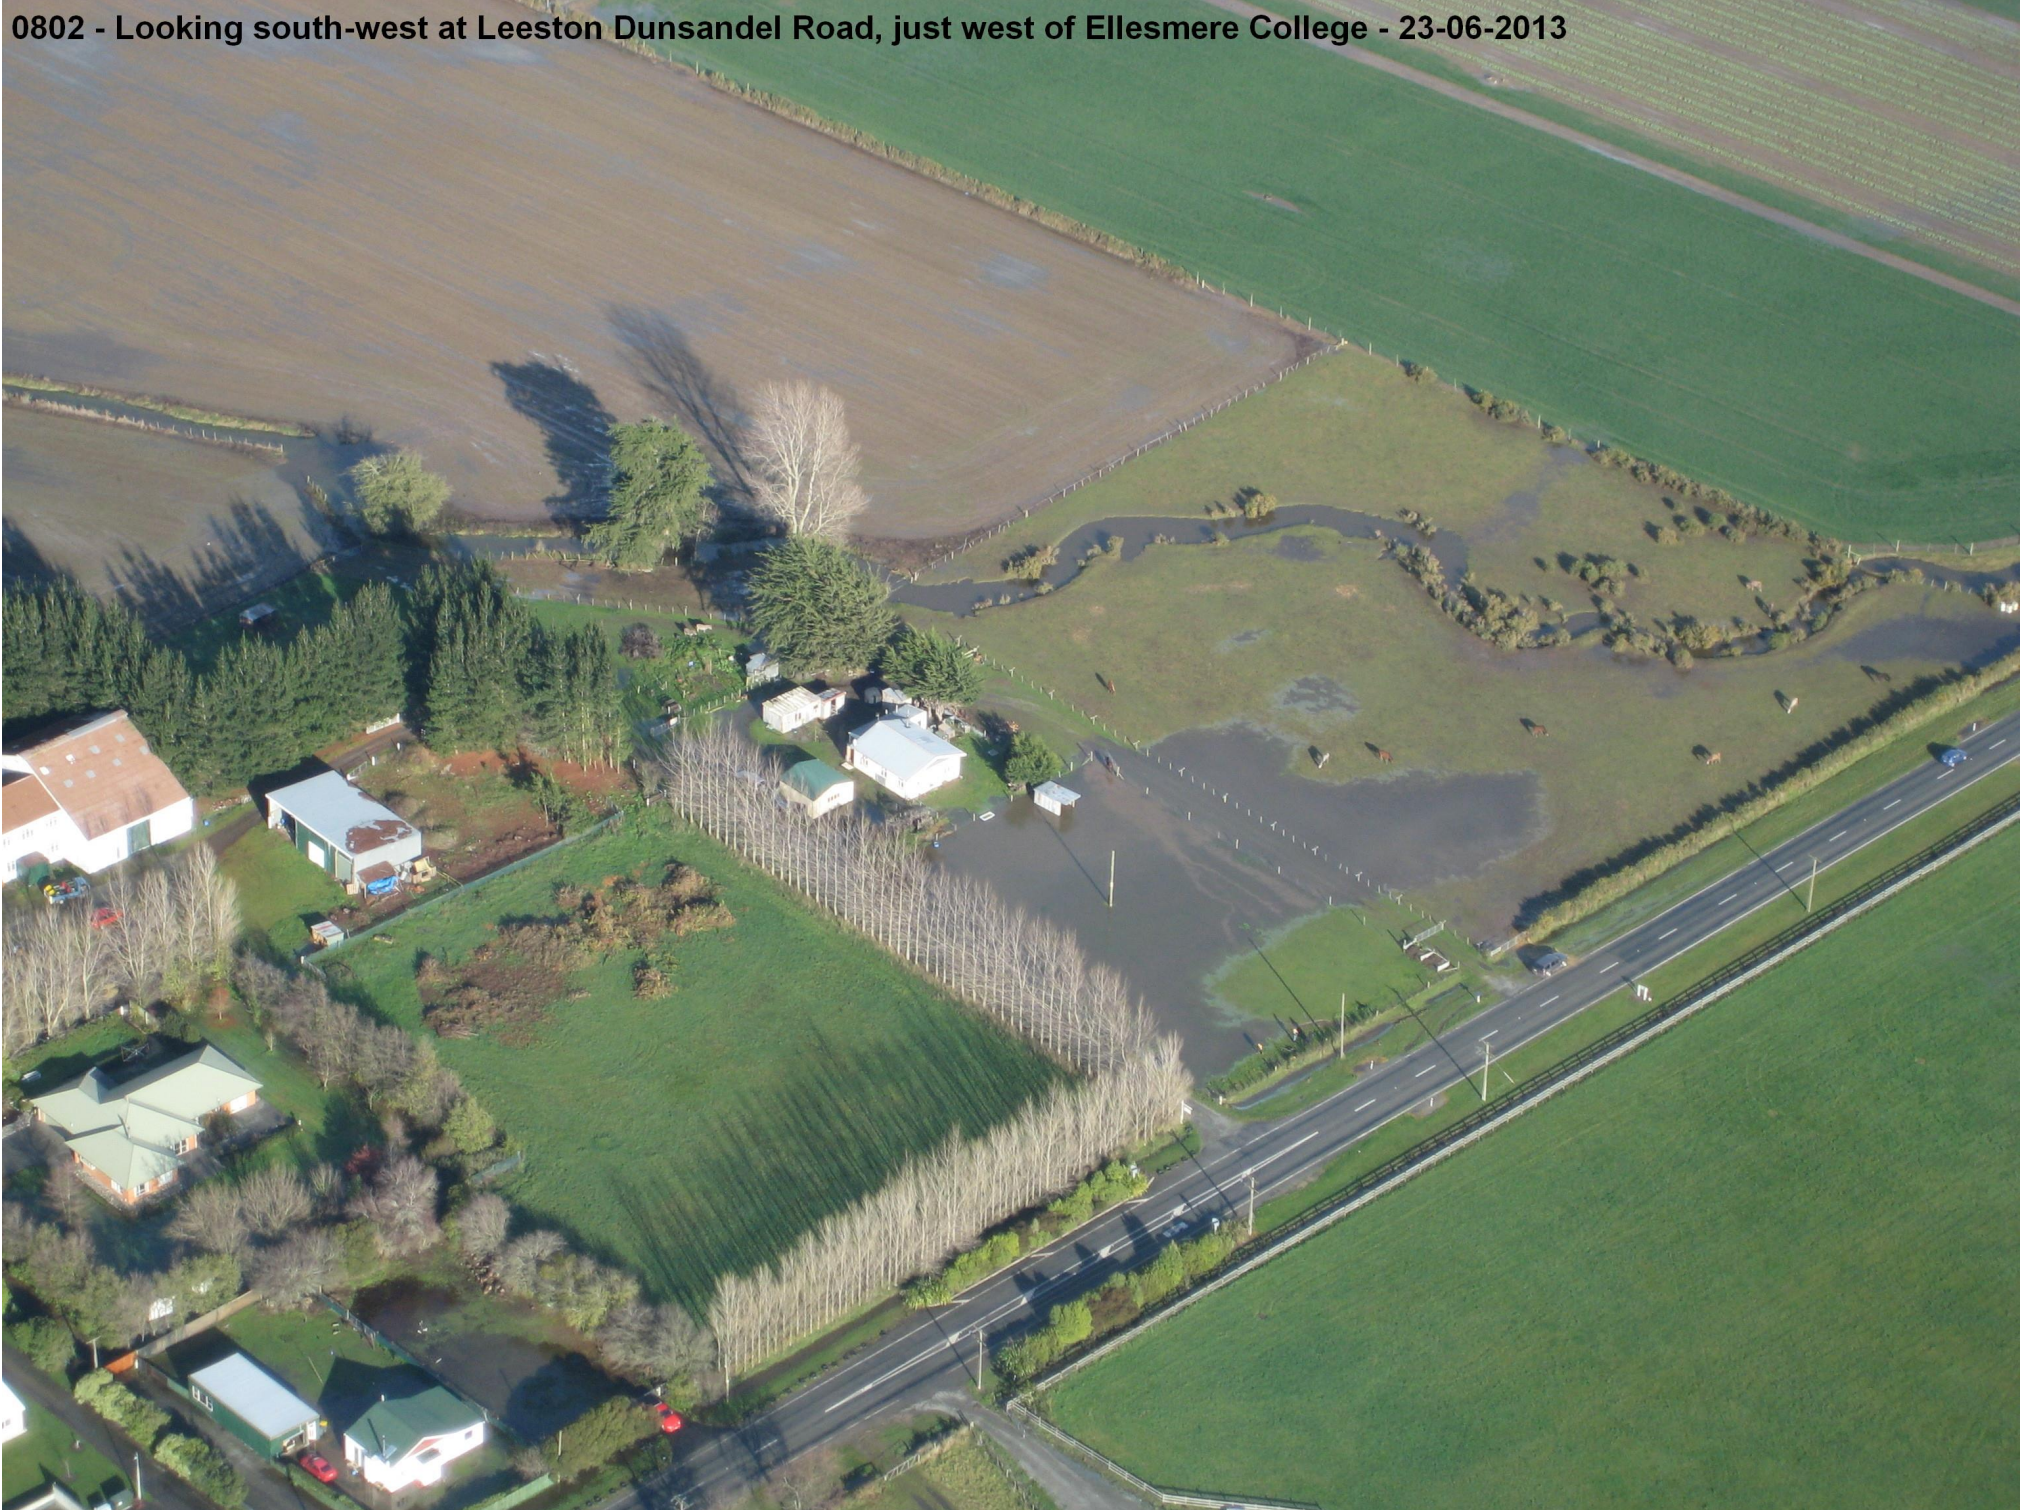
0802 - Looking south-west at Leeston Dunsandel Road, just west of Ellesmere College - 23-06-2013

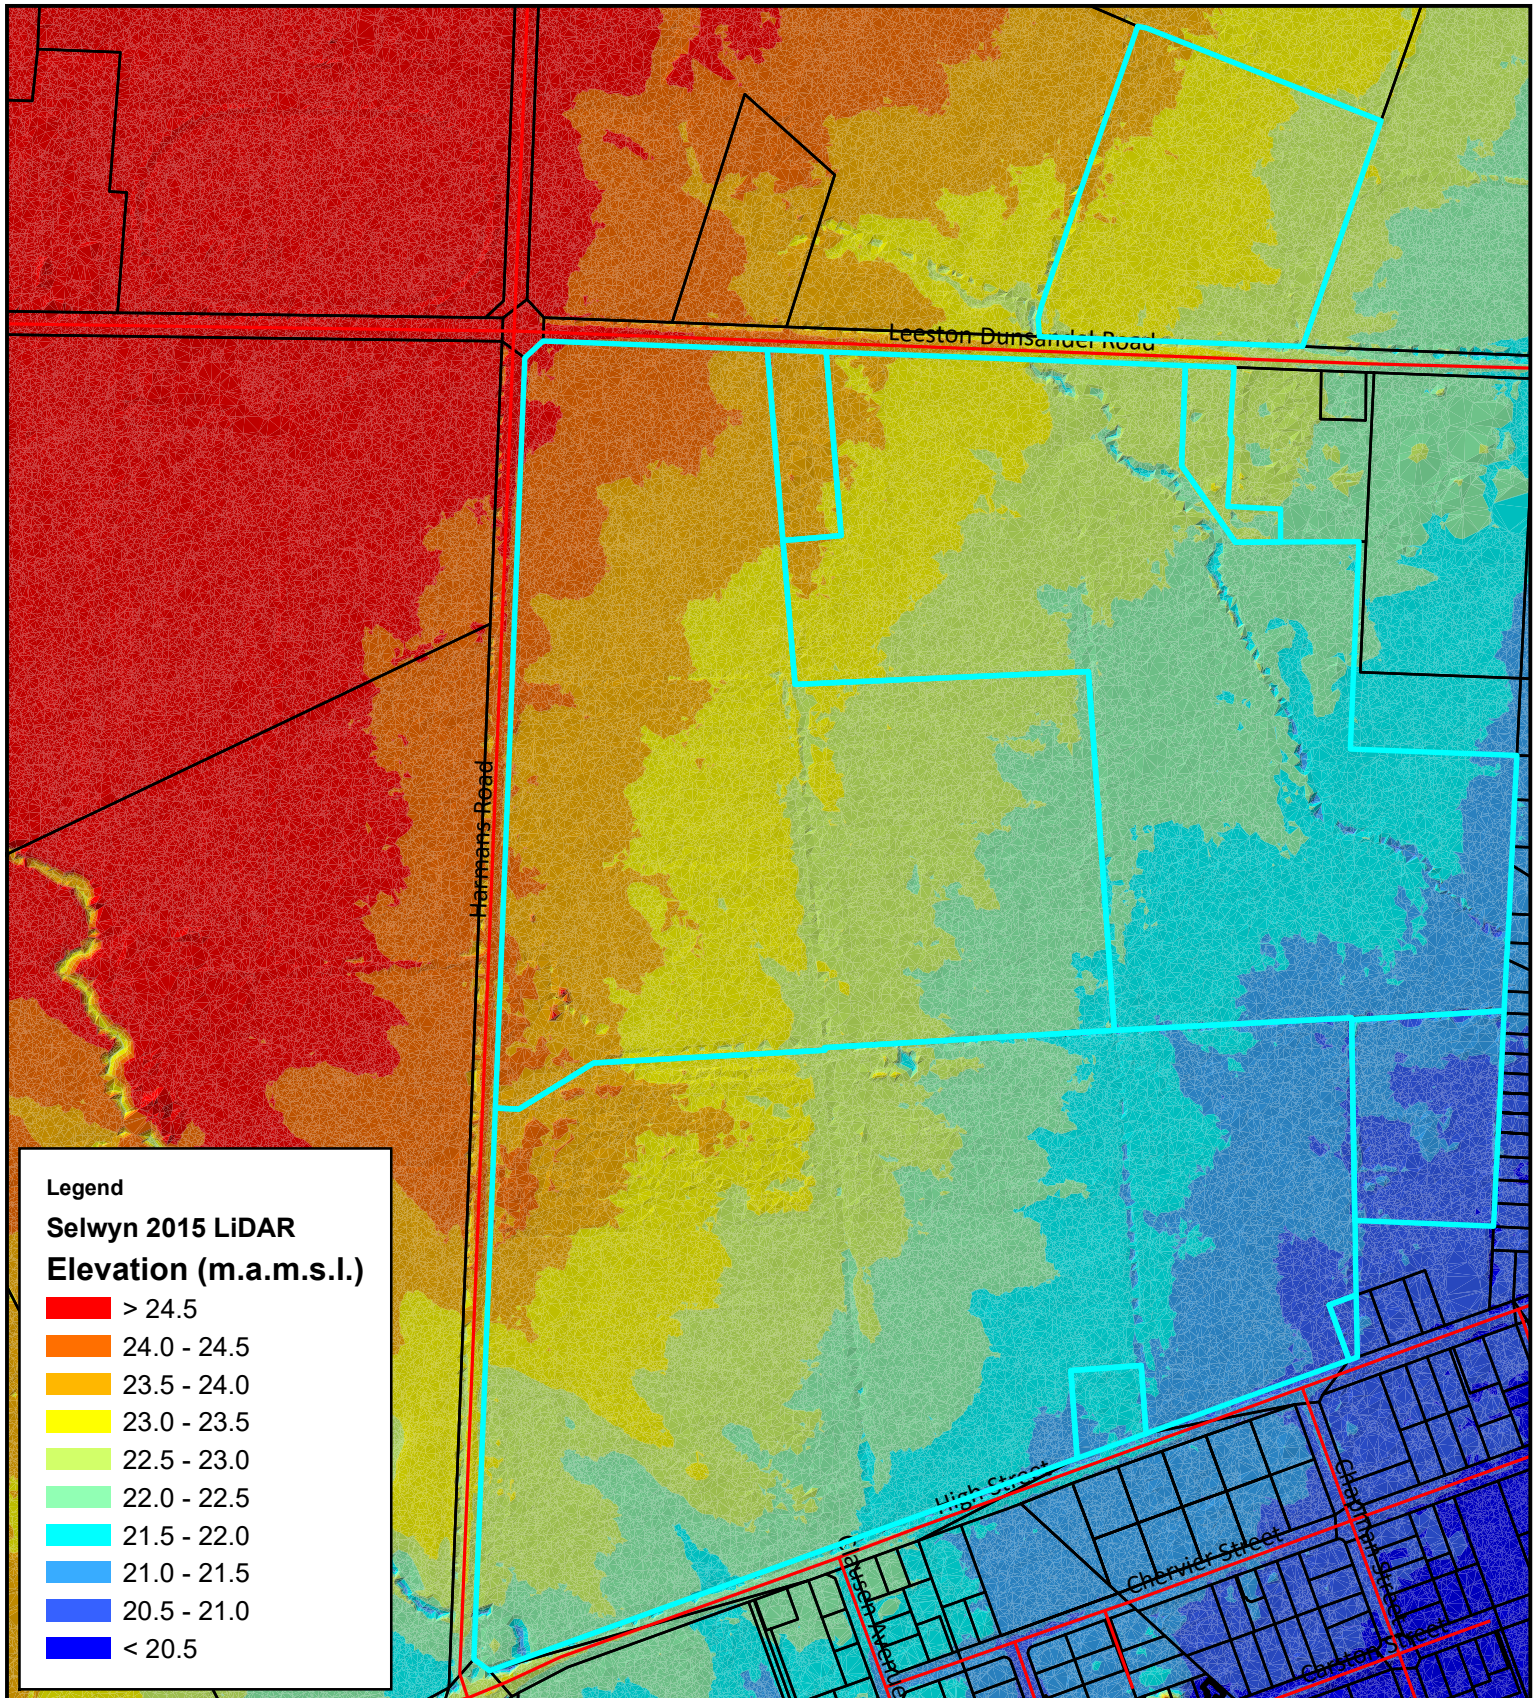
# High Street, Leeston - 2015 LiDAR Map

The property is within part of the Selwyn District that has been flown by LiDAR; an airborne laser system that maps the ground topography. The accuracy of this topographical survey is considered to be in the order of  $\pm 150$  mm or better. Enclosed for your information is a **map showing ground level variations** at the property derived from LiDAR data obtained in 2015. These levels are presented in meters above mean sea level (m.a.m.s.l.) – Lyttelton 1937 Datum.
