**RE:    Geotechnical Summary Letter - Faringdon West, Rolleston, Christchurch**  
**(Our Reference: 12903.000.000\_100)**

## 1     Introduction

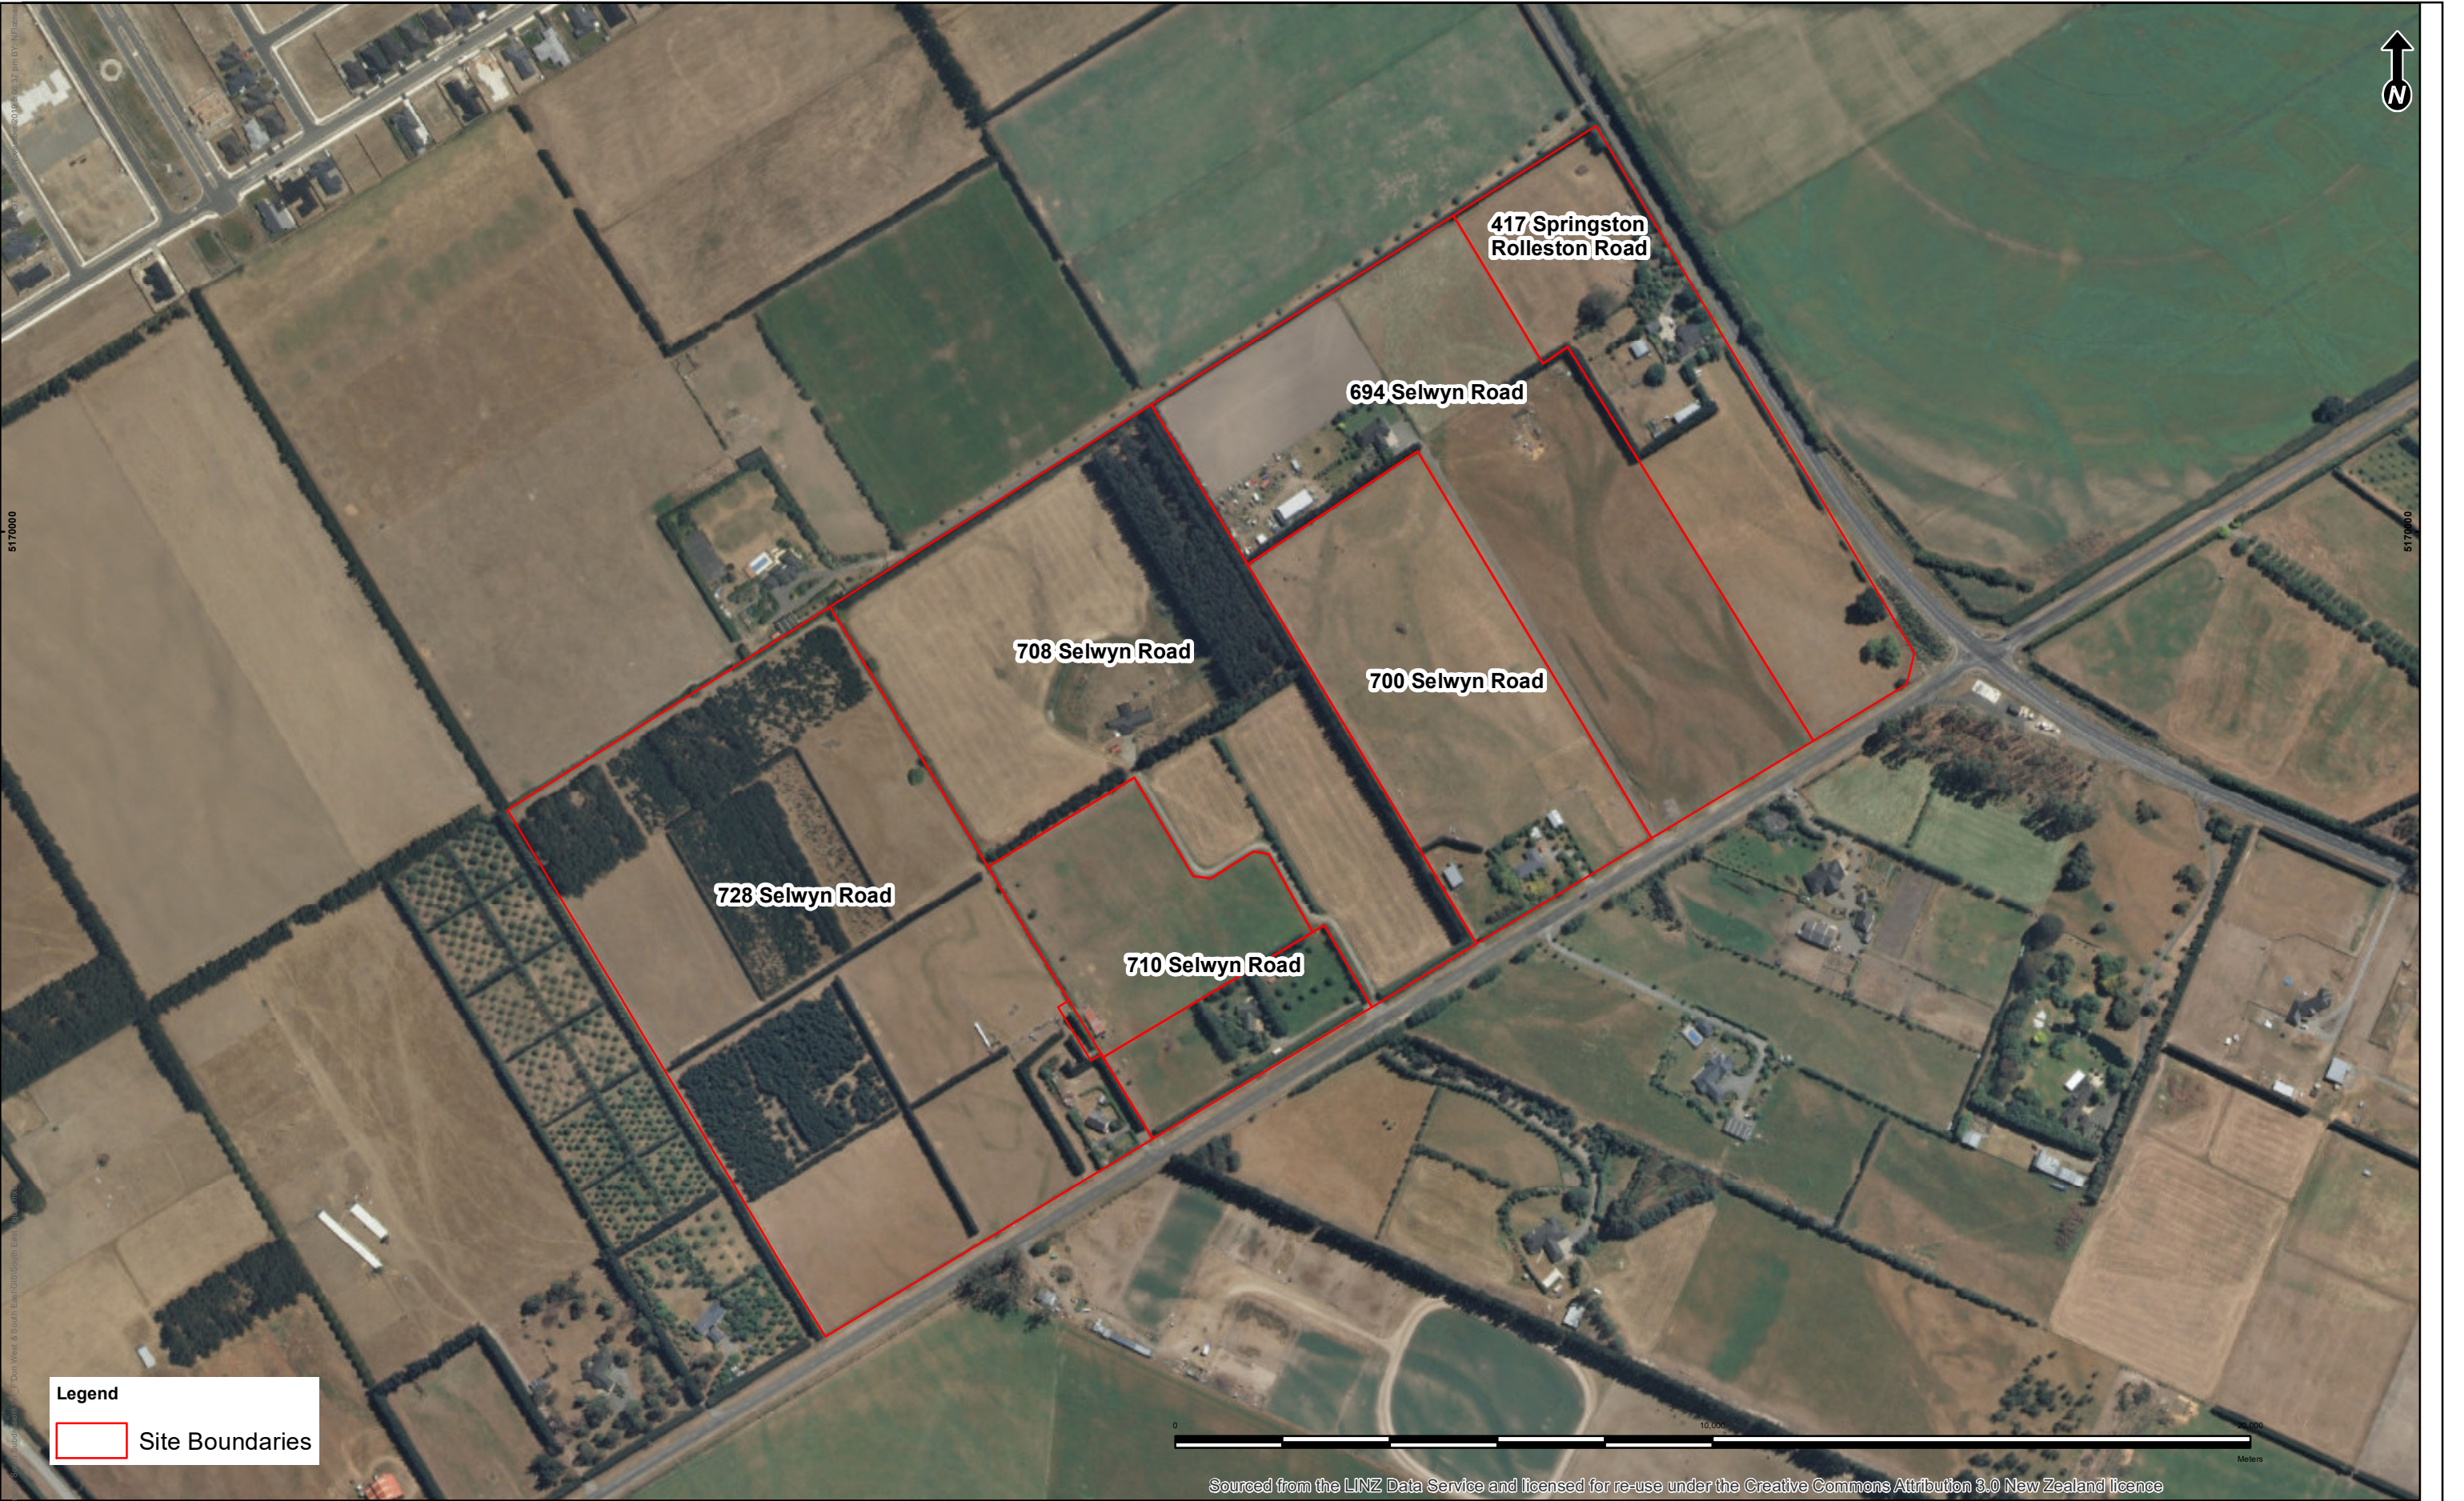
- Site plan

We understand that the Faringdon West development is the area bordered by East Maddisons Road, Selwyn Road and Goulds Road, southwest of the existing Faringdon Development. The approximate site location is shown in Appendix 1 of this report. ENGEO has previously completed the following geotechnical reports within this site:
