Appendix 6: Geotechnical Investigation and RFI response letter

PC200072: TRICES ROAD REZONING GROUP PRIVATE PLAN CHANGE- RESPONSE TO REQUEST FOR FURTHER INFORMATION

PRIVATE PLAN CHANGE TO THE
OPERATIVE SELWYN DISTRICT
PLAN AND SUBMISSION ON
SELWYN DISTRICT PLAN REVIEW,
TRICES ROAD AREA,
PREBBLETON

GEOTECHNICAL INVESTIGATION REPORT

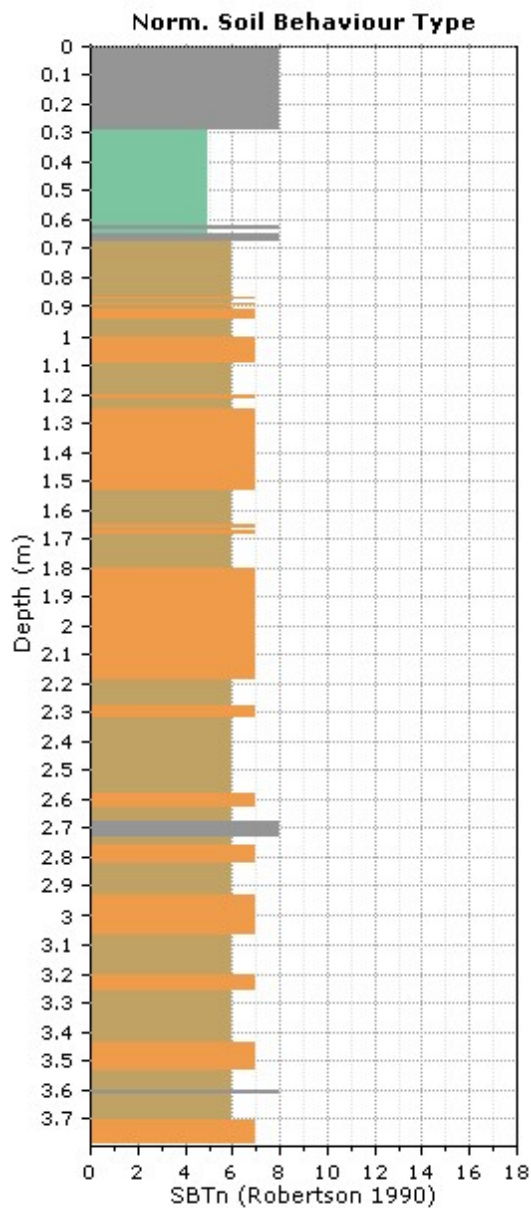
CPT 3

Cone Penetration Test (CPT) Results
