## **Appendix F**

### **Ecological Assessment**

### **Ecological values in two Rolleston Blocks (Rolleston West Residential Ltd.)**

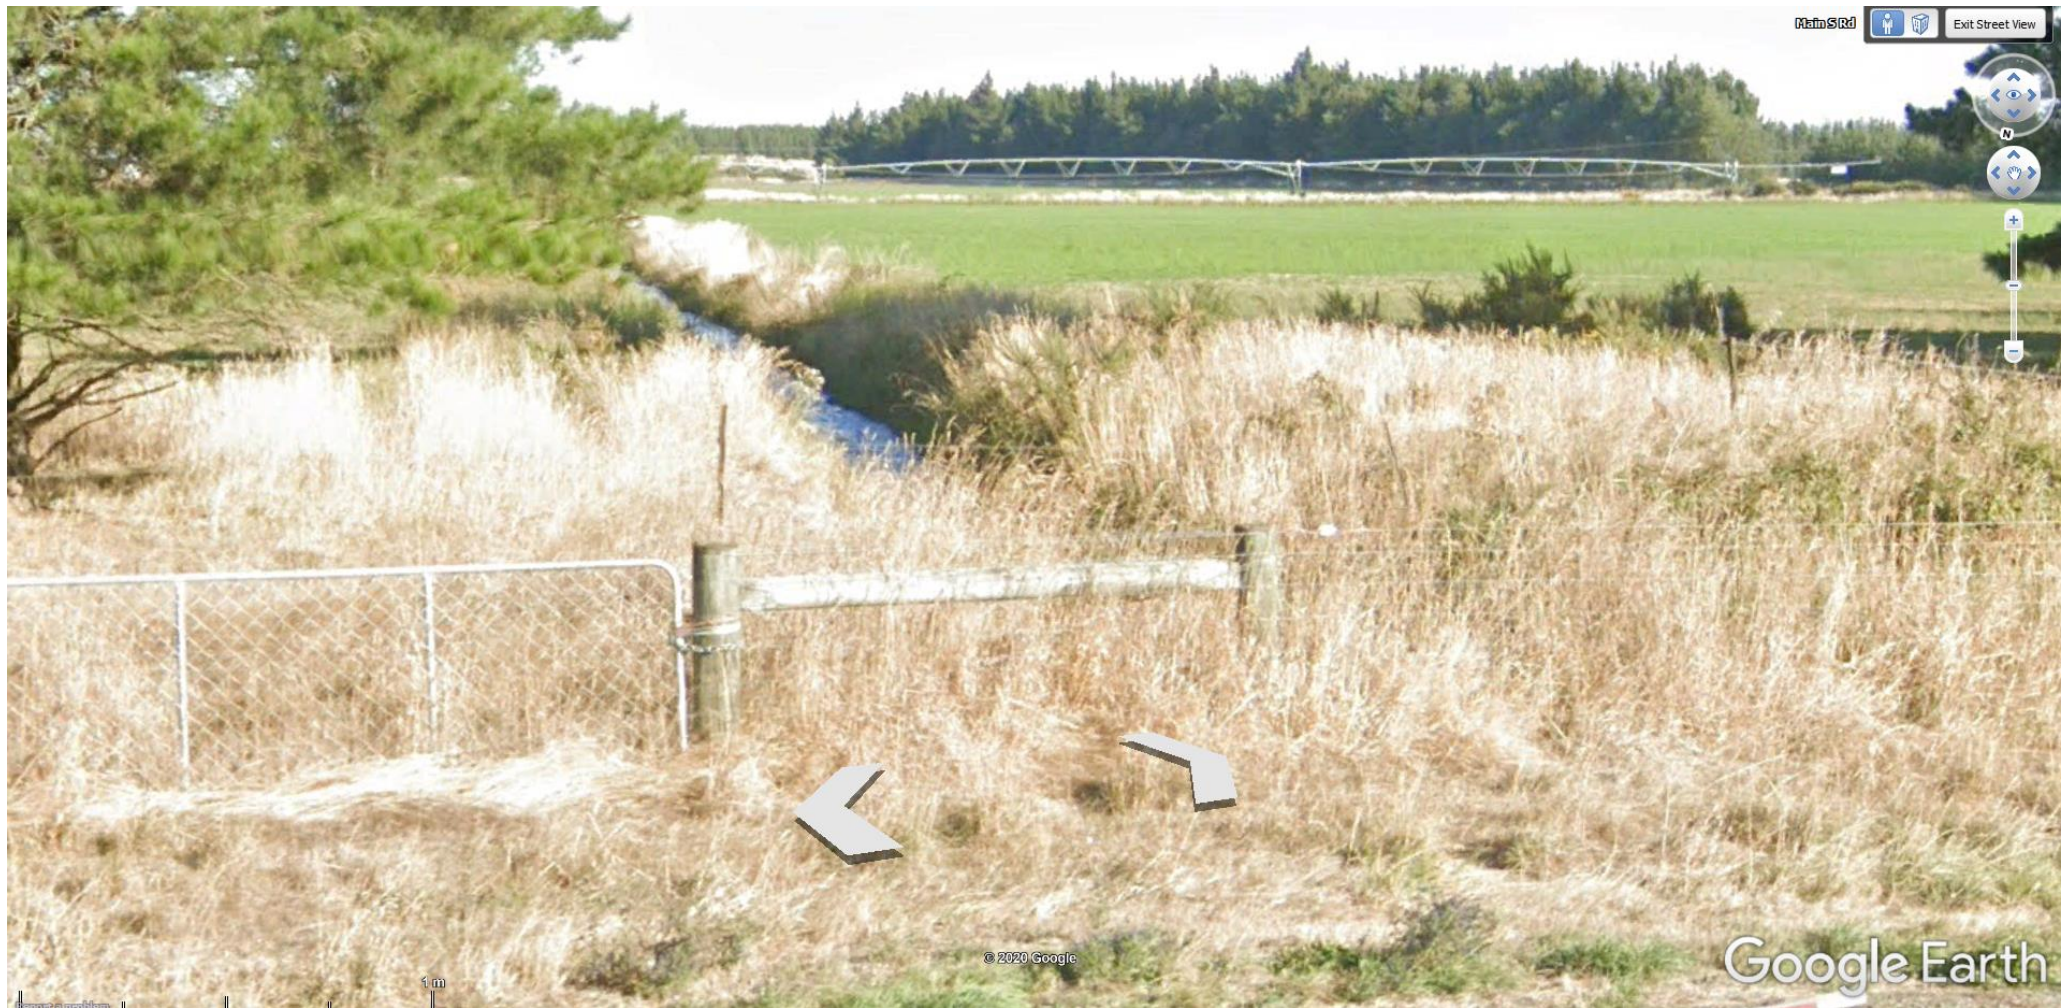
**App. I. Figure iii.** Looking south and downstream from SH1 at the irrigation raceway entering the north boundary of the Holmes Block, March 2020.

The irrigation raceway passes through the Holmes Block in the west corner of the property before it turns west and crosses into land owned by Selwyn District Council (App. I. Fig. ii). The raceway has recent (March 2020) Google Streetview® photos available, looking downstream from SH1 (Main South Road) (App. I. Fig. iii), and another recent Streetview® photo is available looking upstream from Burnham School Road (App. I. Fig. iv). In addition, a recent site visit provided photos presented in App. II. The raceway appears to be within the swinging arc of a pivot irrigator. To prevent impediment of the irrigator the waterway appears to be unfenced and has a buffer of a few metres of grassy vegetation (App. II, Fig. i). The raceway is shallow and has a gravel base in most reaches (App. II, Fig. ii), and culverted where it corners by 90° within the Block.

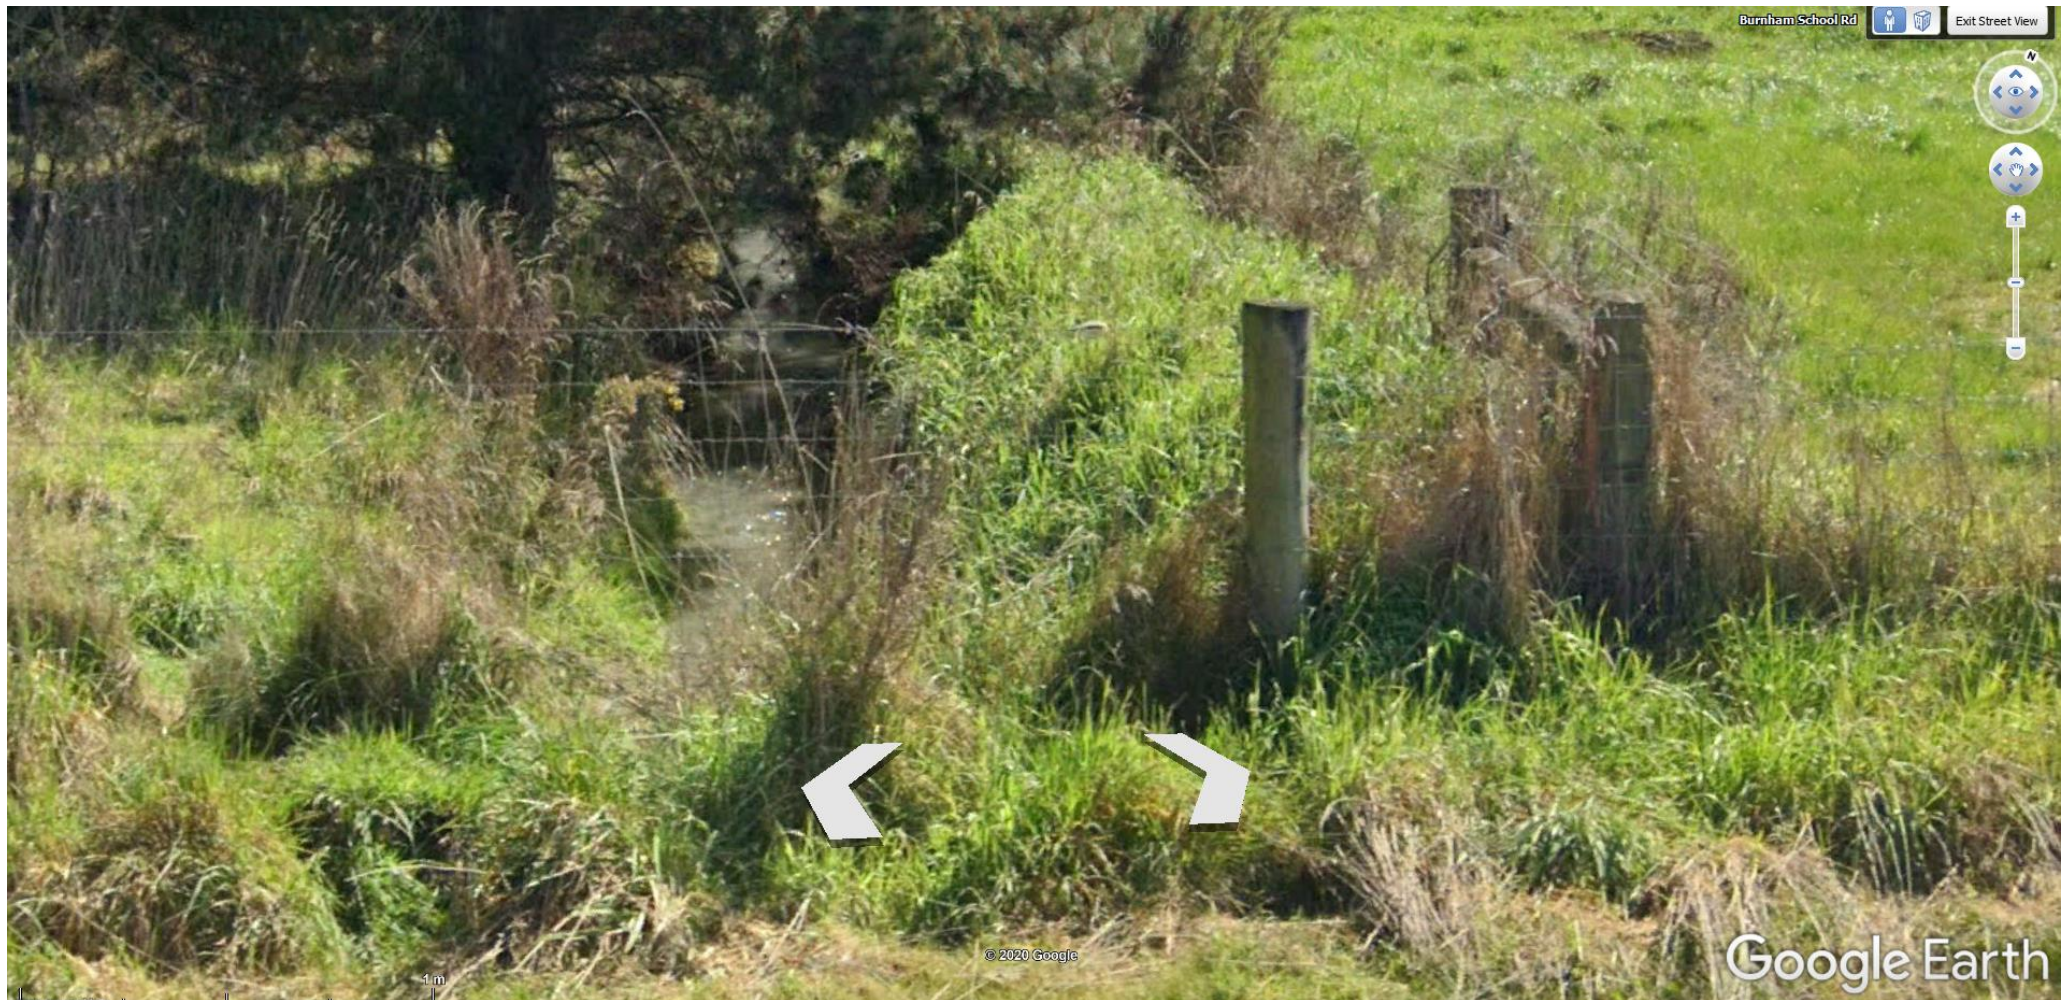
**App. I. Figure iv.** Water race at Burnham School Road, (September 2019), looking upstream (north) into the Selwyn District Council land, at the SW corner of the Holmes Block.

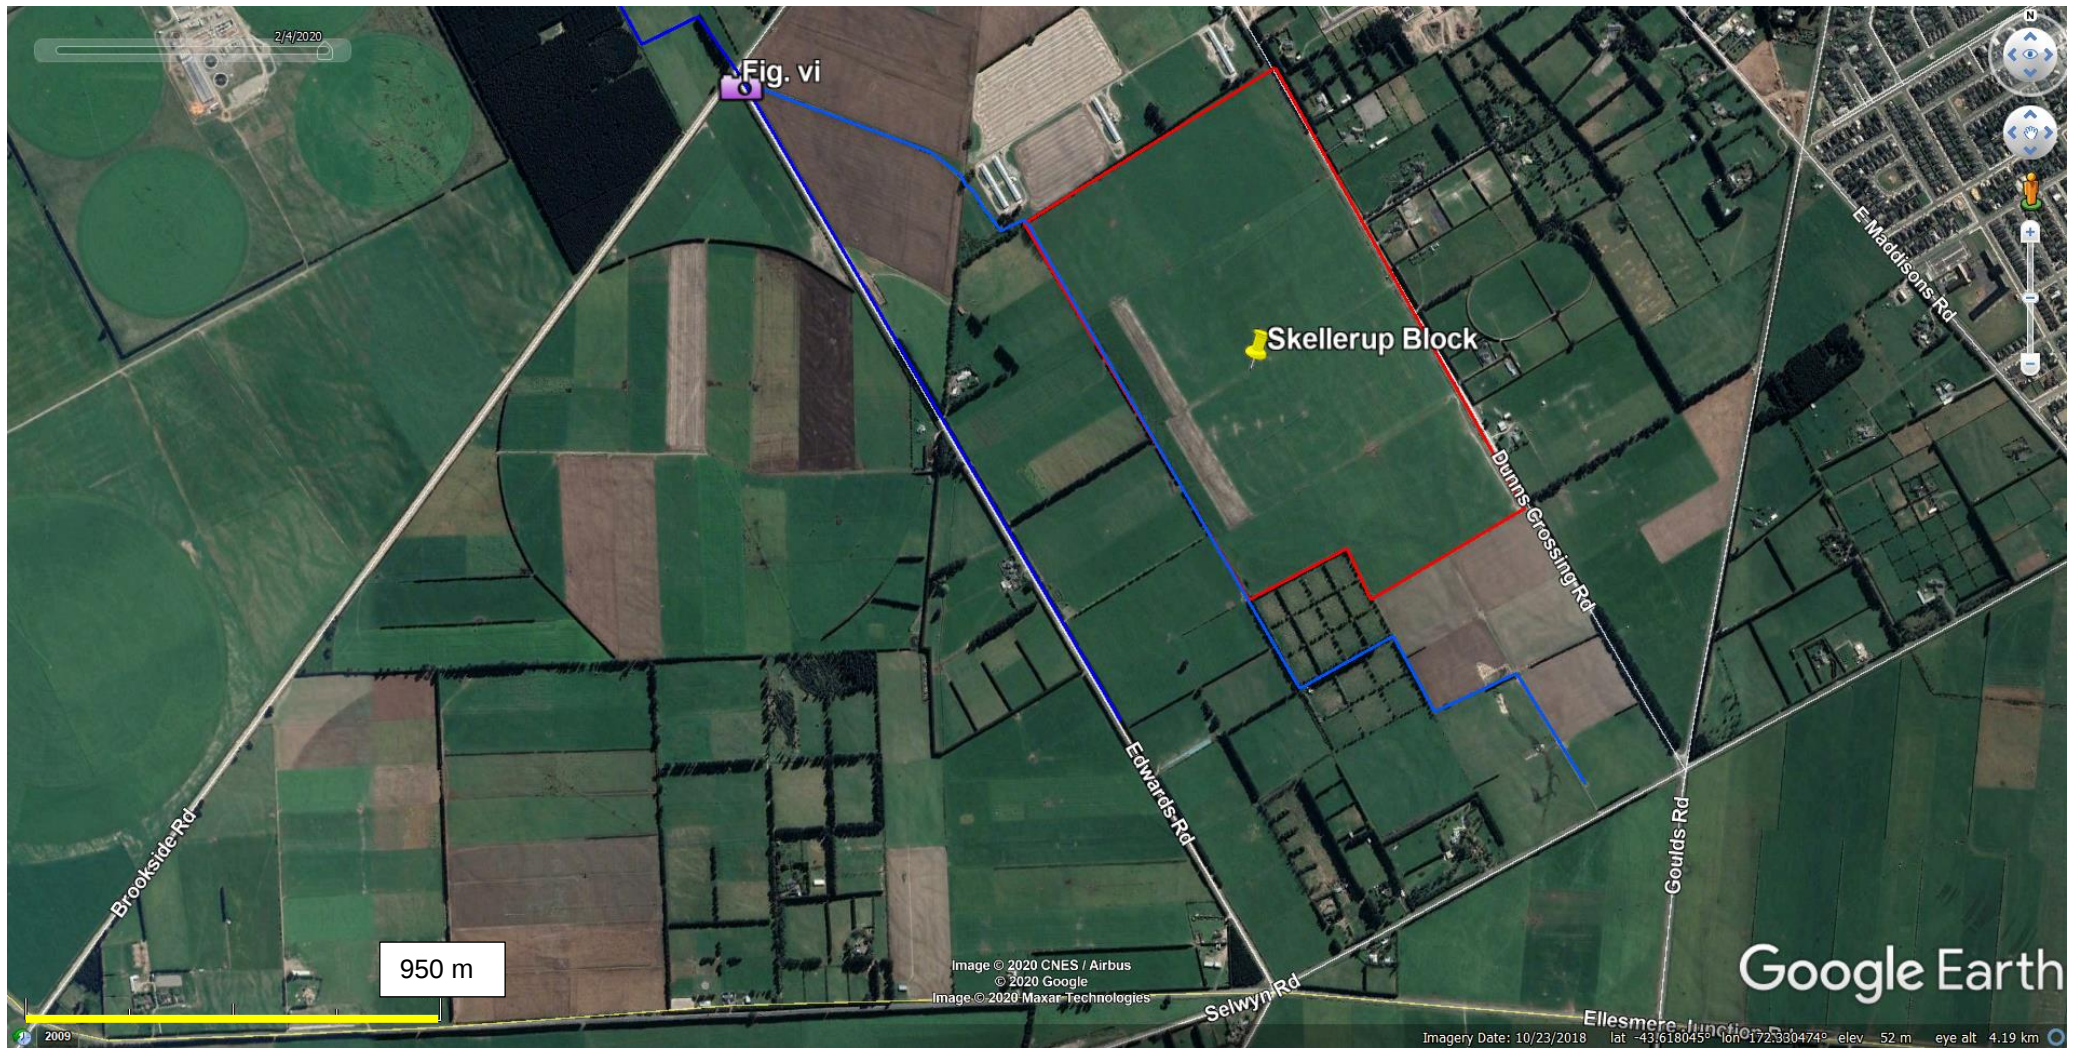
**App. I. Figure v.** The raceway network path (blue line) along the west boundary of the Skellerup Block (red line).

This block is at the terminus of a minor irrigation feed, with a pathway depicted in App. I. Fig. v. I understand this waterway is beyond the western boundary of the block but will provide comments anyway. There is a Google Streetview® photo where the waterway diverts away from Edwards Road (App. I. Fig. vi), which depicts a perennial channel with good fish cover elements. Based on the latest Google aerial imagery, the channel adjacent to the Skellerup Block is well fenced from dairying land use, with a vegetated buffer strip on the west bank of approximately 7 m. The raceway departs away from the Skellerup Block in the south-west corner, and apparently, goes to ground before it reaches Selwyn Road.

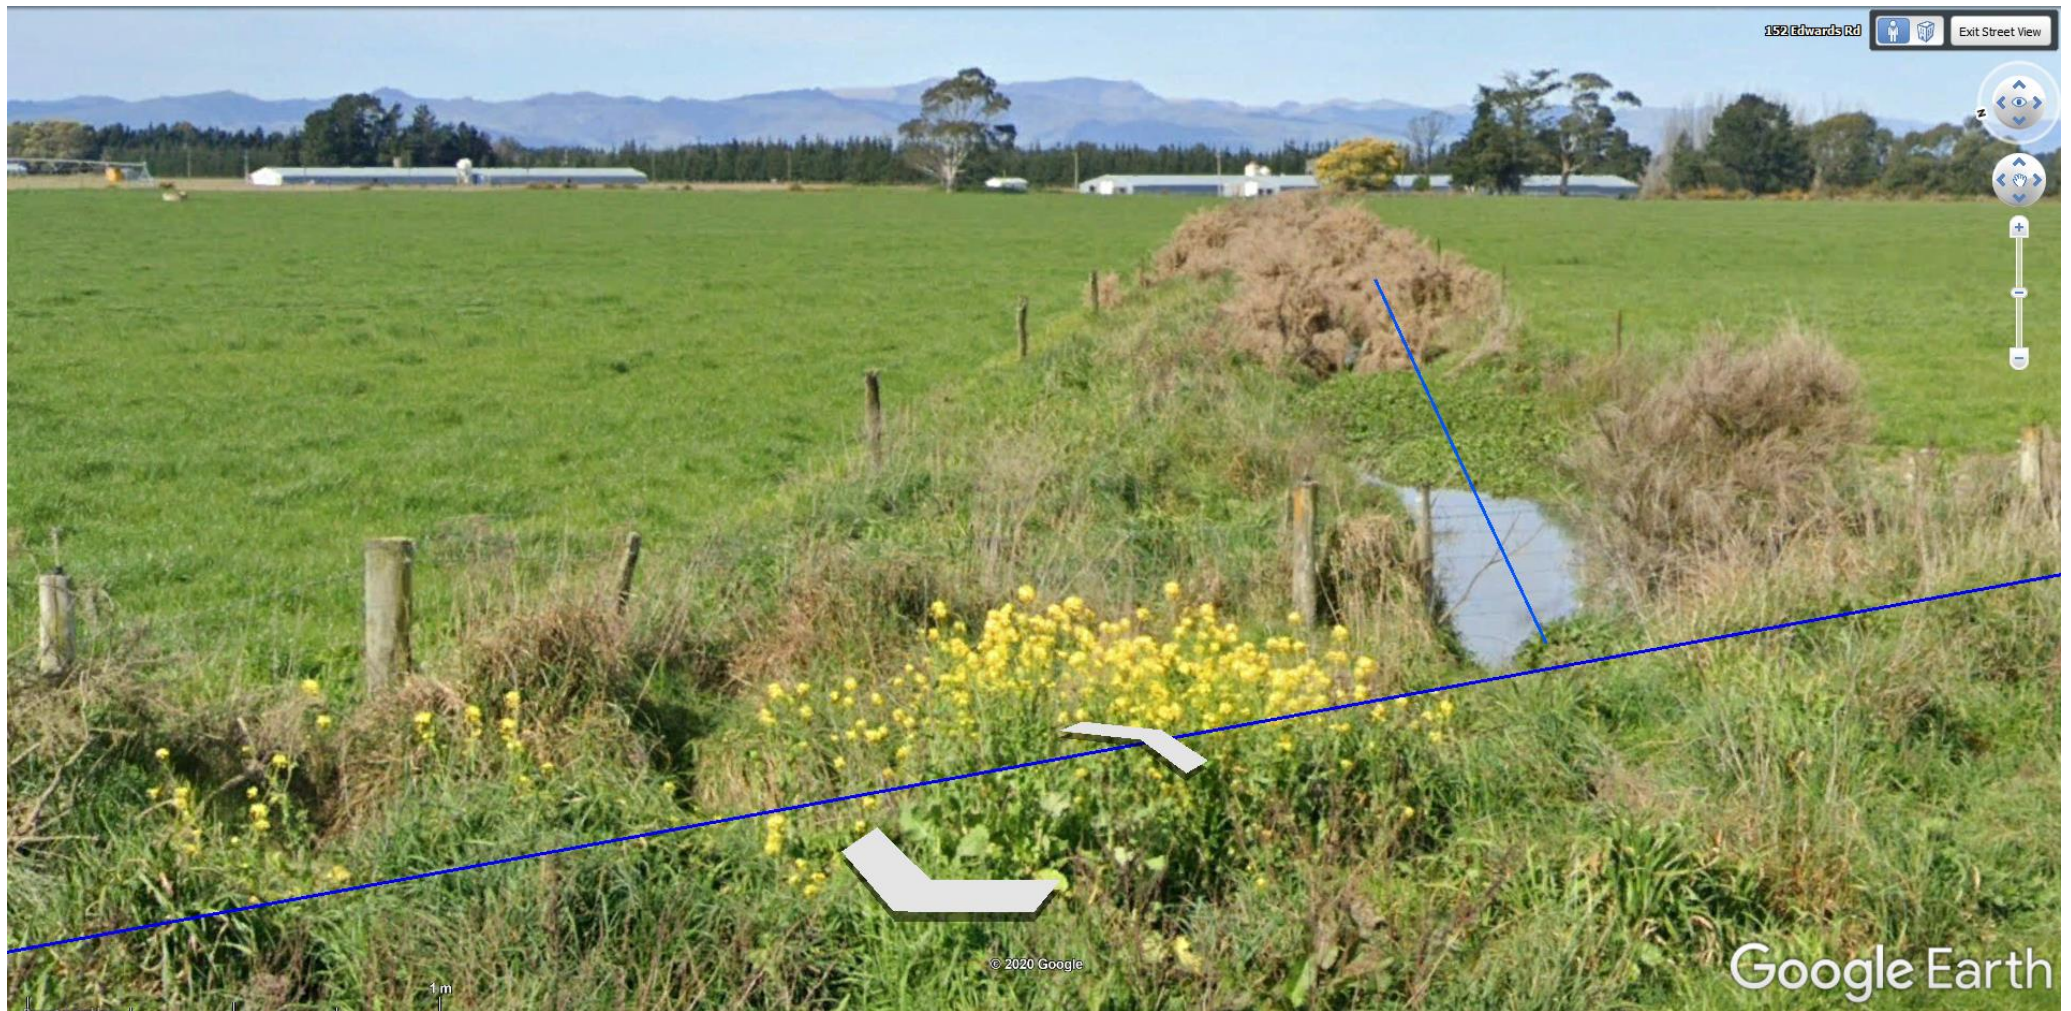
**App. I. Figure vi.** Looking east at the weedy raceway channel which further down borders the Skellerup Block (September 2019). While the broom and/or gorse appears sprayed, introduced emergent macrophytes provide a significant amount of instream cover for koura and fish, especially shortfin eels and trout.

I would expect the fish fauna to be similar to that for the Holmes Block, with a potentially higher total fish abundance due to greater depth and fish refuge. Shortfin eel habitat, in particular, is higher, but recruitment into the reach is severely restricted by the Waimakariri intake screen. Eel recruitment to the Skellerup Block is also restricted by its location far from the intake, where entrained juveniles have adopted resident habitats further upstream and closer to the intake. If present at all, shortfin eel numbers would be greater in reaches with sluggish flow and where there is marked depth of soft sediment (Jellyman *et al.* 2003). This waterway has stable banks, and it is possible freshwater crayfish (koura) are also present.

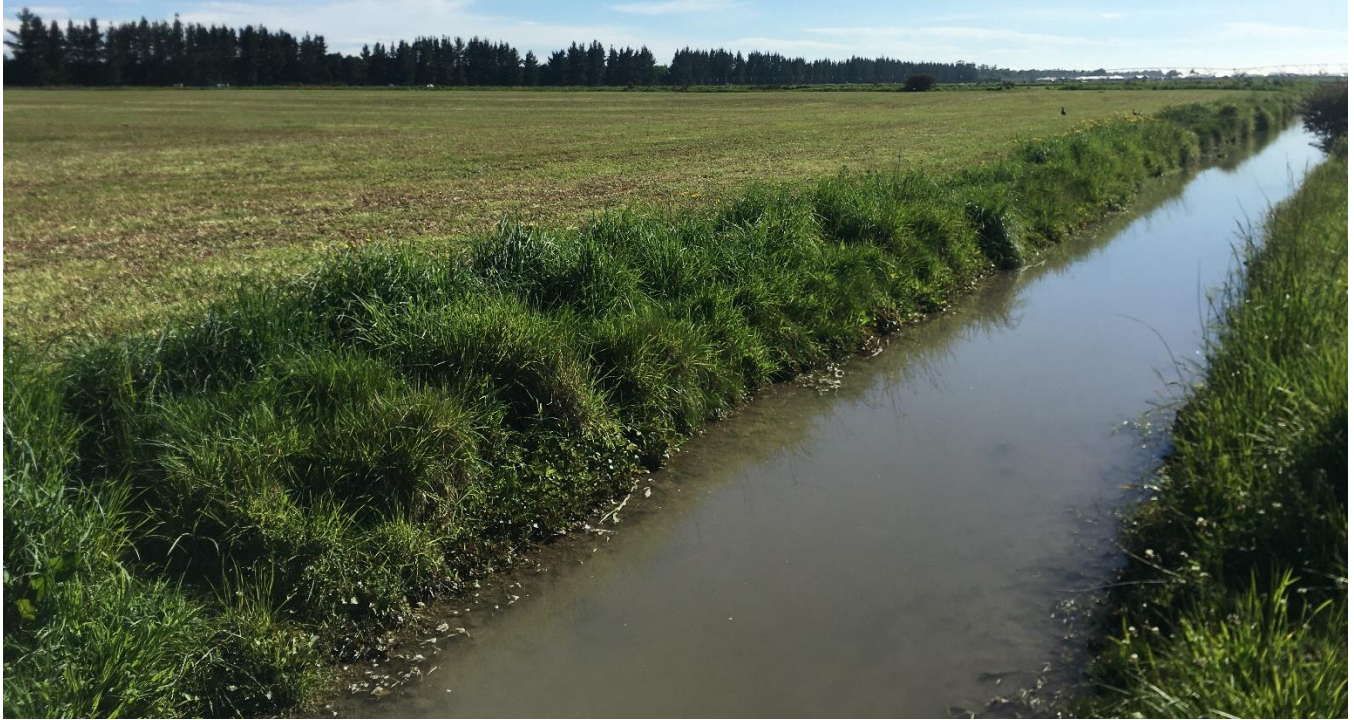
**Figure i.** The raceway through the west corner of the Holmes Block.

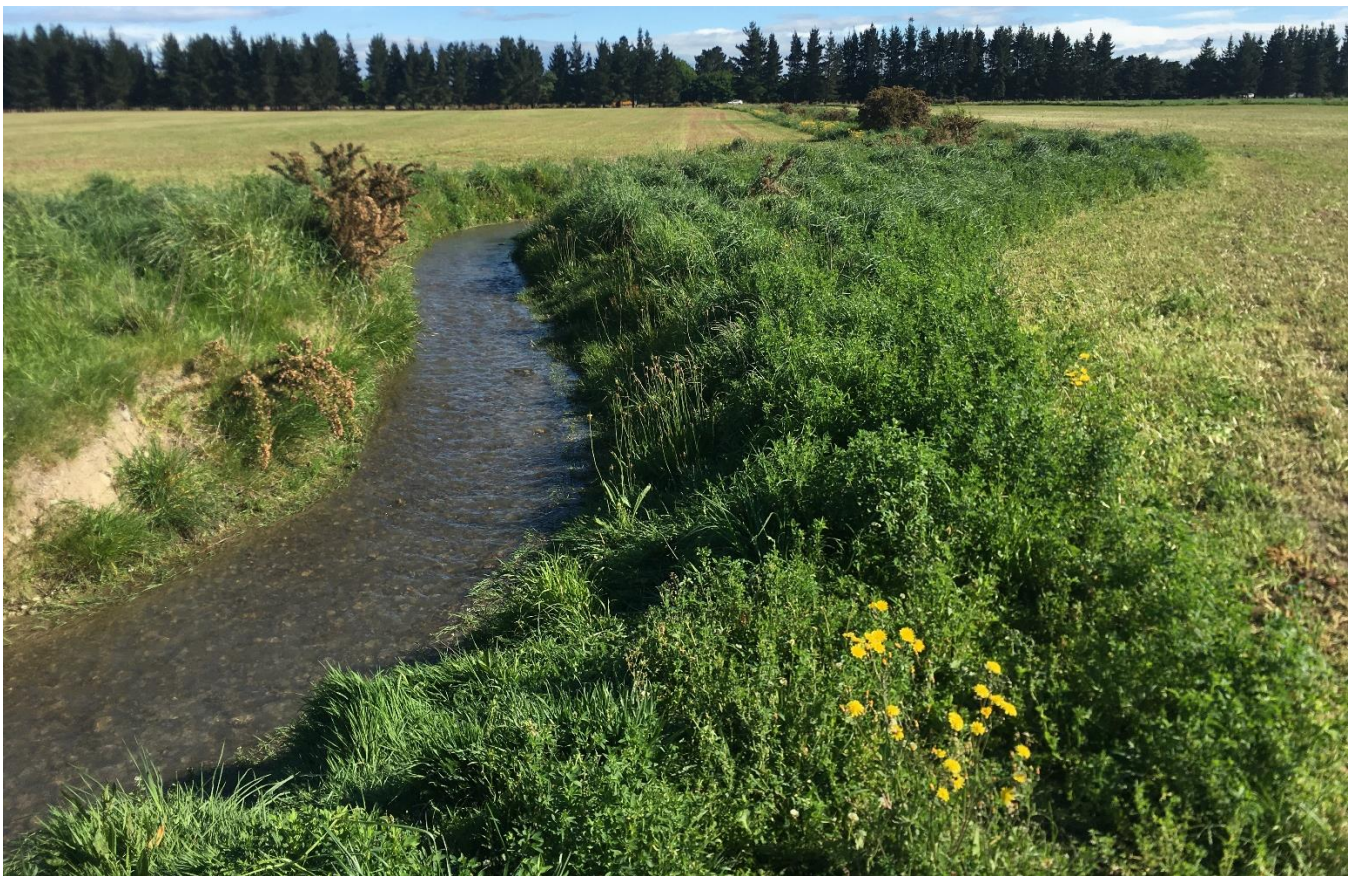
**Figure ii.** Shallow gravel reaches of the raceway through the west corner of the Holmes Block.
