Private Plan Change Request – Urban Estates Limited
Appendix B – Geotechnical Assessment
(Engeo)

Geotechnical Investigation

Multiple Sites

Southeast Rolleston

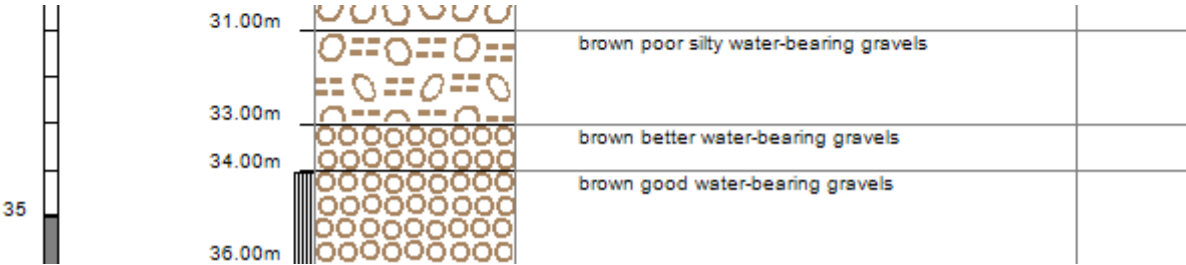
Bore or Well No	M36/8002	 	
Well Name	SELWYN ROAD		
Owner	MR & MRS AT & JM MULCAY		
Well Number	M36/8002	File Number	CO6C/24021
Owner	MR & MRS AT & JM MULCAY	Well Status	Active (exist, present)
Street/Road	SELWYN ROAD	NZTM Grid Reference	BX23:52536-70700
Locality	ROLLESTON	NZTM X and Y	1552536 - 5170700
Location Description		Location Accuracy	50 - 300m
CWMS Zone	Selwyn - Waihora	Use	Domestic and Stockwater,
Groundwater Allocation Zone	Selwyn-Waimakariri	Water Level Monitoring	--
Depth	66.00m	Water Level Count	0
Diameter	150mm	Initial Water Level	12.40m below MP
Measuring Point Description	ToC	Highest Water Level	
Measuring Point Elevation	36.00m above MSL (Lyttelton 1937)	Lowest Water Level	
Elevation Accuracy	< 2.5 m	First reading	
Ground Level	0.30m below MP	Last reading	
Strata Layers	13	Calc Min 80%	11.96m below MP (Estimated)
Aquifer Name		Aquifer Tests	0
Aquifer Type		Yield Drawdown Tests	1
Drill Date	28 Oct 2005	Max Tested Yield	4 l/s

Driller	Smiths Welldrilling	Drawdown at Max Tested Yield	11 m
Drilling Method	Rotary/Percussion	Specific Capacity	0.37 l/s/m
Casing Material	Steel	Last Updated	08 Nov 2013
Pump Type		Last Field Check	
Water Use Data	No

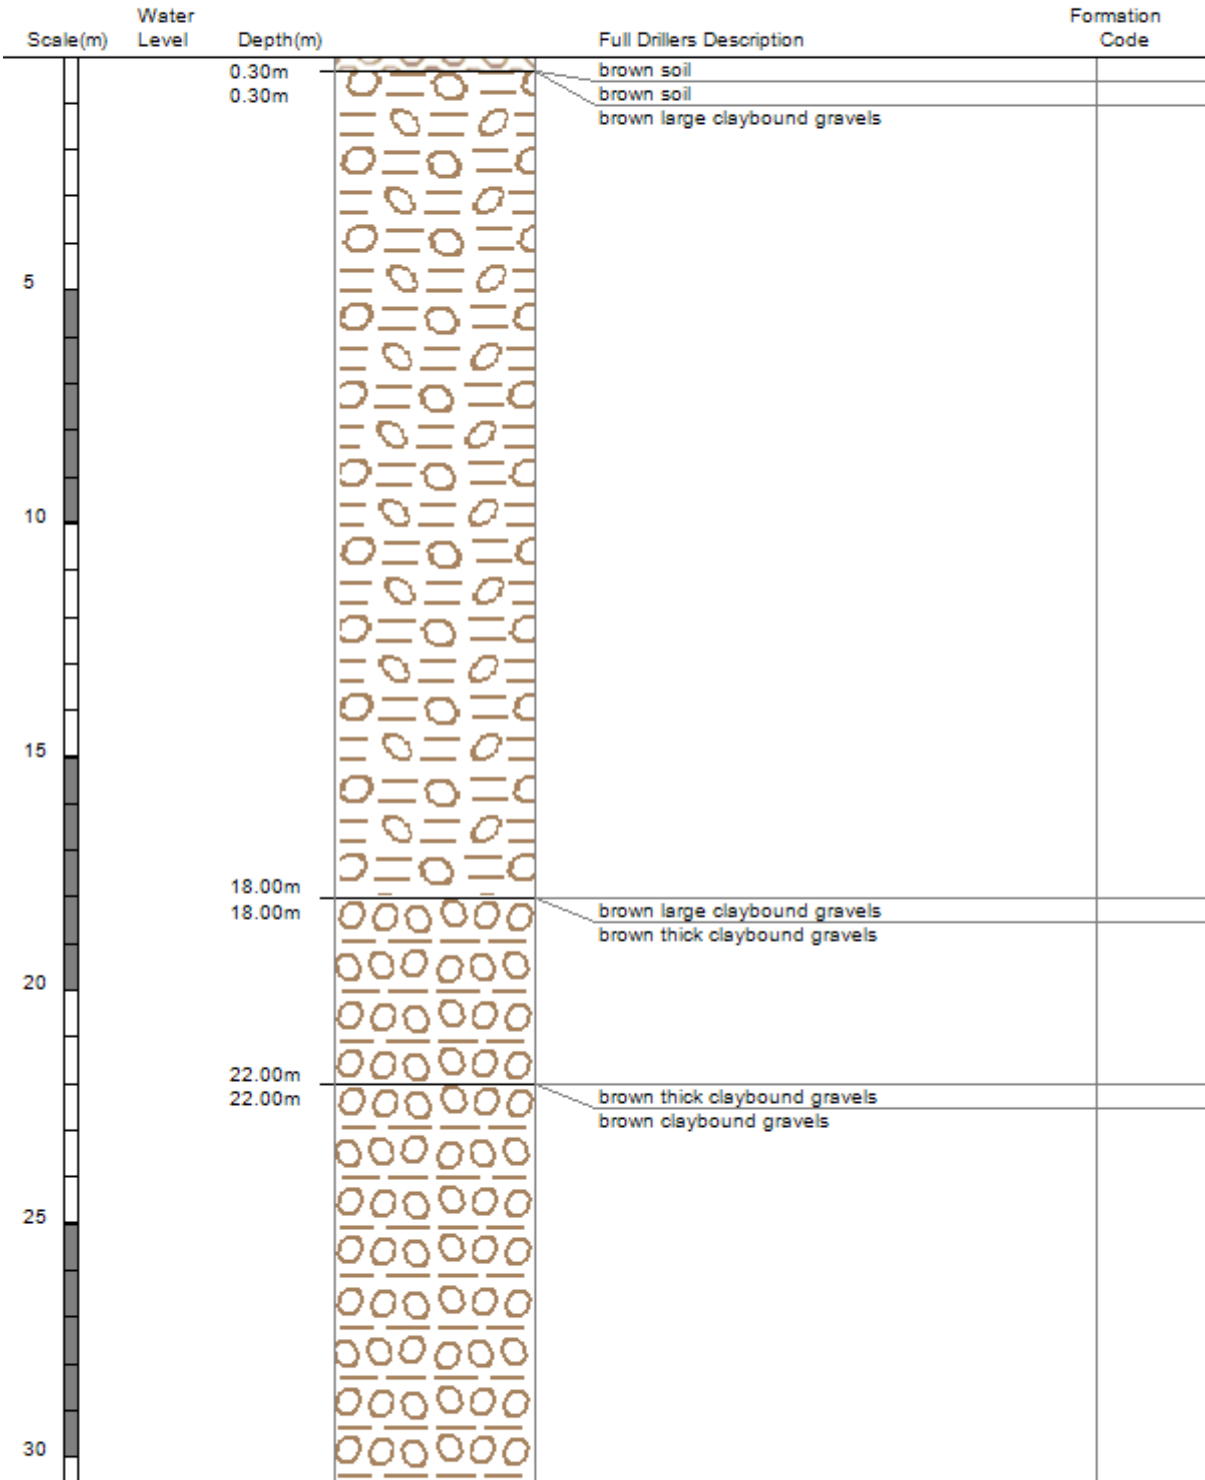
Borelog for well M36/8392

Grid Reference (NZTM): 1552568 mE, 5170575 mN
Location Accuracy: 2 - 15m
Ground Level Altitude: 34.3 m +MSD Accuracy: < 0.5 m
Driller: Daly Water Wells Ltd
Drill Method: Rotary Rig
Borelog Depth: 36.0 m Drill Date: 12-Jun-2007
