# Hydrogeology Assessment for Proposed Burnham Quarry

✧ Prepared for  
Burnham 2020 Ltd

✧ July 2023

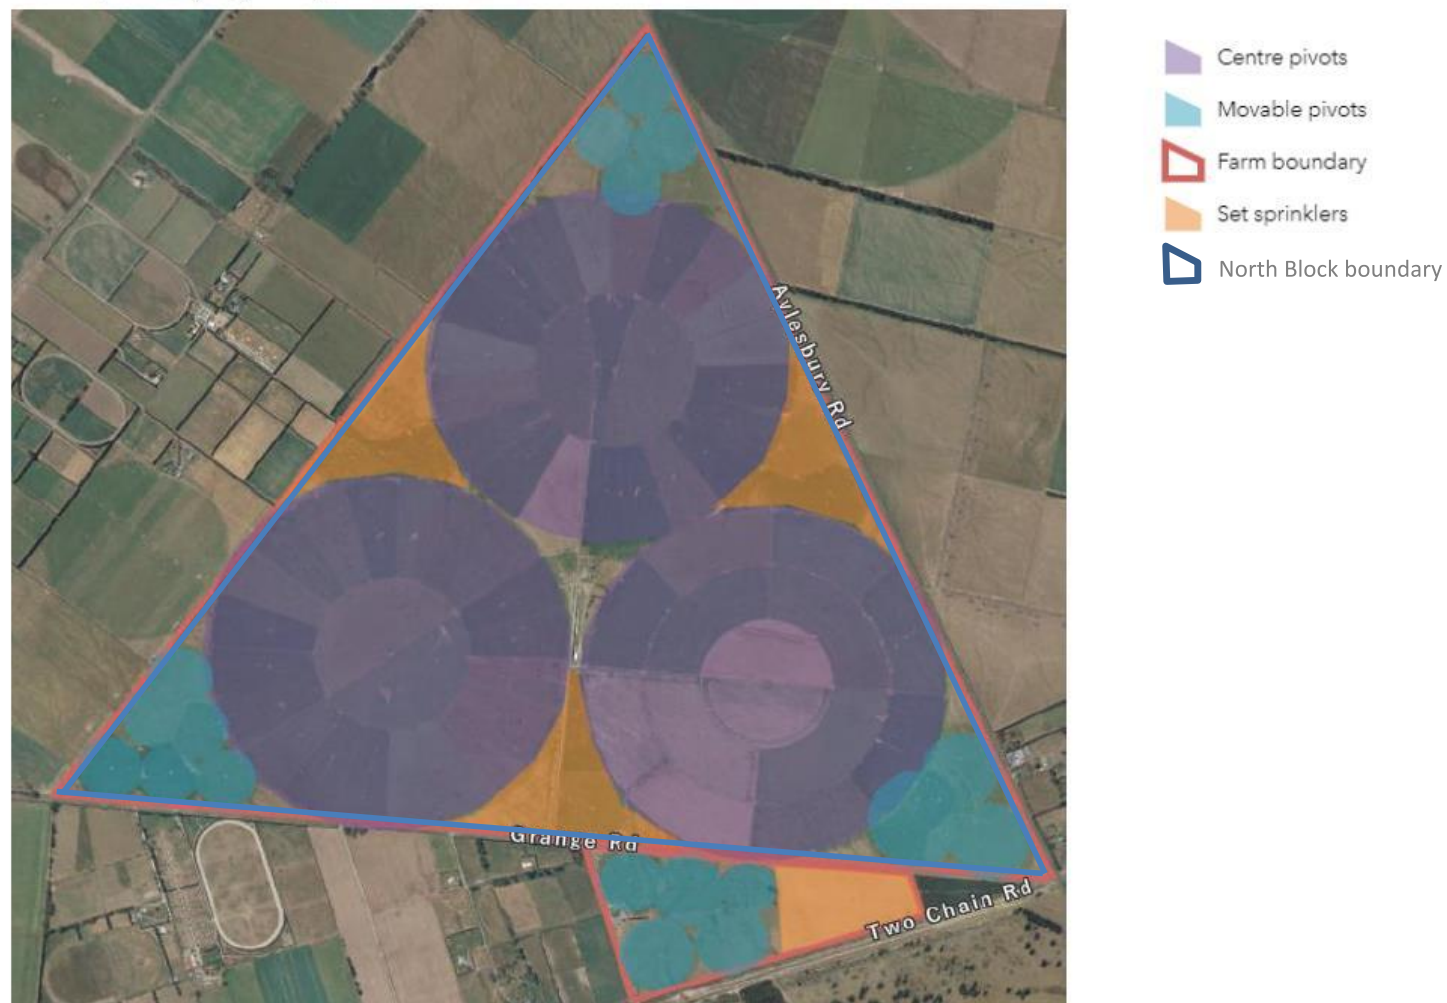
Farm map showing irrigation types.

FIGURE 1: PLAN SHOWING IRRIGATION TYPES USED ACROSS BURNHAM FARM

Burnham 2020 Ltd owns the 362 ha property known as Burnham Farm, shown in Figure 1. It proposes to progressively quarry the property to provide aggregate for construction projects. This report has been prepared by Pattle Delamore Partners Ltd, at the request of Burnham 2020 Ltd, to describe the hydrogeologic setting for the area and to assess the way in which the proposed quarry activity will interact with that hydrogeology.

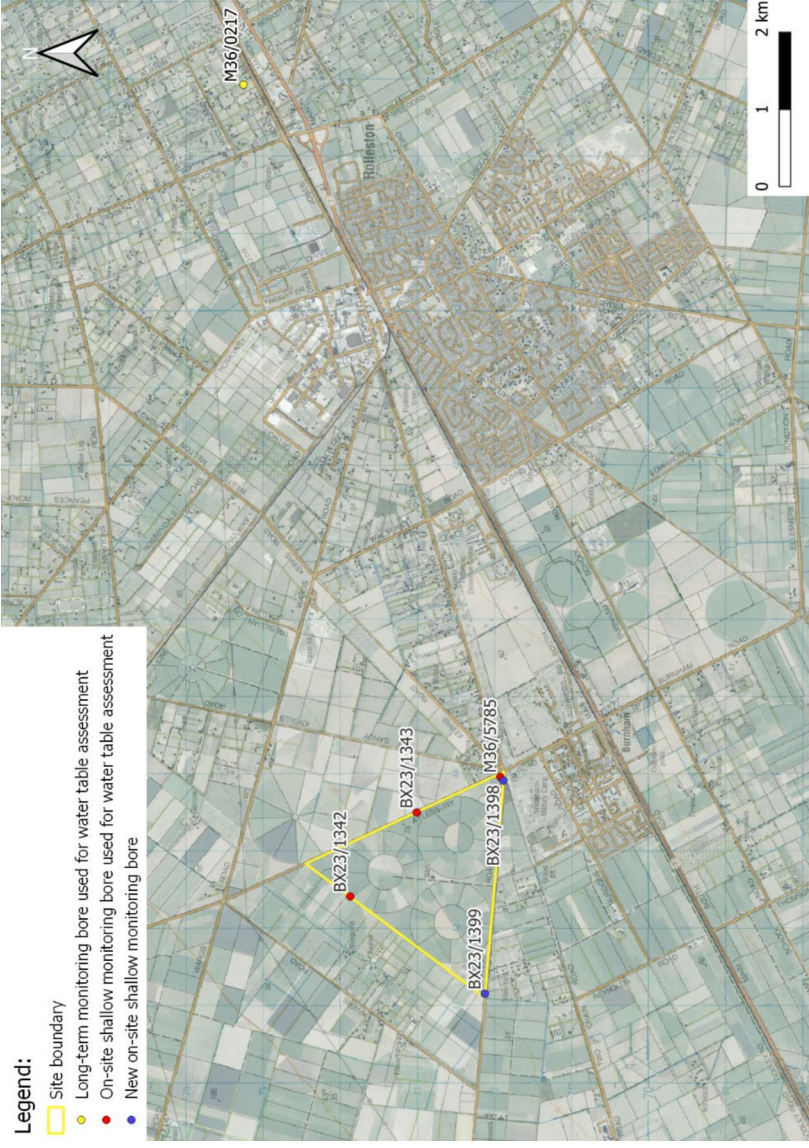
**Figure 1: Site location, and the location of monitoring bores used for creation of extrapolated groundwater long-term groundwater level records for the site.**
